## Water Resources Department

December 27, 2012

### Re: Silver Creek Dam (S-66) – Inspection Summary

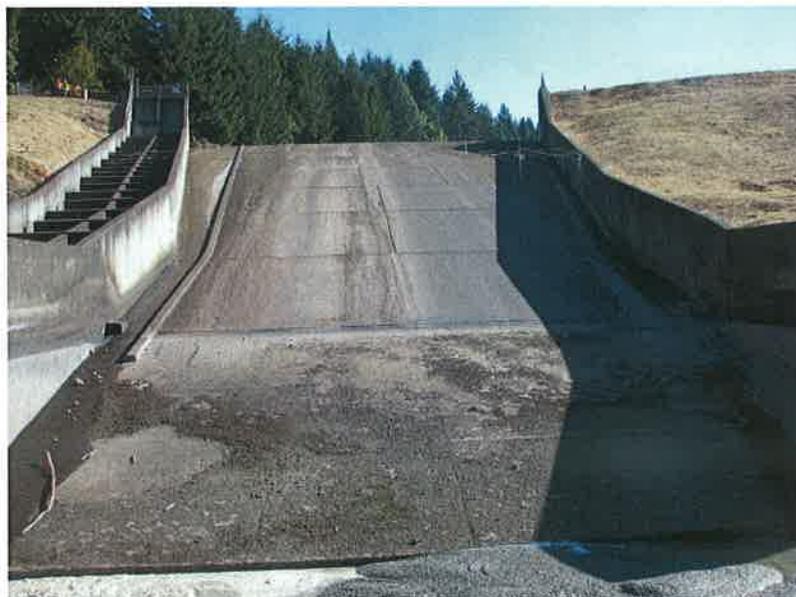
The spillway is the most important safety feature of the dam. At the time of the inspection the spillway was undergoing repairs to fix damage caused in part by scour associated with loose boulders at the outlet of the spillway.

Spillway with fresh concrete filling scour in stilling basin

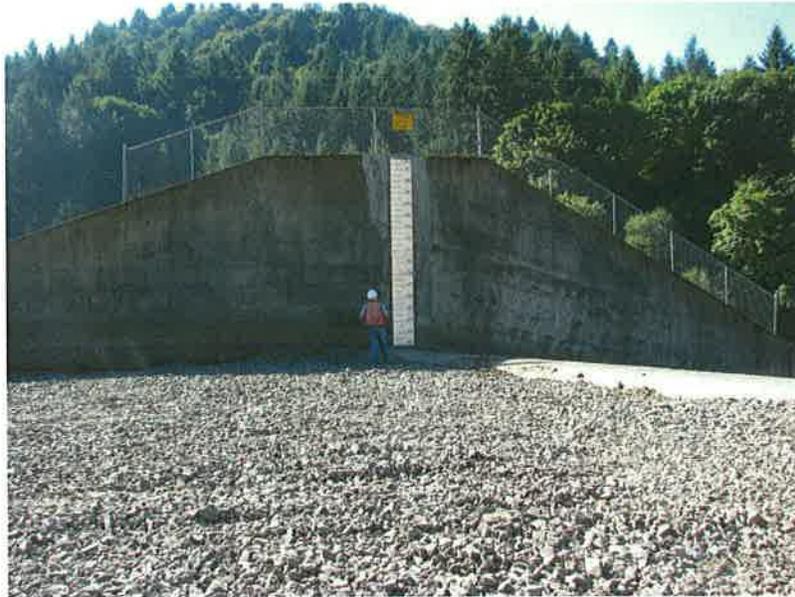
New staff gage at spillway crest

After the winter storm of January 2012, it was apparent that an easy to read gage at the crest of the spillway would be very useful, as the existing gage is much harder to see. And it will be interesting to see how the static level in the reservoir compares to the depth at the crest of the spillway during large peak flows.

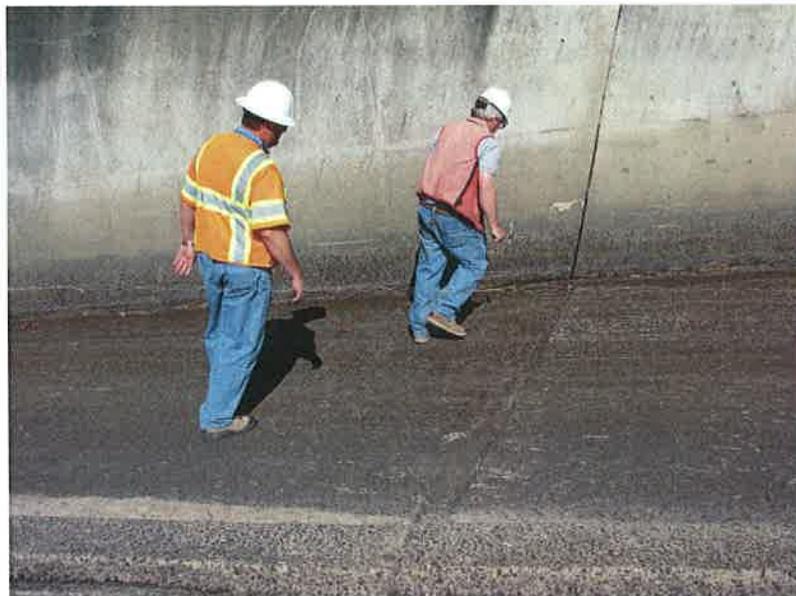
Inspecting spillway discharge channel slabs

The lowest slabs were visually inspected last year, and at least at the base of the spillway are poured directly onto competent basalt rock. The materials under the upper part of the

spillway include more of a colluvial material, so the concrete slabs and walls serve a critical dam safety function at this location.

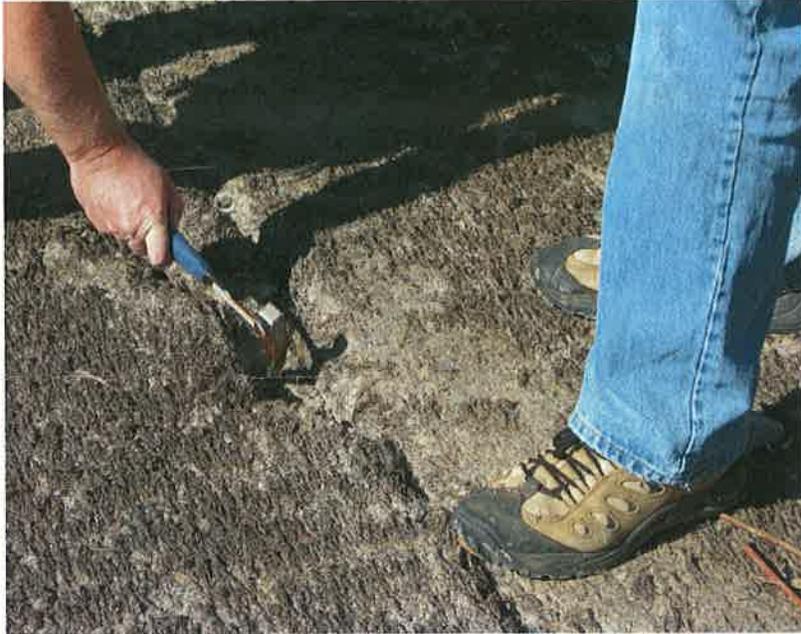
Spall and cracking of concrete slabs of the emergency spillway

There was a hollow sound when hitting concrete with the hammer at very limited locations. This may indicate small voids under the slabs at these locations. There is no associated distress observed in the slabs at this time. There was no sign of water flowing out of or into the joints either.

- 1) Secure access by road to the main dam embankment (probably from the south)
- 2) Investigate possible small voids under discharge spillway slabs
- 3) Secure any loose rip-rap on spillway approach
- 4) Continue to work towards remote monitoring of the dam. The simplest monitoring will be to have cameras installed in key locations. In my opinion, the next priority will be to reservoir level and accurate discharge flow measurements

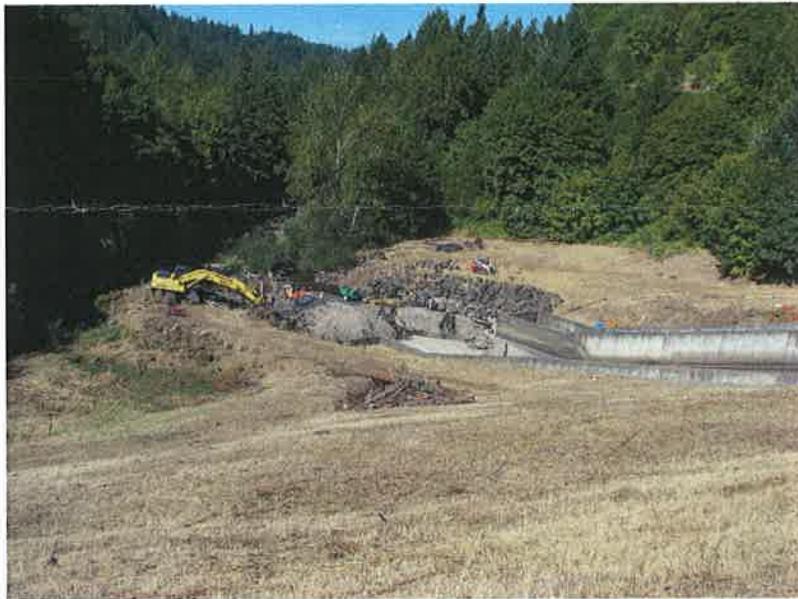
Downstream face, toe and spillway work

This photo provides the best view of the maintenance and repair work done on Silver Creek Dam in 2012. This addressed many of the priority issues from the 2011 inspection. The one issue here is that the embankment is currently accessible to heavy equipment during low flow periods, as there is no road to the south side of the dam.

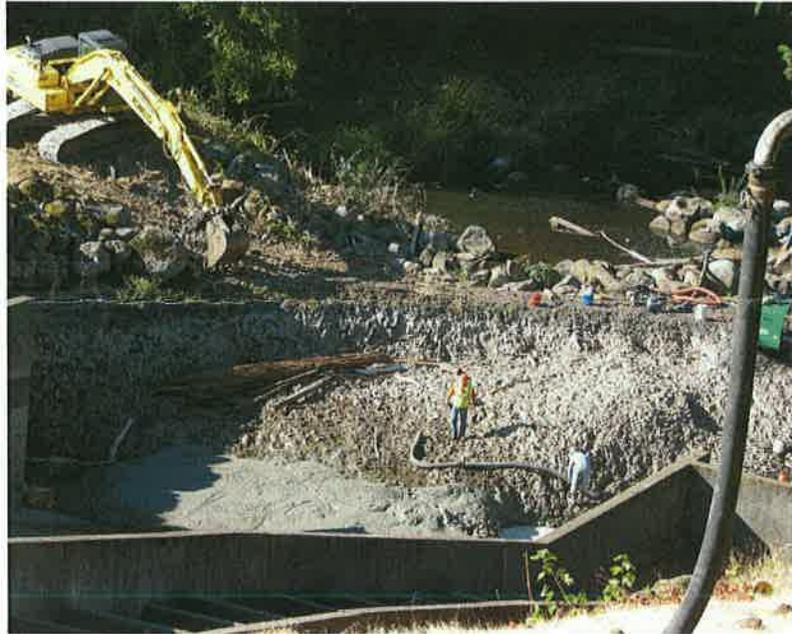
Repairs taking place at the outlet of the emergency spillway channel

This project filled the scour hole at the approach to the stilling basin. The concrete was nearly all placed during our inspection. This looks to have addressed a recommendation made by CH2MHill and by me from the 2011 inspections.

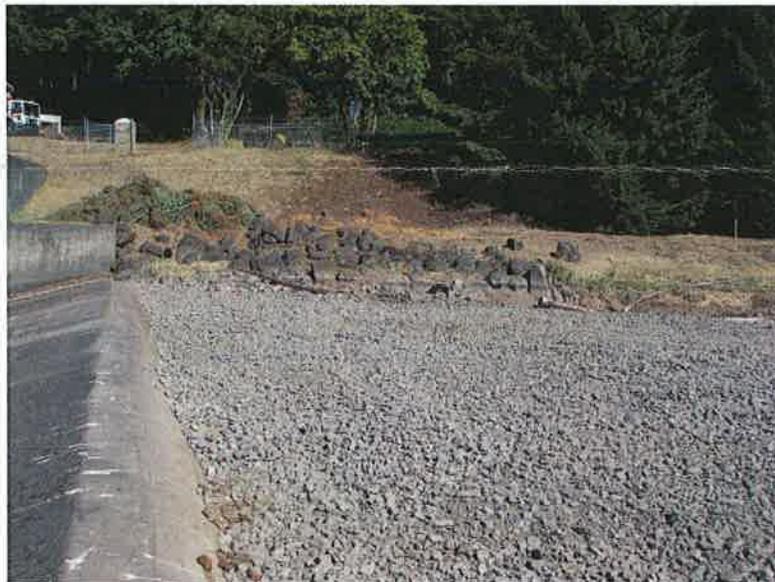
Rip rap located near the spillway approach

The gravel in the in foreground has just been re-graded, and I will be interested in evaluating this next year after winter flows. Most of the rip-rap appears sufficiently grouted, but there appear to be a few loose boulders. I believe these have been responsible in part for the past erosion in the approach to the stilling basin.

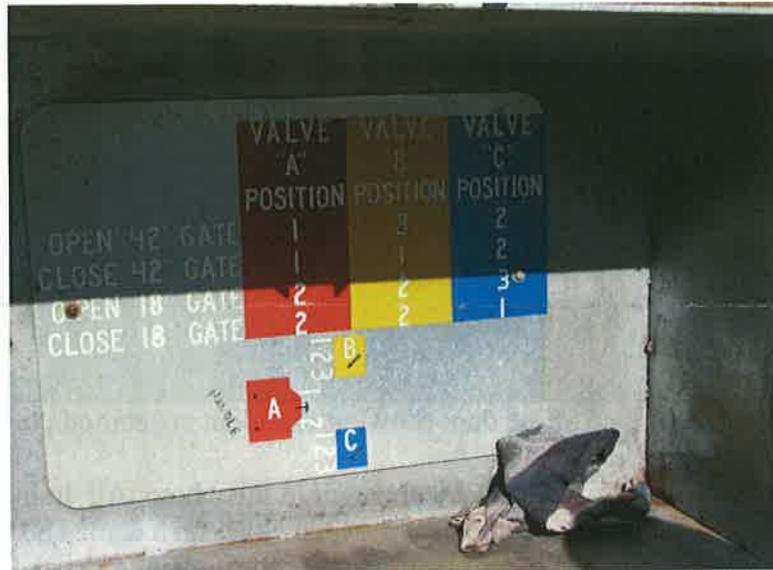
Instructions for hydraulic controls of two gate valves

These controls shown above are secure in a lock control box. The instructions are relatively simple, and the interior of the box was clean and operational. Operational contingencies in the case of a leak in the hydraulics will be important.

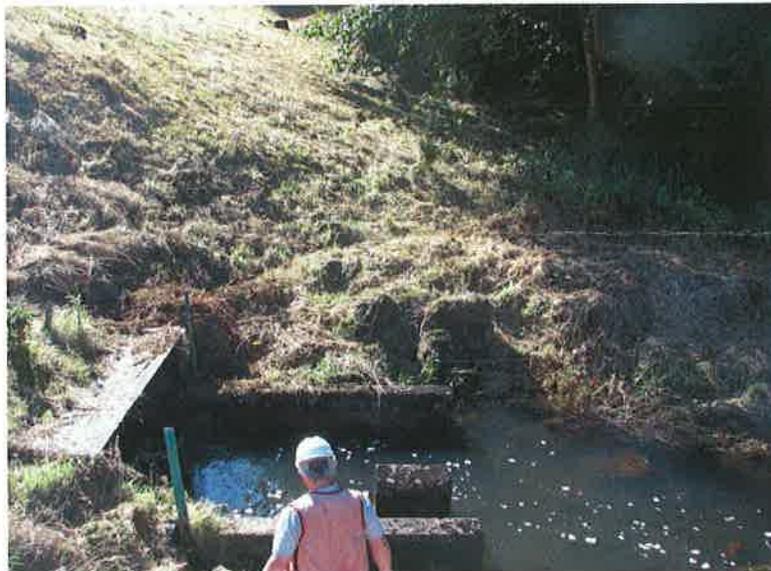
Low level conduit

The low level conduit of this dam was partly submerged. The upper portion of the conduit could be observed and showed no distress. The concrete is in good condition, and there is no erosion around the outlet structure.

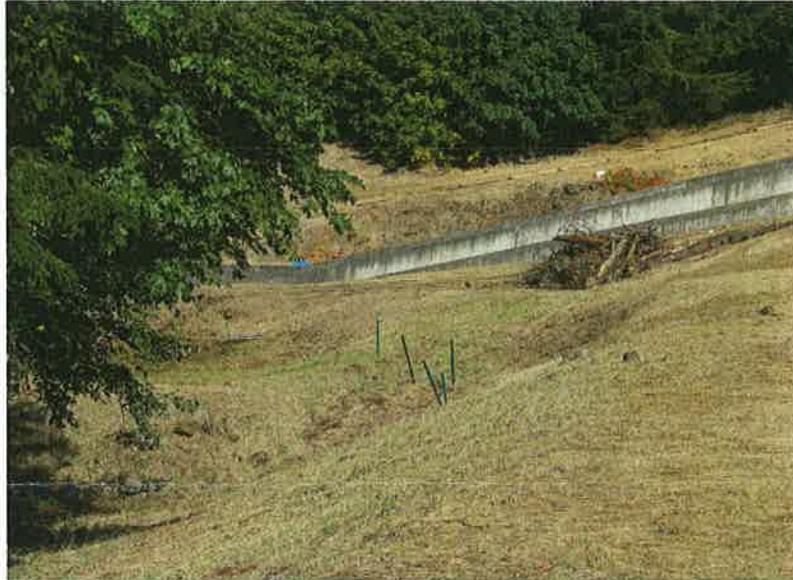
Downstream face of the dam showing excellent vegetation control

Thorough maintenance from 2012 is very apparent in this photo. All drains are carefully marked, and this low grass cover is the best possible cover on a dam. The low grass cover effectively prevents erosion, yet allows evaluation of the embankment and drains.
