Water Resources Department

December 24, 2014

Re: Silver Creek Dam (S-66) – Inspection Summary

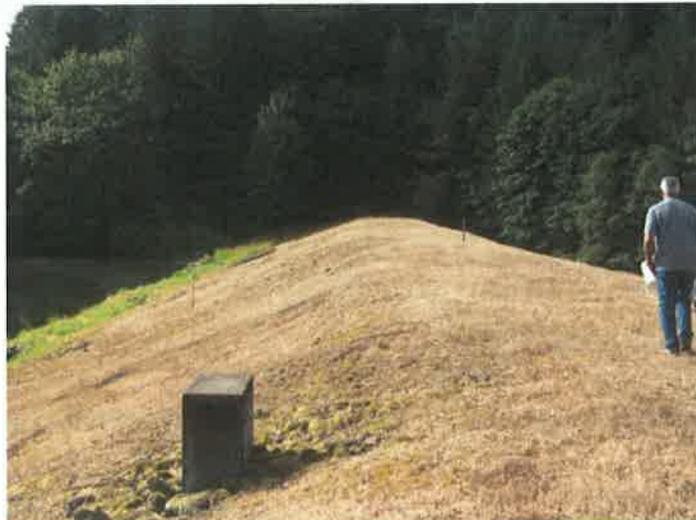
Crest

Vegetation on the dam had just been maintained, and it had a manicured appearance. This allowed simple and thorough inspection of all exterior surfaces of the dam. No evidence

of surface erosion or movement of the embankments was observed. The crest is fairly uniform and wide.

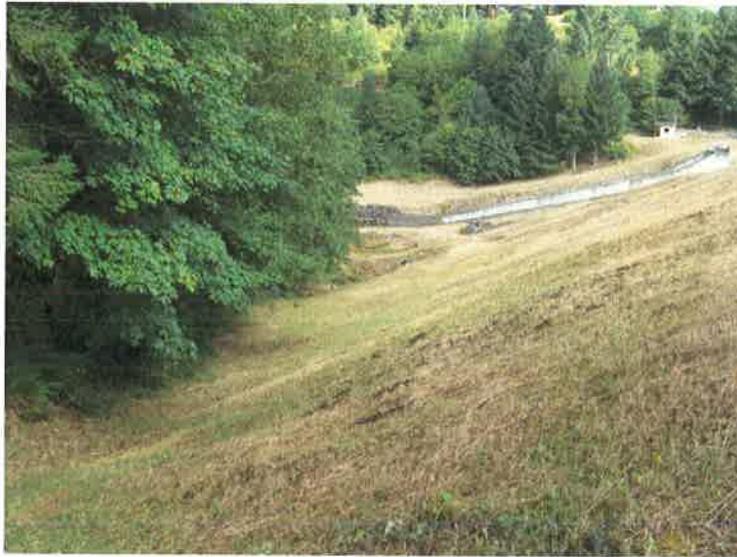
Downstream face from left abutment

The dam has a well maintained cover of grass and other non woody vegetation. The grass cover on the dam now effectively reduces surface erosion and provides very little cover for burrowing animals.

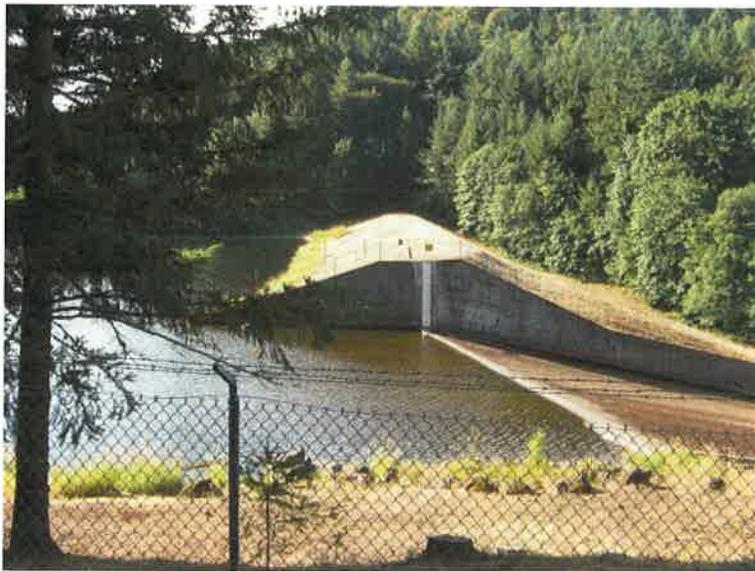
Spillway control section

The reservoir level was just below the spillway control section elevation for this inspection. There is a new staff gage to determine freeboard at the spillway crest, installed a couple of years ago to aid visual monitoring of water level during any significant flood event. Since the spillway was dry, a thorough inspection of the spillway surface was possible.

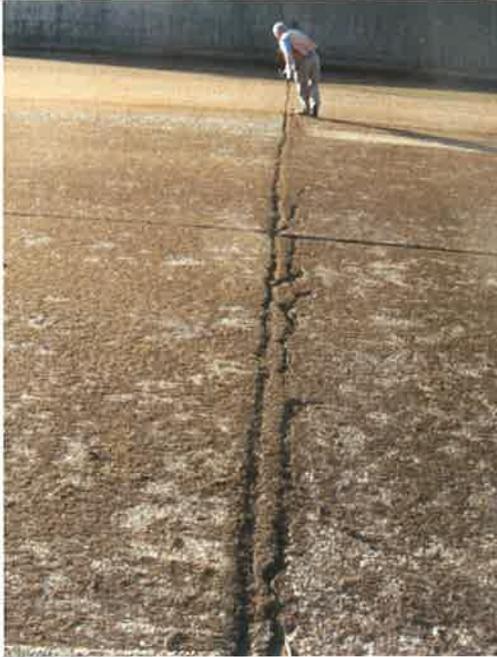
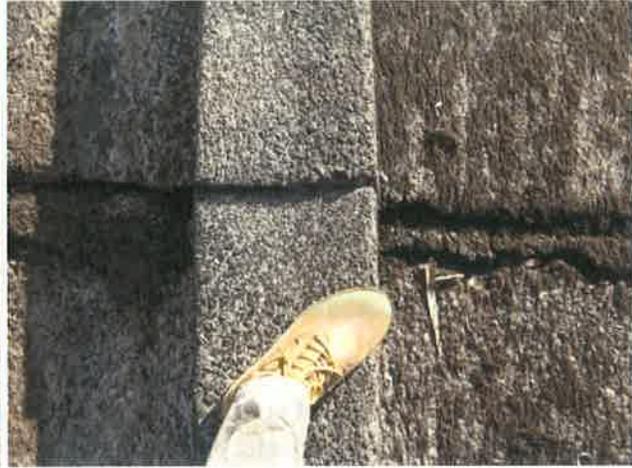
There are a few spillway slab locations with apparent voids under the concrete. It is unclear if the voids are the result of slight separation of concrete at the joints or if there are larger voids under the slabs. To make this determination it will probably require small cores through the concrete. It may be necessary to grout or make other repairs depending on what is found to be the cause(s) of these voids.

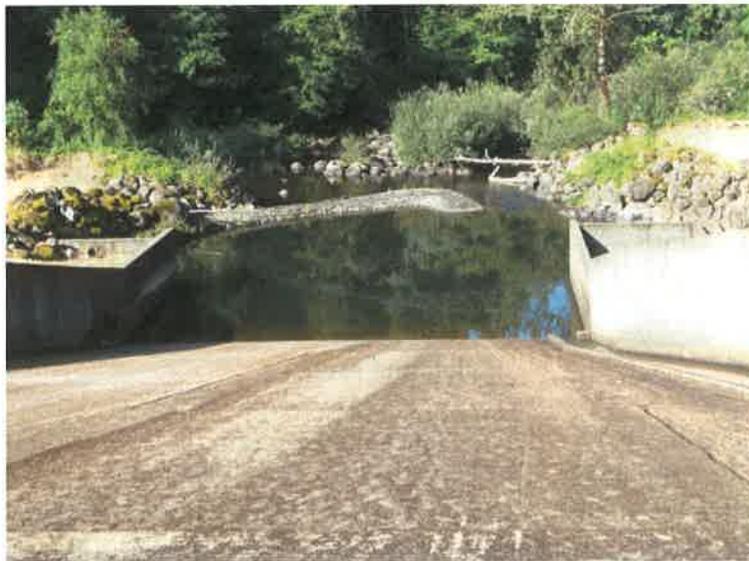
Stilling basin

The stilling basin and the base of the concrete section have been undercut by erosion over the years. The stilling basin was completely restored two years ago by use of a dental concrete to fill all the eroded surfaces. No changes were observed in seepage through the spillway drains.

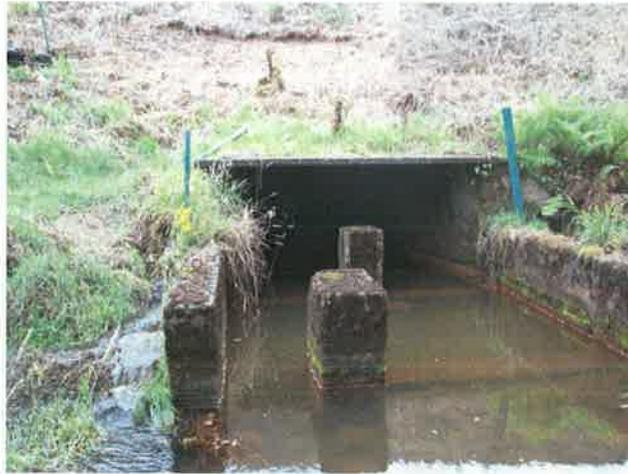
Outlet of low level conduit

The interior of the low level conduit has not been inspected in at least the last 8 years, at least not by an OWRD dam safety engineer. There appears to be continued minor leakage through the valve. It is a priority to inspect the conduit during the inspection this coming year, at a time where it is convenient for the City to close the valve.

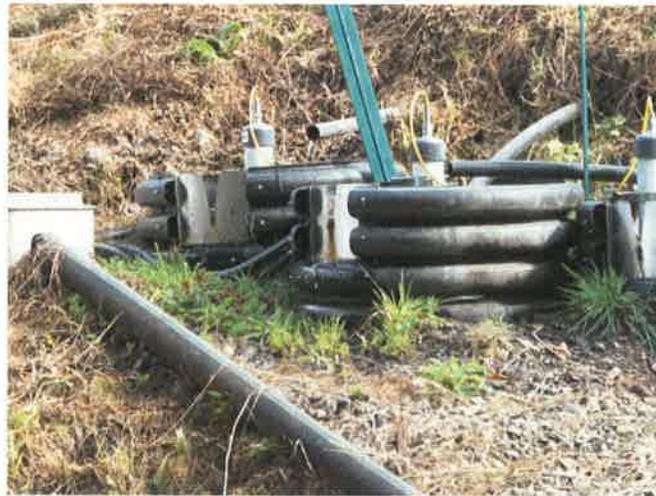
Collecting seepage

Seepage on this dam has been collected since construction. In the past, individual measurements have been made, often by filling buckets. Remote monitoring was under development for this inspection, I look forward to future reports from this monitoring. This monitoring will add to the security of this dam, as it should be able to detect any unusual changes in seepage rates.

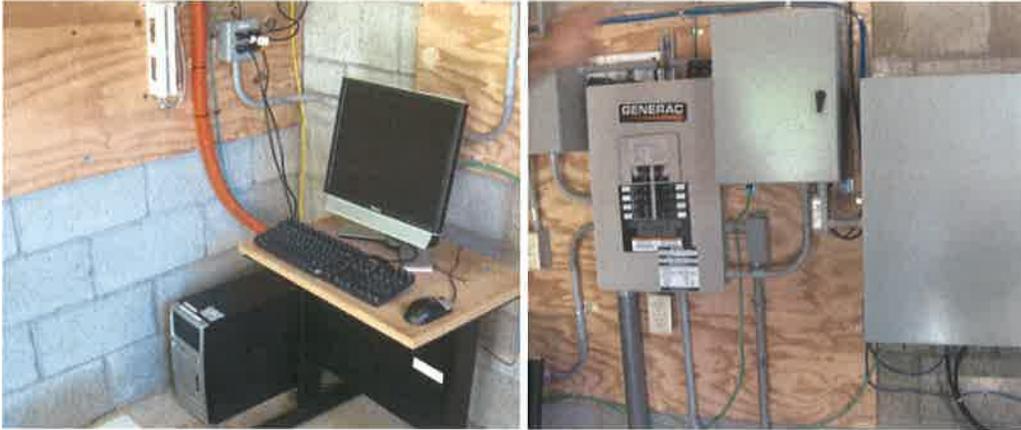
New monitoring of Instrumentation

Since our prior inspection in 2013 a small outbuilding has been built to house the electronic instrumentation equipment. Currently there are weir boxes and flow gages on all of the toe drains to monitor any changes in flow through the dam. Rich Barstad also informed us that a more comprehensive Early Warning System is going to be implemented sending notifications to appropriate personnel when the reservoir reached hazardous levels. Furthermore, Engineered Monitoring Systems is installing more piezometers to monitor flow depths and rates through the dam. Although this will not be complete for some time, having an electronic notification system such as this is very beneficial to the safety of downstream residents and dam safety when unusual conditions present themselves. Thank you for taking such an active role in maintaining the safety of Silver Creek Dam.
