January 4, 2016

## Re: Silver Creek Dam (S-66) – Inspection Summary

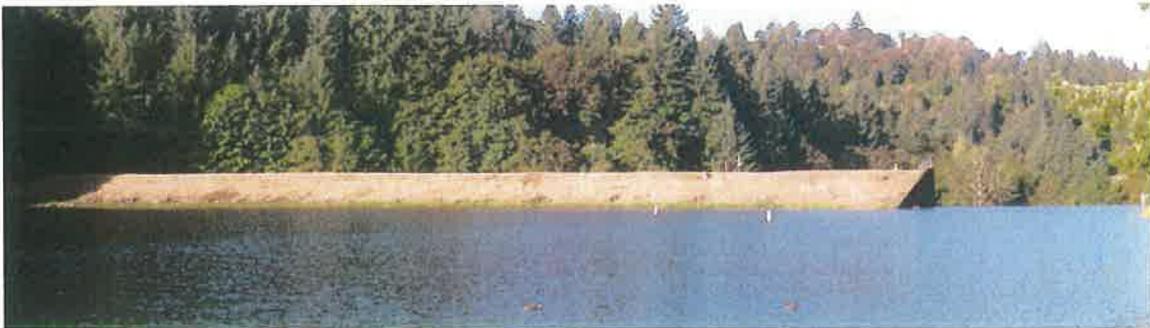
Silver Creek Dam embankment section, upstream slope, spillway at right.

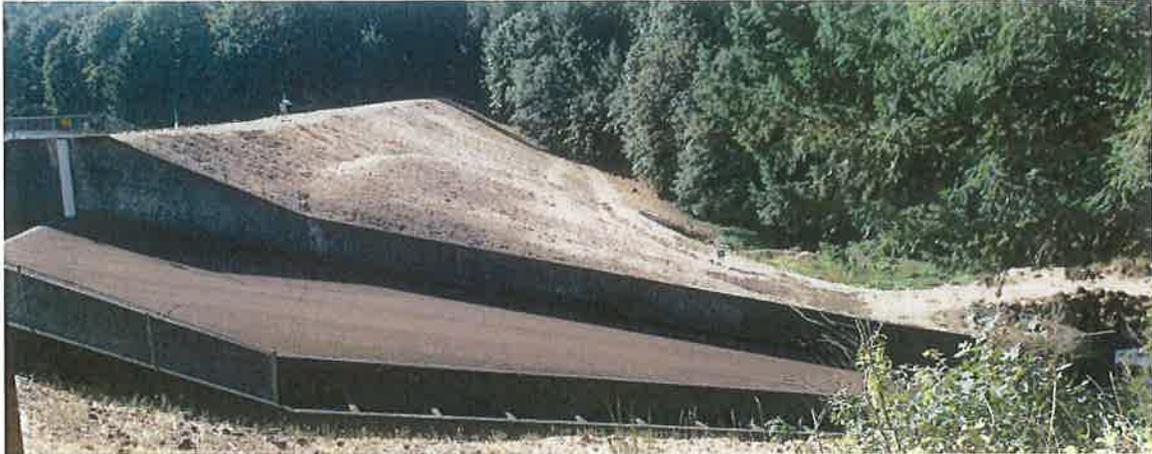
Silver Creek Dam downstream side, spillway in foreground, embankment in background.

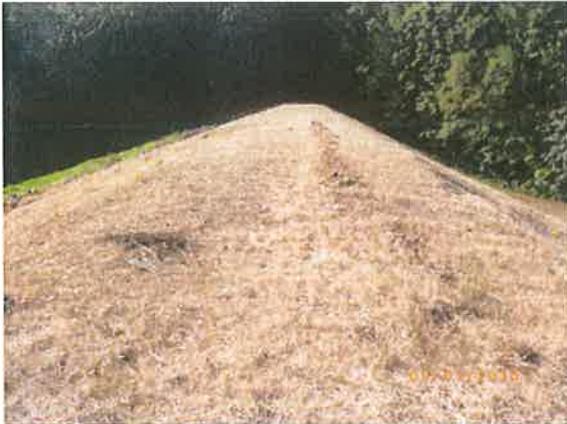
The embankment section had a mowed grass cover that effectively reduces surface erosion. No sign of settlement, instability, or erosion were observed on the embankment section. The downstream slope and abutments were dry.

Embankment section crest.

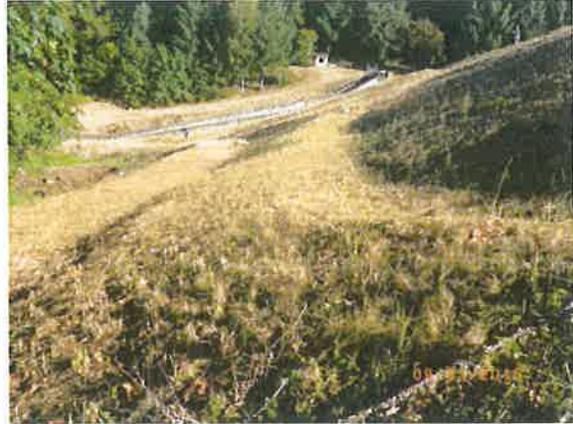
Embankment section downstream slope.

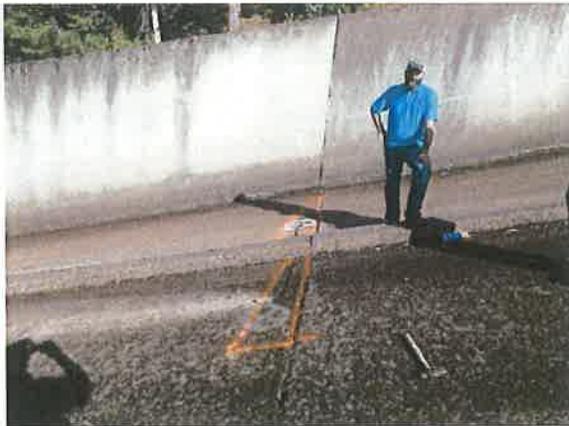
Cracking and spalling was observed along some of the concrete spillway's transverse slab joints. It appears that this condition may have been caused by hydraulic uplifting of the downstream edge of the adjacent slab. The inspection team returned to the site on September 9, 2015, for the City's repair of the worst of these slab joints, the second from the crest, on the right side of the spillway. Loose concrete was removed and the top of the joint was exposed. The joint was dry. A ¼-inch layer of fine soil was observed underneath the waterstop, where it had lost its bond with the underlying concrete. It appeared that the upper slab had lifted about 3/4-inch relative to the lower slab. The repaired area should be monitored for any changes. If similar cracking returns, it may be an indication that slab uplifting has recurred and further investigation would be required.

Spillway, second transverse joint from crest. Damaged concrete outlined in orange.

Stilling basin	<input type="checkbox"/> N/A <input checked="" type="checkbox"/> Functional <input type="checkbox"/> Minor Erosion <input type="checkbox"/> Severe Erosion/Undercutting	
Aux. Spillway	<input type="checkbox"/> Yes <input checked="" type="checkbox"/> No (use comments below)	
Comments:	Cracks and spalling at right side of second lateral joint below crest.

1. Continue vegetation management in your ongoing maintenance program.
2. Provide vehicular access to the main embankment section.
3. Monitor the repaired spillway joint for changes.
4. Continue to develop a remote monitoring program for the dam.
5. Investigate leakage through the low level conduit.

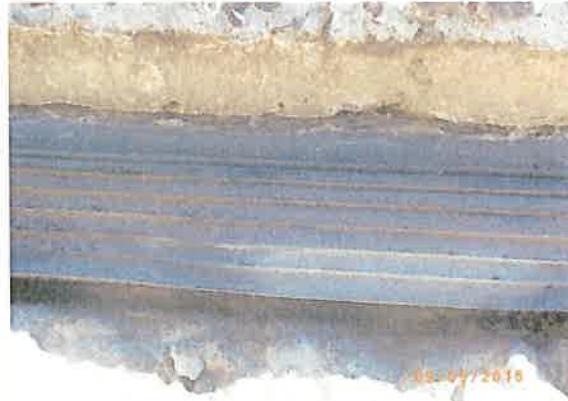
Water stop at exposed spillway joint. Note gap between water stop and lower slab.

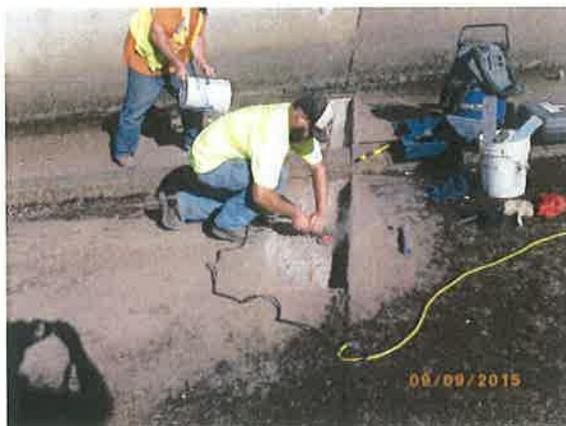
Repairing damaged concrete at second traverse joint from crest; September 9, 2015.

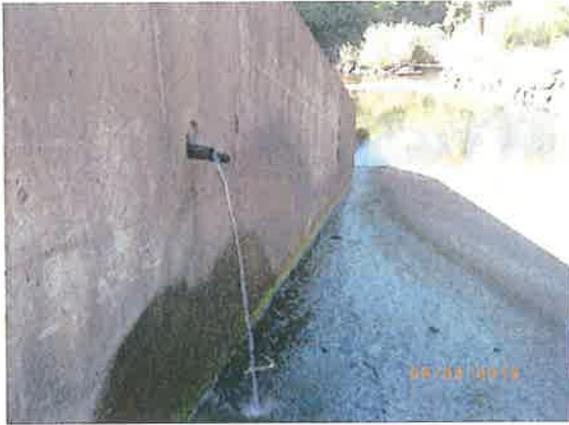
Drain 3 is the outlet for the underdrain located along the second transverse joint from the crest. This drain outlet orifice has two plastic pipes extending out of it. One of these pipes was discharging about 5 gpm. Reportedly, these pipes are outlets for embankment section underdrains that were installed subsequent to initial construction. It is not known whether the spillway underdrain remains connected to the outlet orifice.

Discharge from pipes in drain Outlet 3.

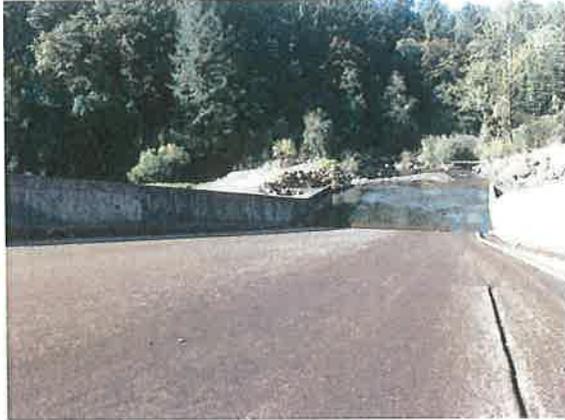
Spillway, stilling basin in background.

The spillway stilling basin was repaired in 2013. To date, the stilling basin repairs have not been subjected to a high flow event.
