US Army Corps
of Engineers®
Portland District

Final Report

Silver Creek Dam Potential Failure Modes Analysis (PFMA)

11 APRIL 2011

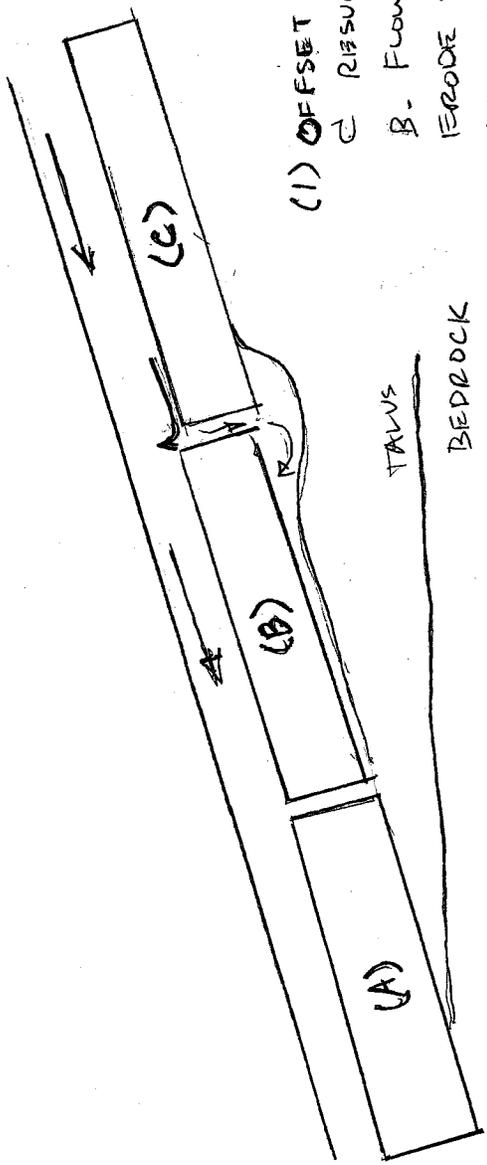
Spillway flow impacts on vertical offset in spillway slabs which result from uplift pressure or slab settlement (either under long term static conditions or seismically induced). The most critical offset is the downstream slab uplifted relative to the upstream slab, which creates localized high pressures that may penetrate down along the slab joint and create high uplift pressure. Landslide foundation materials are exposed initiating erosion. Exposed talus/landslide is highly erodible and scour will progress. Continued loss of foundation material results in additional slab failures upstream and additional foundation exposure and erosion. Erosion progresses to the upmost slab eroding down to basalt resulting in uncontrolled release. Figure 2 is a sketch of this failure mode.

(1) OFFSET BETWEEN SLABS B AND C RESULT UPLIFT PRESSURE ON SLABS.
 B. FLOWS BETWEEN THE SLABS ERODE THE TALUS. GAP INCREASES RESULTING IN GREATER UPLIFT PRESSURES; SLAB B LIFTS UP INTO FLOW AND IS LOST DOWNSTREAM.

- 4) Inspect the spillway for vertical offsets between slabs during period when spilling is not occurring (summer low pool inspection). The most critical offset is the downstream slab uplifted relative to the upstream slab; this creates localized high pressures that may penetrate down along the slab joint and create high uplift pressure. If downstream vertical offsets are present, grind the downstream slab down to remove offsets. Recommend visual inspections are completed at least once per year.

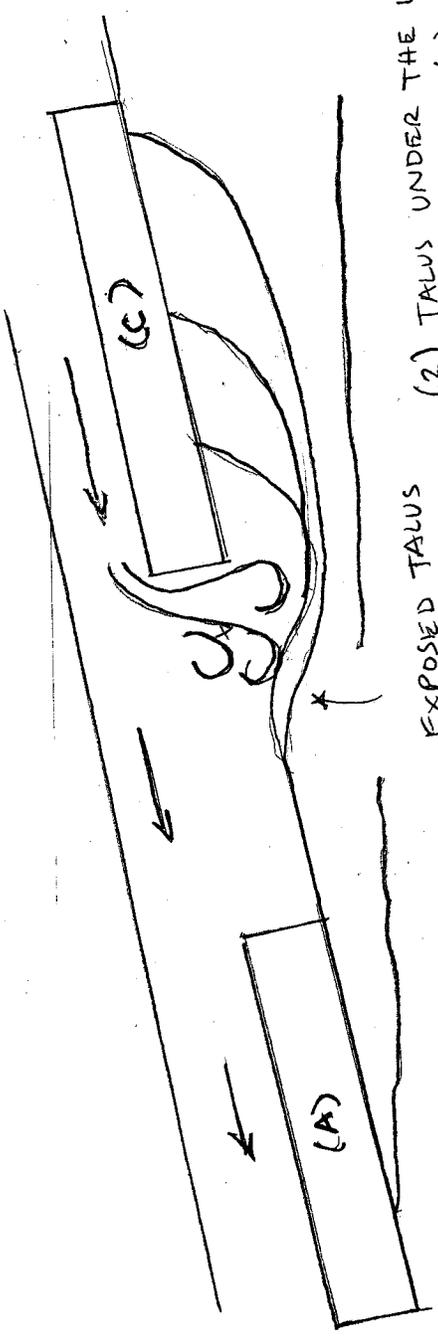
Figure 2. Spillway Slab Jacking Failure Mode

(2) TALUS UNDER THE LOST SPILLWAY SLAB (B) RAPIDLY ERODES BENEATH SLAB C UNTIL IT FAILS, EXPOSING ADDITIONAL TALUS AND THIS CYCLE CONTINUES UNTIL EROSION REACHES THE RESERVOIR AND UNCONTROLLED RELEASE.

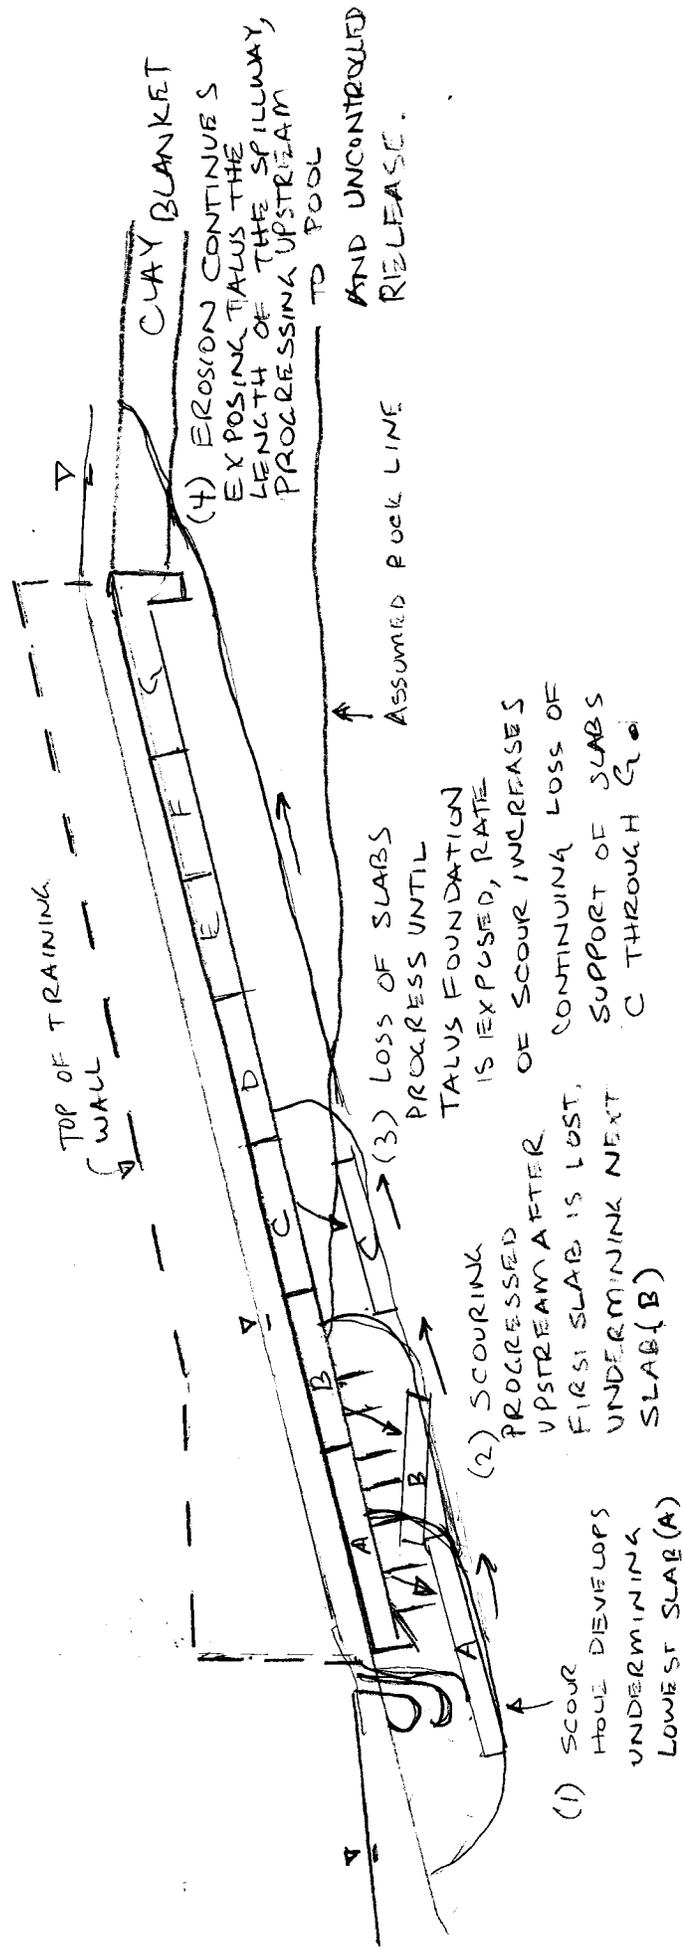
Figure 3. Spillway Downstream Sill and Stilling Basin Scour Failure Mode

Spillway flow initiates erosion of the basalt and spillway stilling basin concrete. Erosion continues, undermining the spillway concrete and foundation. Failure/undermining of the spillway foundation at the toe results in loss of spillway slab support. Loss of slab support permits slab failure, exposing the talus/landslide foundation. Exposed talus is highly erodible and scour will progress. Continued loss of foundation material results in failure of additional slabs upstream and additional foundation exposure and erosion. Erosion progresses to the upmost slab, resulting in all spillway slabs having been displaced and eroding down to basalt resulting in uncontrolled release. Figure 3 is a sketch of this failure mode.

- Spillway was extended due to poor foundation conditions (talus)

- Construction final report documents difficulty with rock anchor installation due to poor rock quality and saturated foundation (water in anchor holes).
- Oct. 1975 inspection mentions scour at the sill.
- Visual observation during the site visit showed turbulence/flow disturbance on the left side of the spillway at the toe.
- Foundation bedrock was described as poor to fair quality.
- Original inspection manual indicated concern about erosion of the stilling basin and recommends frequent inspections and monitoring for erosion. (Maximum historical pool of Elev. 430 corresponds to flow of approximately 5,000 cfs).
- Spillway flows occur approximately 9 months out of the year.
- Pool was very calm immediately downstream of end of spillway then turbulent downstream of calm area (possible deep pool). This may be indicative of a possible deep pool created by scour.

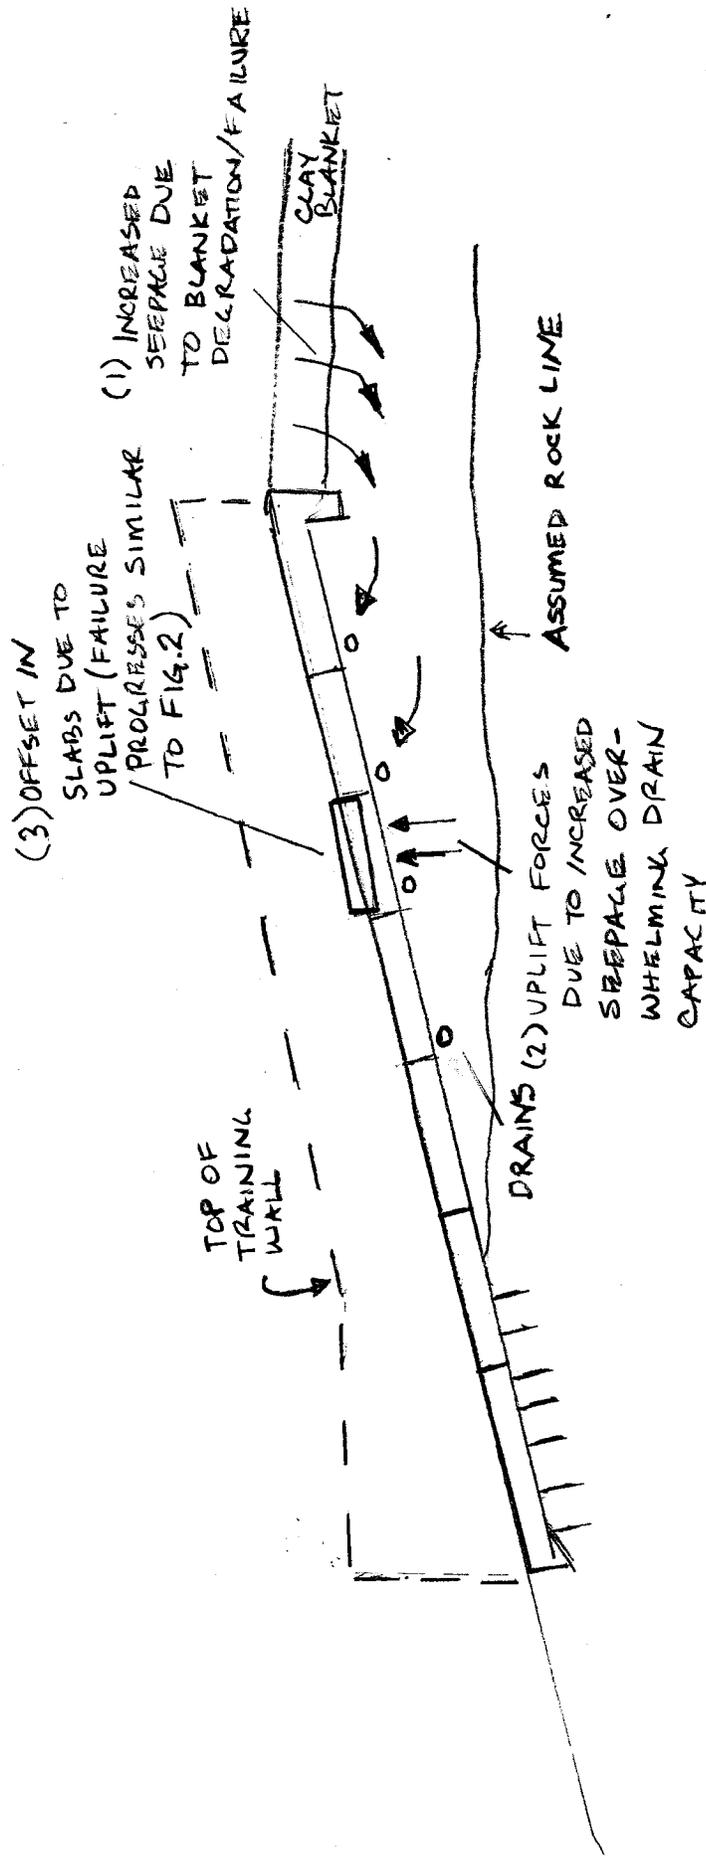
Figure 4. Upstream Spillway Sill Scour Failure Mode.

Scour present on the upstream sill of the spillway permits additional flow under the spillway. The resulting flow overtaxes the spillway drain system creating full uplift on the spillway and slabs. Increased uplift and cycles of loading displace spillway slabs (by offset, settlement, anchorage failure, etc.) resulting in exposed highly erodible talus/landslide foundation. Erosion progresses through continued loss of slab support and scour. Scour progresses upstream to full pool resulting in uncontrolled release down to bedrock (approximately El. 375). Figure 4 is a sketch of this failure mode.

- Construction final report documents difficulty with rock anchor installation due to poor rock quality and saturated foundation (water in anchor holes).
- Spillway flows occur approximately 9 months out of the year.
- Upstream impervious blanket has historically eroded and been repaired with pit run rock which does not provide the same seepage cutoff that the original blanket would provide.

- Each repair cycle indicates removal of impervious blanket, resulting in reduced scour but increased flow beneath the spillway.

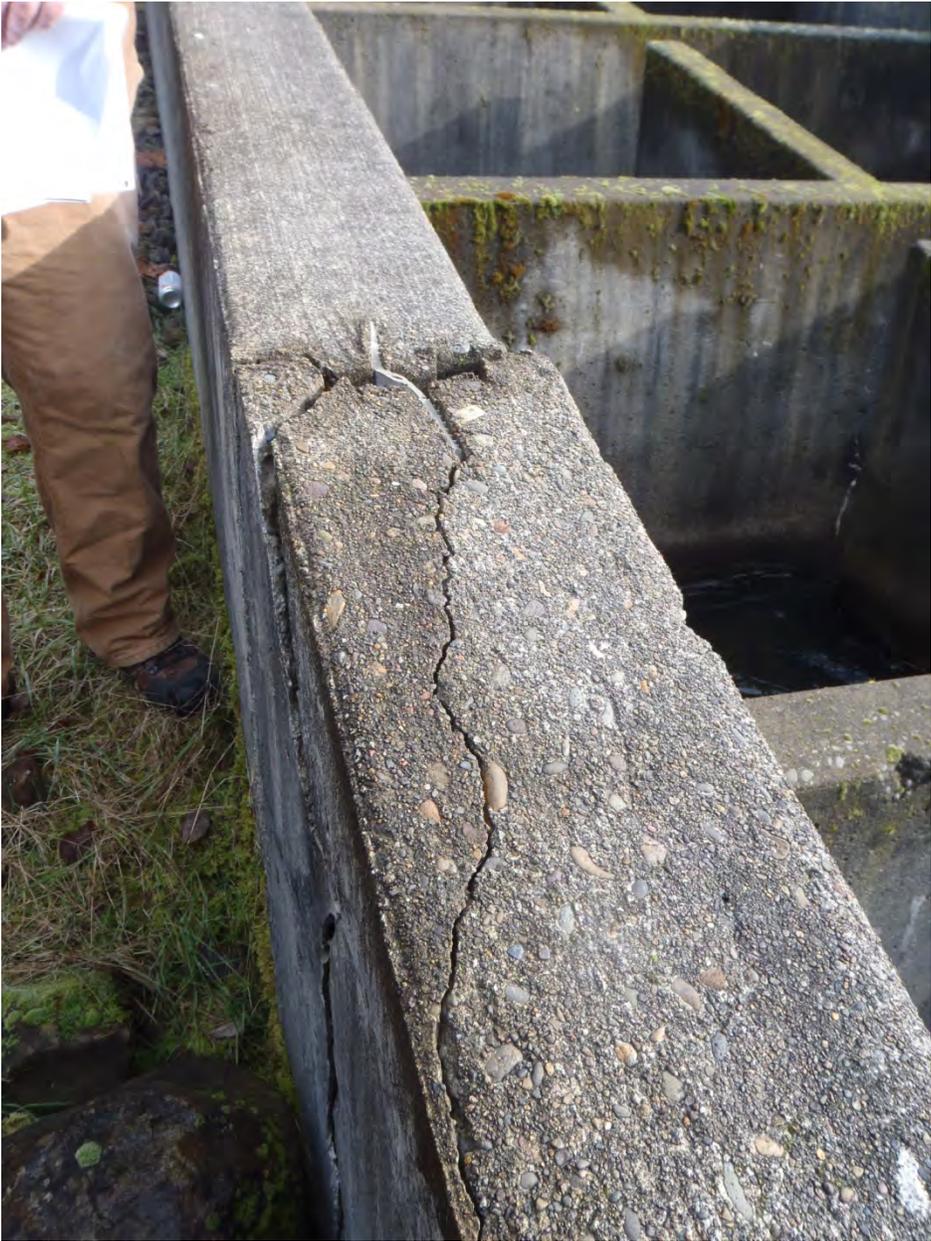
Photo 3. Deformation at Right Fish Ladder Wall

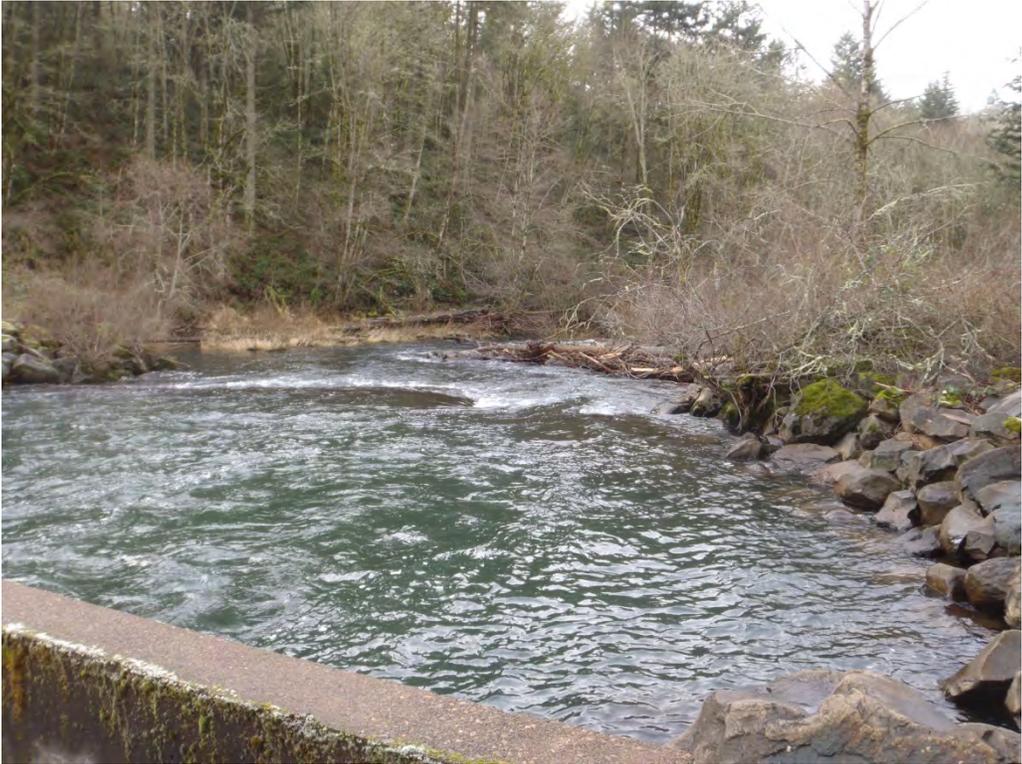
Photo 4. Relatively Calm Tailrace Water Conditions

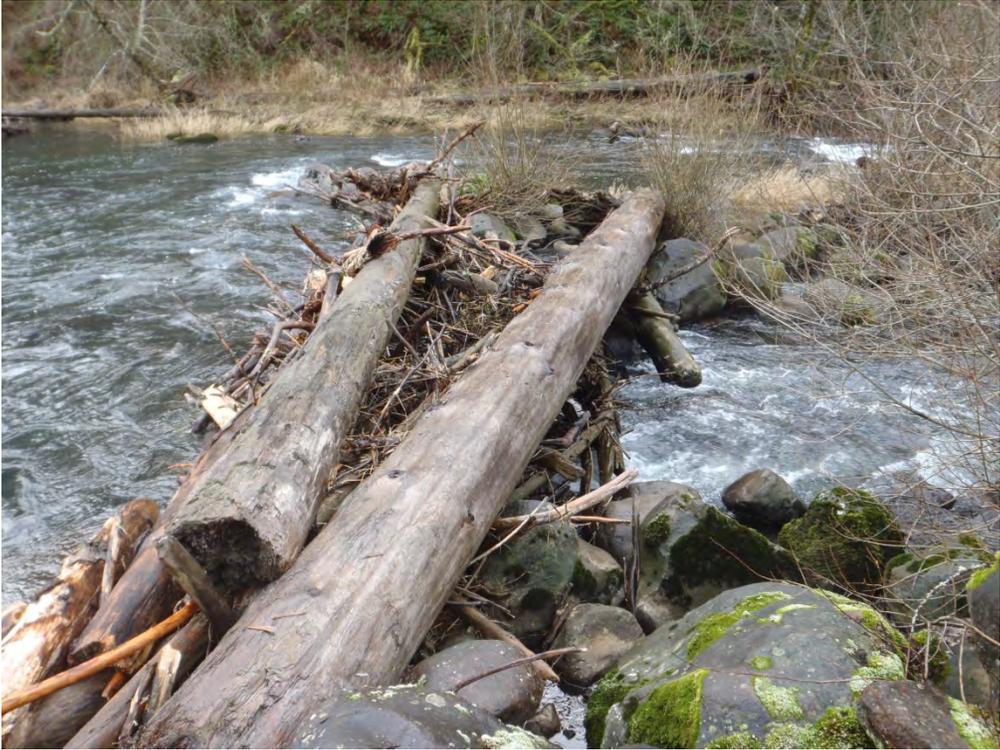
- 34) Large vegetation debris is expected to continue to collect downstream of the spillway below the stilling basin, reducing channel capacity. If this material continues to collect over many years, it may create a downstream hazard during a subsequent large flood event as occurred in recent flooding events on the Sandy River resulting in downstream damage to bridges and property.

Photo 5. Vegetation Debris in the Tailrace Area

- 11) The increased woody debris building up downstream of the stilling basin creates a potential for downstream damage during future storm events. During large events, this material may become dislodged and cause damage to bridges and property. The City should consider removing this material every 5 years.

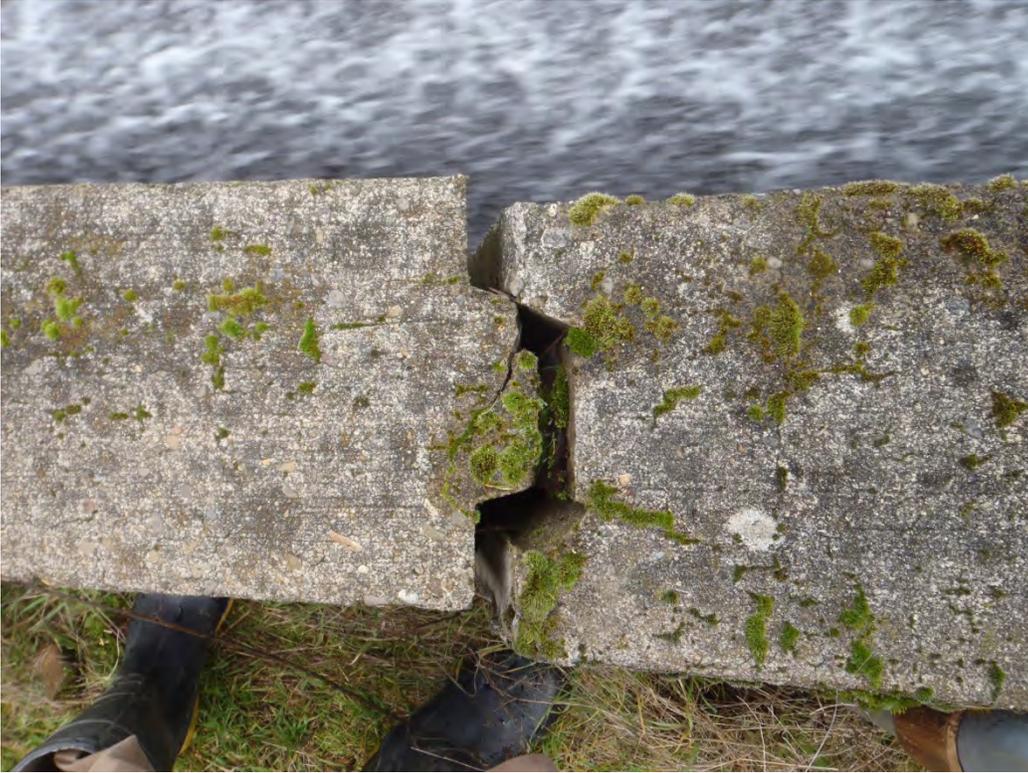
Photo 6. Relative Lateral Deformation, Left Spillway Wall

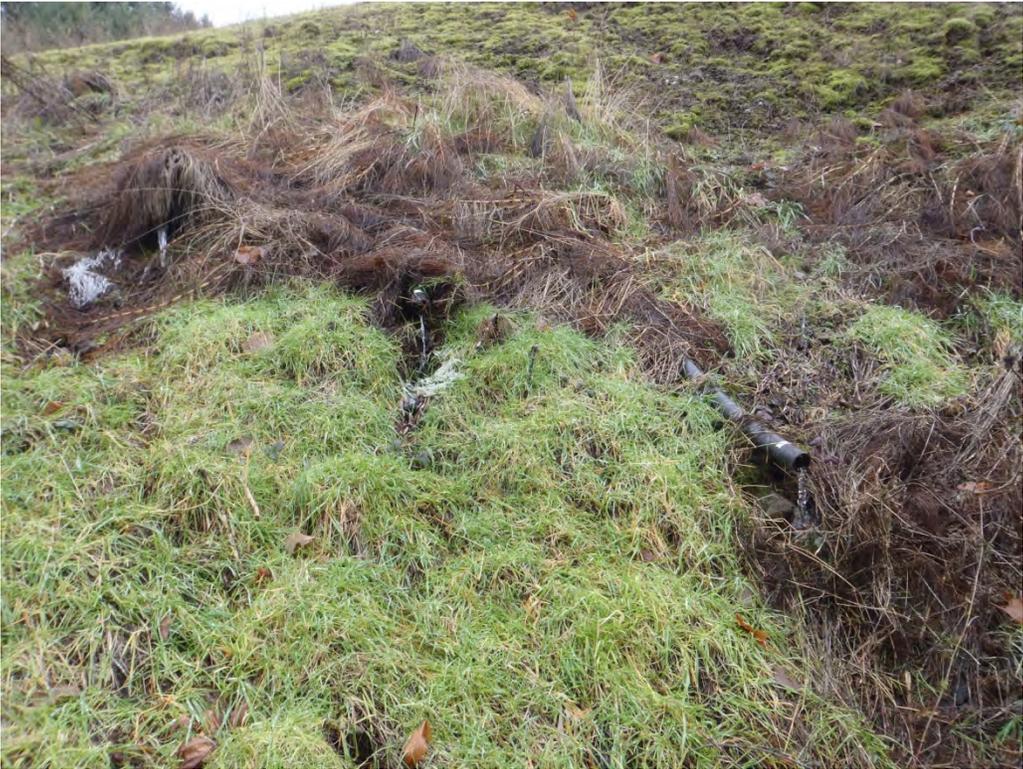
Photo 7. Seepage from Horizontal Drains

- 2) The City should design and install weir collection boxes to measure the flow rate of known seeps and drain flows, especially flows associated with the toe drains. Changes in these flow rates may indicate changing conditions at the dam.

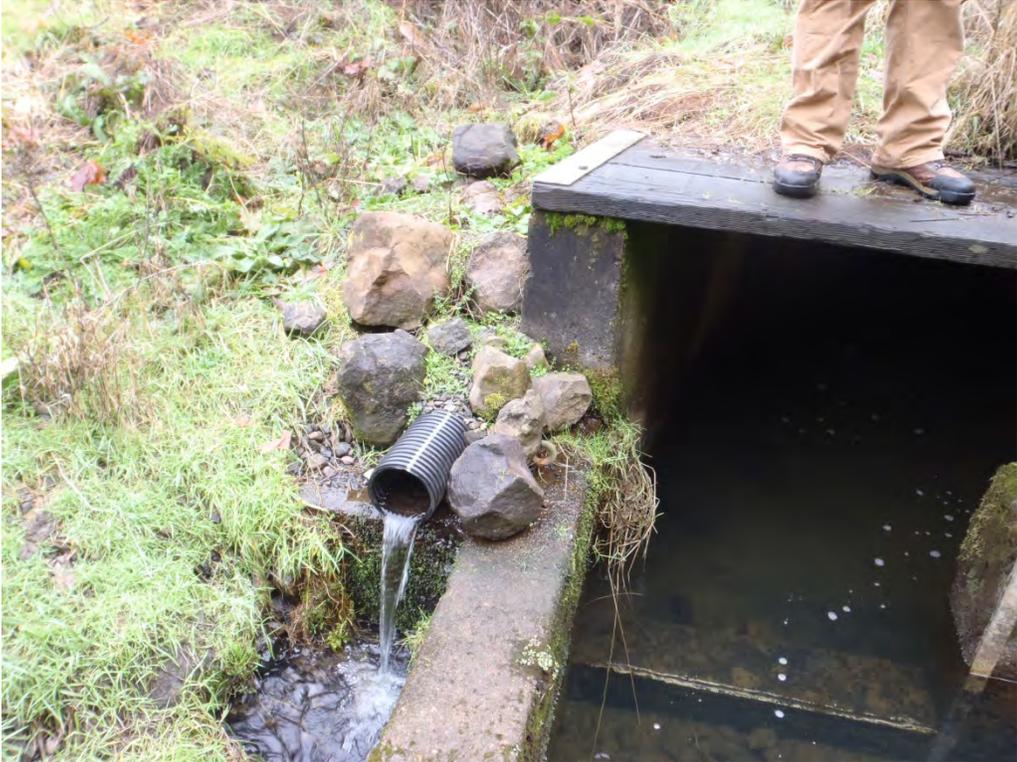
Photo 8. Seepage Around Outlet Structure
