**Water Resources Department**

July 11, 2011

## Re: Silver Creek Dam S-66 – Inspection Summary

## Dam Safety Inspection Form

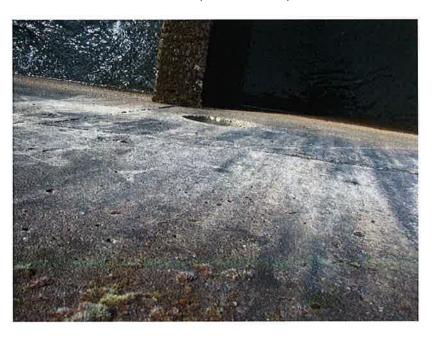
1) You observed the first issue with the plugged drain by the fish ladder, and you already directed maintenance action (shown below).

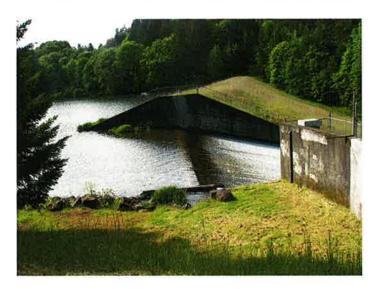
2) Another issue has been large woody debris collecting at the spillway. Although this was not an issue during this inspection (below), a plan to have an excavator remove debris during very high flows would be prudent. The photo does show that there is an area that can be easily improved for excavator access.

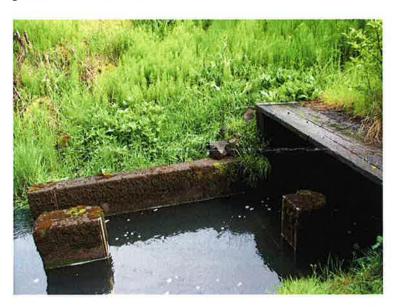
3) A third issue is maintenance and monitoring of peizometers and drains. I have reports on water levels until 2007, but have not seen an update since. It is very important to have working peizometers on the dam, with water level monitored on a periodic basis. The picture below shows the outlet works, where some of the drains are located.

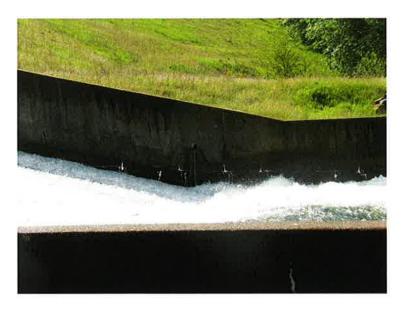
Because of the still fairly high flow in Silver Creek, we were unable to inspect the base of the spillway and the scour of the plunge pool. I would like to have State Engineer Barry Norris re-inspect this area with me in the next couple of months. Barry has a lot more experience than me in spillway inspection and evaluation.
