Water Resources Department

January 13th, 2017

Re: Silver Creek Dam (S-66) – Inspection Summary

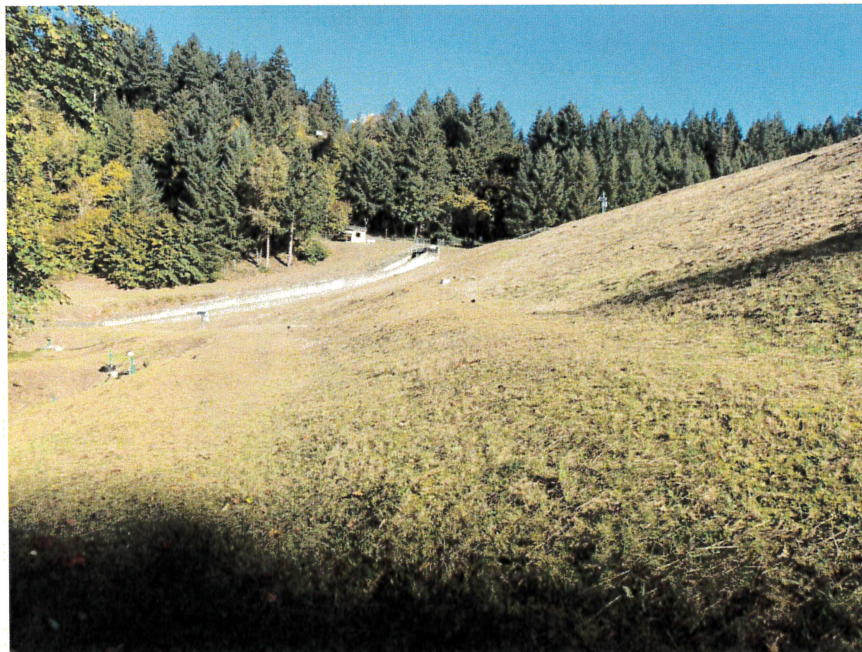
The reservoir level was at an elevation of 423 feet, which corresponds to a freeboard of approximately 17 feet. The reservoir was clean and did not contain any logs or floating debris. The crest of this dam is wide and has a road that allows access to the entire crest. No signs of settlement, cracks, or depressions were observed during the inspection. Most of the dam has a well maintained grass cover, which is ideal. A well maintained grass cover on the dam effectively reduces surface erosion and provides very little cover for burrowing animals.

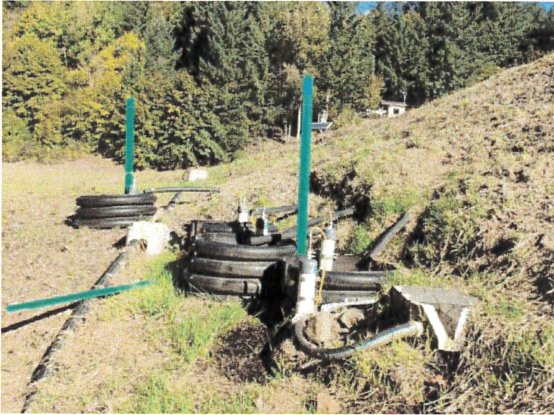
Toe drains and monitoring weirs

At the time of the inspection, there was a minor amount of seepage flow through the embankment and into the toe drains. The seepage was clear of sediment which suggests that it is normal seepage. Most earth fill dams have seepage so a certain amount of

Seepage is characterized in terms of the amount of flow (quantity) and whether or not the seeping water is clear or contains sediment. Increase in the quantity of seepage and/or the presence of sediment in the seeping water indicates that internal erosion and piping has developed through the embankment. Internal erosion and piping are serious dam safety issues that can lead to a dam failure if left unchecked. As a result, it is important that the seepage characteristics be monitored for changes over time. Remote monitoring was added in 2014/2015, which included the seepage measurements. This monitoring has made it easy to track the data and detect any unusual changes in seepage, if changes should occur.

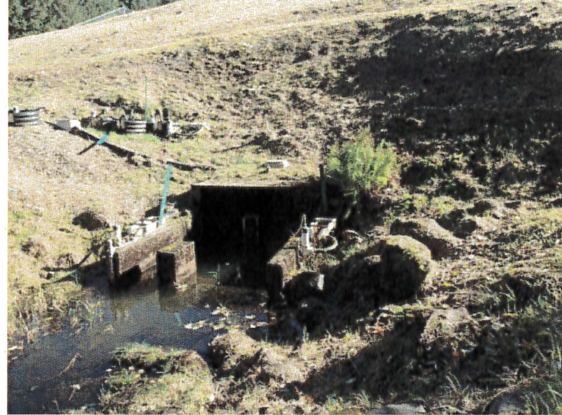
Low level outlet, toe drains, weirs

The low level conduit outlet was partially submerged and does not close completely. In review of past inspections since 2001, it appears that this situation has not changed much. At some point this leak should be addressed.

1. Continue regular vegetation management
2. Monitor the repaired spillway joint for changes
3. Continue to monitor seepage
4. Investigate leakage through the low level conduit

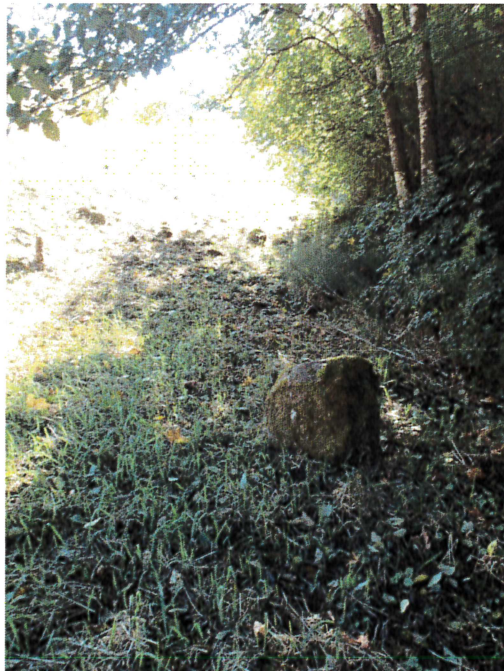
Wet spot below toe

seepage through the embankment from the reservoir is normal. In addition, there was an area below the toe of the dam near the left abutment that was wet. There was no flowing or standing water but the soil was moist. This area was located off of the dam and likely is seepage from the reservoir that is moving underneath the dam. This type of seepage infrequently occurs on embankment dams and is less important from a dam safety perspective than the seepage through the embankment mentioned above.

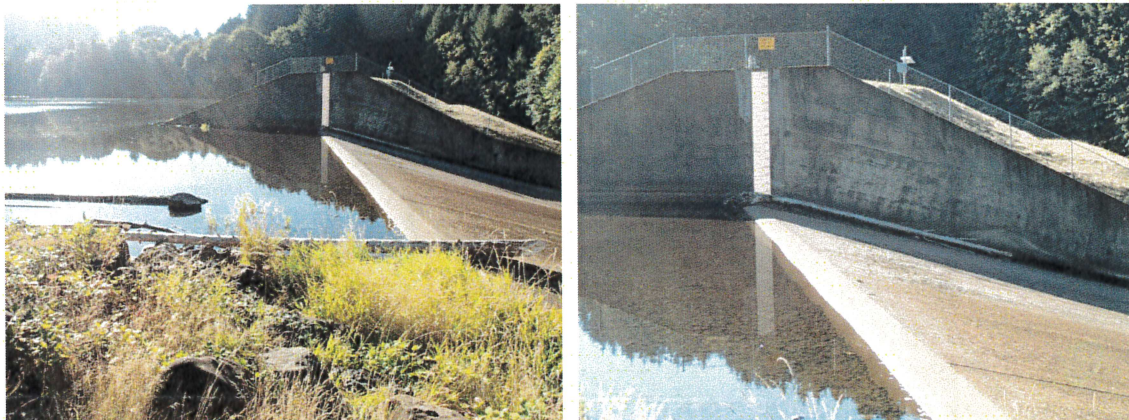
Logs in spillway approach, control, and discharge section

There are many sources of large wood (trees) in the watershed for this dam. This has resulted in logs and debris floating into the reservoir and moving through the spillway. The spillway for this dam is very large and typically has been able to pass the large logs that have floated through the reservoir. However, as can be seen in the photos above and below, occasionally logs become stuck at transition points in the spillway. When this occurs, it is important that they be removed as soon as possible, as it creates an opportunity for additional logs and debris to get hung up. Accumulation of debris at any point in the spillway reduces the capacity of the spillway to pass flood flows and prevents it from functioning as designed. Removing this debris regularly will prevent it from becoming an issue. An alternative would be to install a log boom to catch logs and other floating debris before it reaches the spillway.

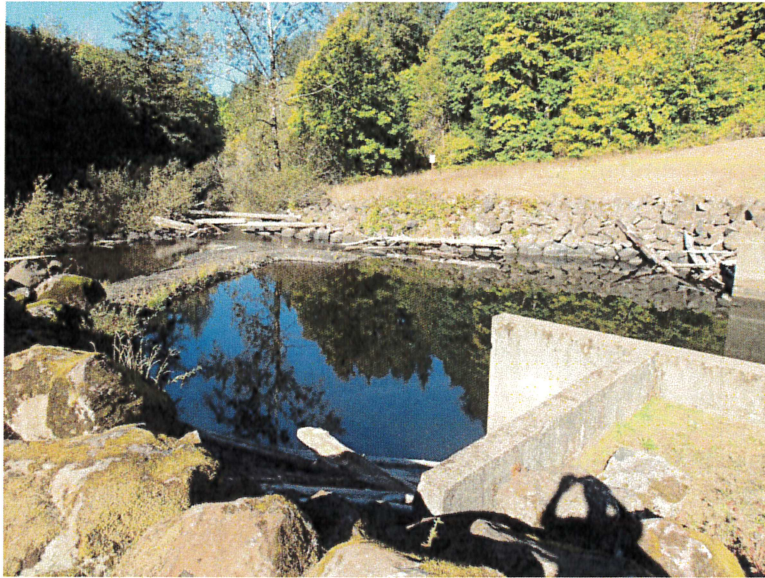
Logs accumulating in stilling basin

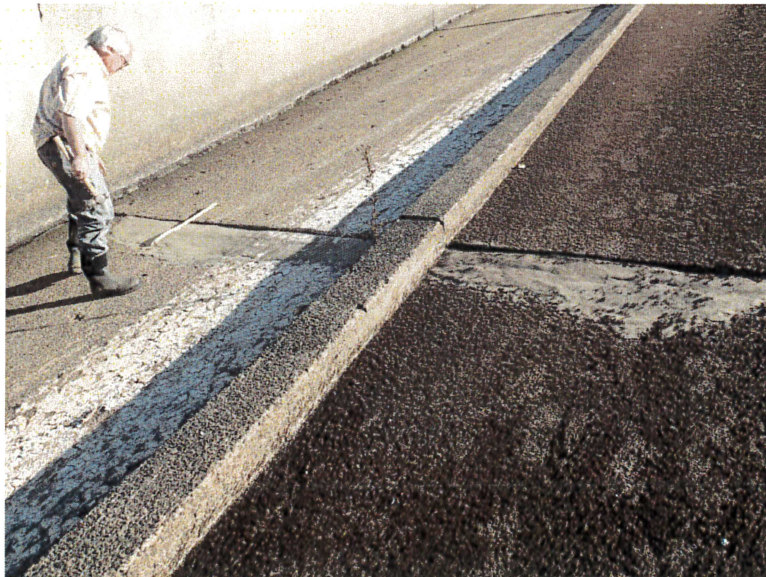
Spillway repair work

During our last inspection, in September 2015, repair of the spalled and cracked concrete portions of the spillway channel were in progress. The repairs seem to be holding up well. However, the repaired area should be monitored in the future for any changes. If similar cracking returns, it may be an indication that slab uplifting has recurred and further investigation would be required.

Stilling basin	<input type="checkbox"/> N/A <input checked="" type="checkbox"/> Functional <input type="checkbox"/> Minor Erosion <input type="checkbox"/> Severe Erosion/Undercutting		4
Aux. Spillway	<input type="checkbox"/> Yes <input checked="" type="checkbox"/> No (use comments below)		—
Comments:	<i>CONCRETE REPAIRS (TOP SURFACE), FEW SURFACE CRACKS</i>
