RE: Silver Creek Dam 2017 Inspection

Silver Creek Dam (S-66) – Inspection Summary Recommendations

Re: Silver Creek Dam (S-66) – Inspection Summary

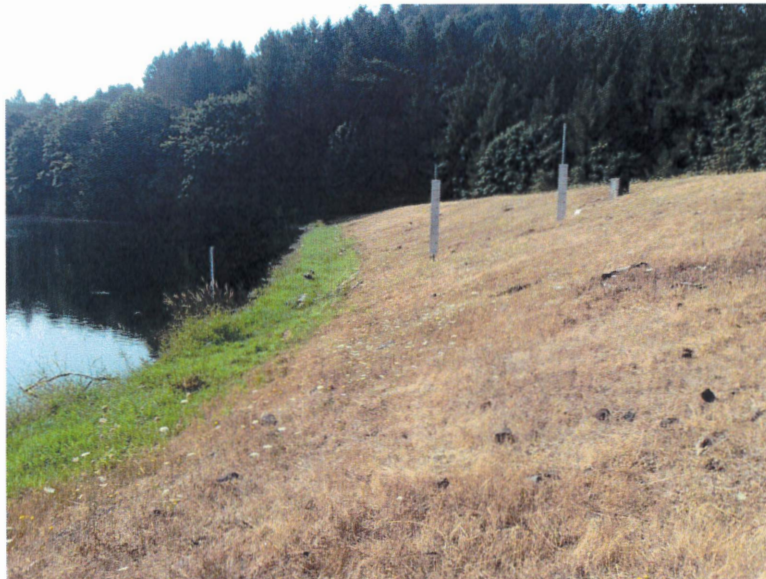
The reservoir level was over 16 feet below the dam crest when inspected. Minimum freeboard was 14 feet, which is excellent. The reservoir was clean.

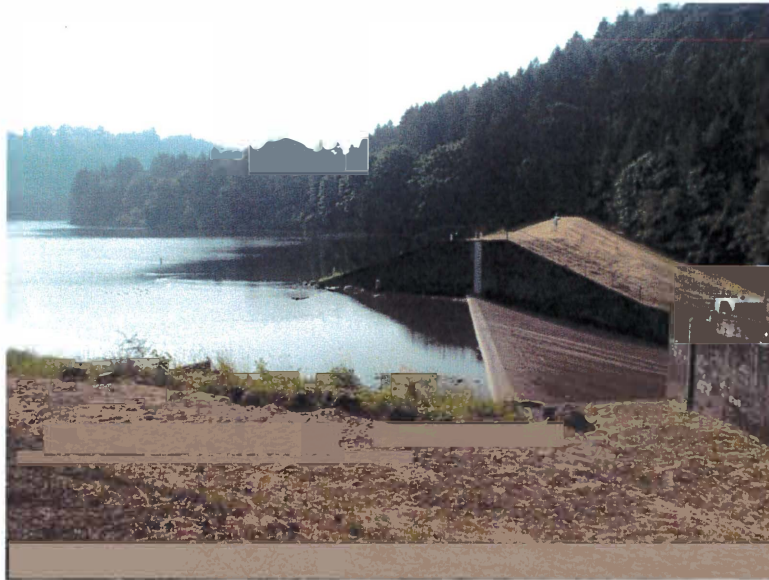
Spillway Approach

Spillways have been a main focus of OWRD dam safety inspections over the last couple of years. There were no obstructions to flow over the spillway approach. It was clear of debris, and so was the reservoir. Vegetation is very well maintained, with short dry grass covering all of the embankment slopes. No significant animal burrows were observed. The one issue is that there is still no road access to the dam, which is very important in the event of unusual conditions in winter months.

1. Inspect the low level conduit to the valve to determine if the seepage is from the valve or from another source.
2. Develop an access road so that equipment can get to the dam if the spillway is flowing.
3. Monitor the repaired spillway joints for new cracking.
4. Update the EAP with unusual condition and potential failure thresholds based on monitoring data. Also update all contact information in the EAP.

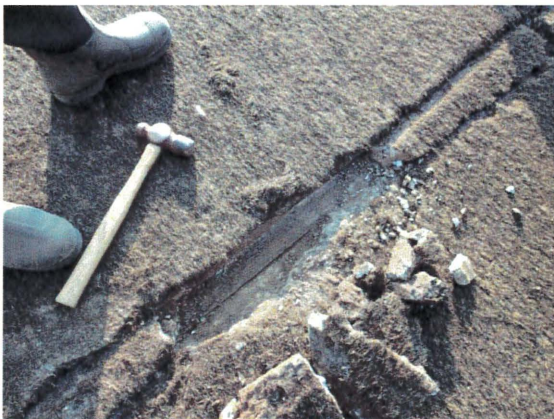
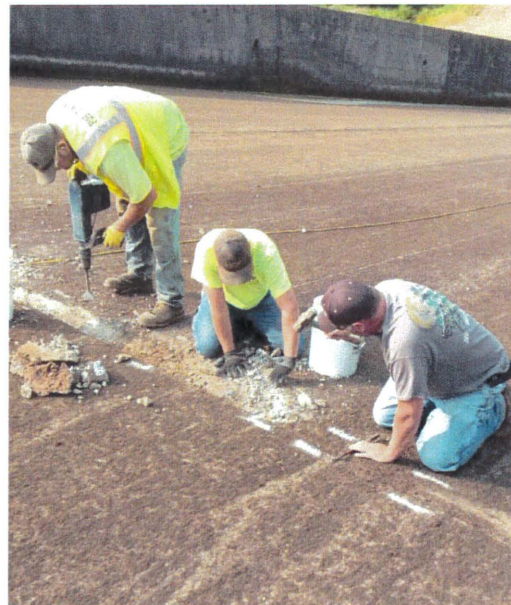
Cracking around slab joints and quick repair

Local cracking was observed in concrete joints in the spillway base slabs. The cracking was addressed by the City very quickly. The repair work is shown in the photo on the

right. It is important to watch the spillway slabs for any changes, and complete repairs quickly just as was done this past fall.

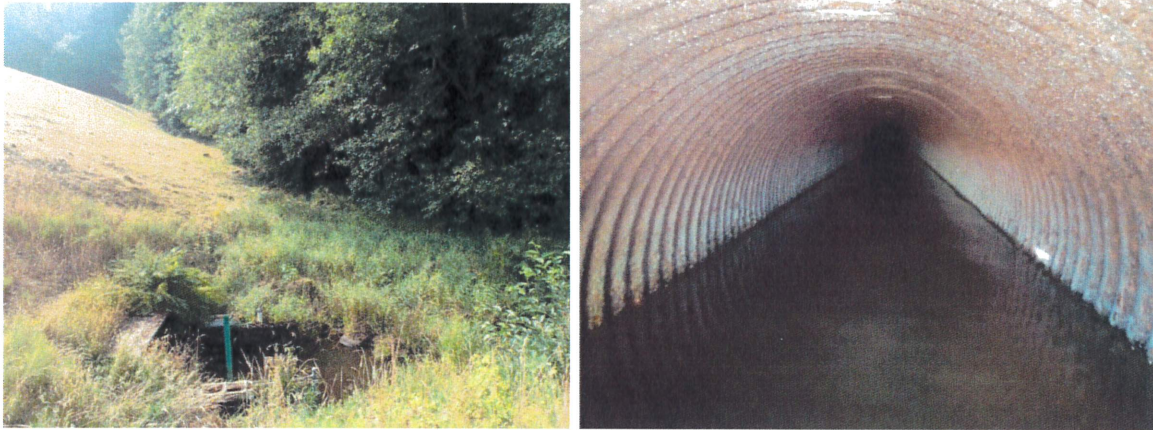
Outlet and interior of conduit

There is some continuous flow through the conduit even when the valve is closed. Water is clear. It is most likely an obstruction or minor wear at the seat of the valve. There has been no inspection of this location for at least ten years; it was last inspected done by John Falk (former Dam Safety Engineer for OWRD). It is no longer appropriate to inspect this by walking through the conduit. Inspection by City equipment would be most effective.

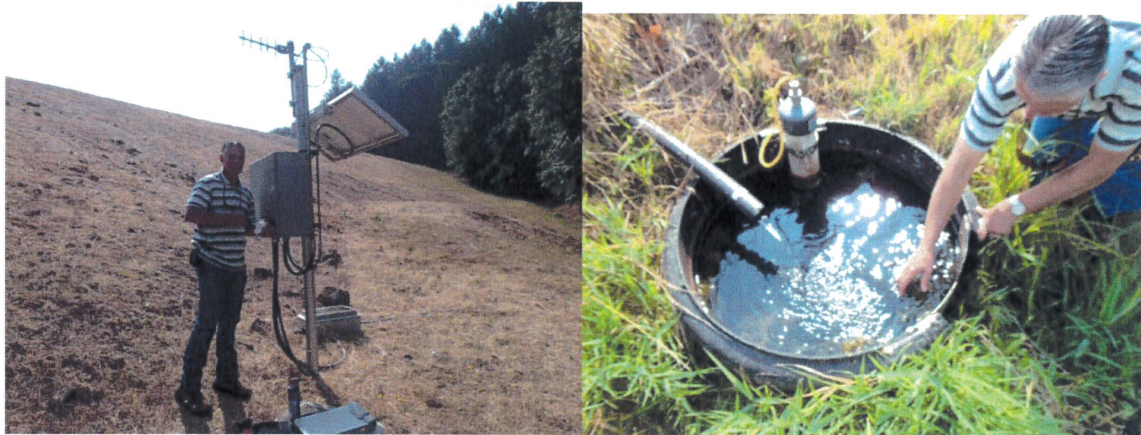
Monitoring telemetry

Effects of vegetation and debris on monitoring

Over the last few years the City has worked with an expert engineer on setting up remote monitoring of the dam. Seepage is now very well monitored, with no significant changes over the last year and no sign of internal erosion. Some additional determination of the levels that trigger an unusual condition classification should be developed. These would be added to the EAP. They should set conditions when the City would ask the dam safety program for a more detailed evaluation or expedited inspection.
