Water Resources Department

Re: Silver Creek Dam (S- 66) – Inspection Summary

Name of Dam: Silver Creek File #: S - 66

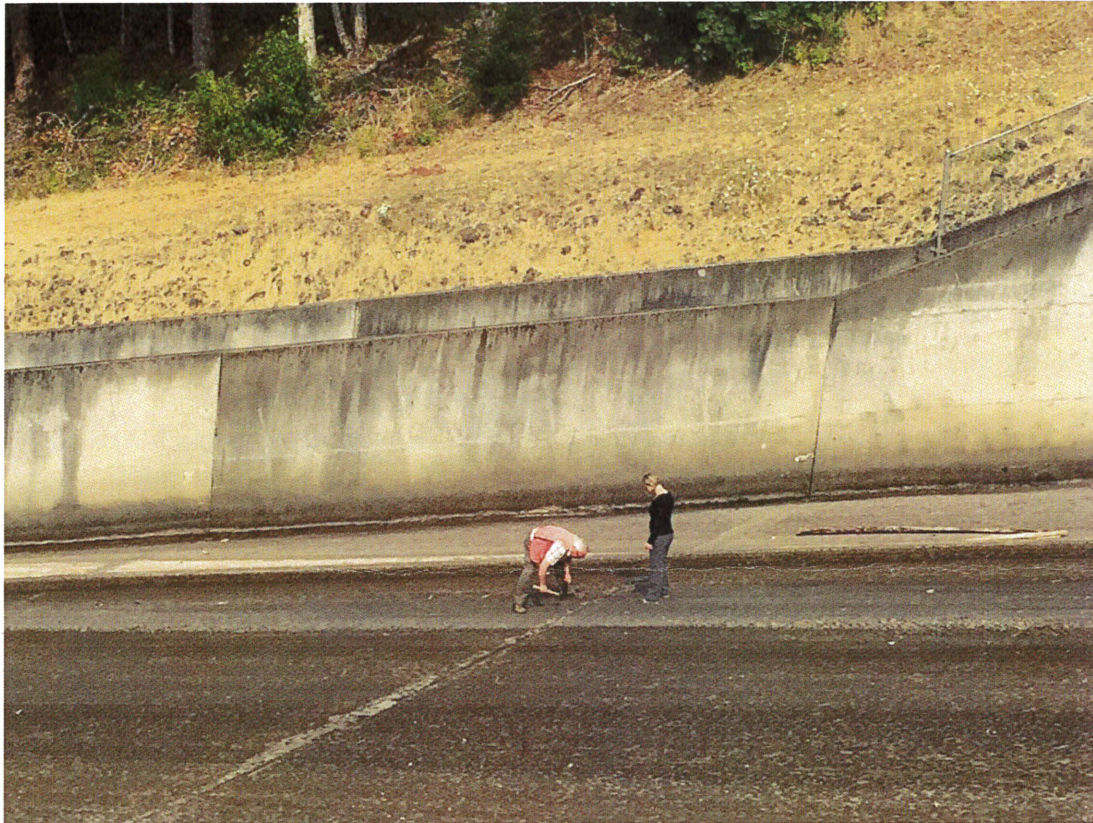
Inspection of the patched concrete repairs

The cracks at the spillway slab joint were patched last year. It is important to monitor the patched areas for any changes after heavy flow events. Patching concrete is not a permanent fix and can last for a year up to several years. Eventually these areas will need to be repaired rather than just patched. The repair consists of cutting around the affected areas of the concrete and chiseling this area to below the rebar (the rebar needs to remain intact). New concrete is then poured to complete the repair work. If done properly, the repair work should be permanent. We will continue to monitor the spillway concrete during our inspections as conditions permit.

1. Develop an access road so that equipment can get to the dam if the spillway is flowing.
2. Monitor the repaired spillway joints for new cracking.
