August 4, 2021

Re: Silver Creek Dam (S- 66) – Inspection Summary

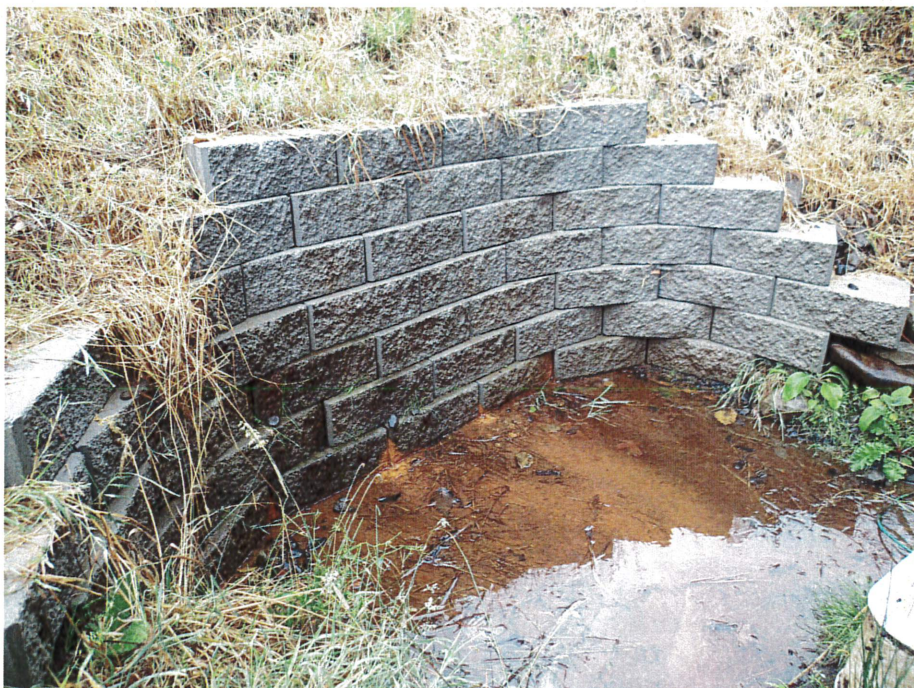
Conduit There was an area of seepage observed above the outlet pipe at the time of inspection. This area had been excavated to examine the extent of the seepage and then repairs have been completed as shown in the photo below. The seepage should be monitored for any changes to quantity or quality.

Repaired area of seepage above outlet

1. Monitor the repaired spillway joints for new cracking.
2. Monitor the conduit for changes in flow from the leak
3. Conduct an exercise of the just updated Emergency Action Plan.

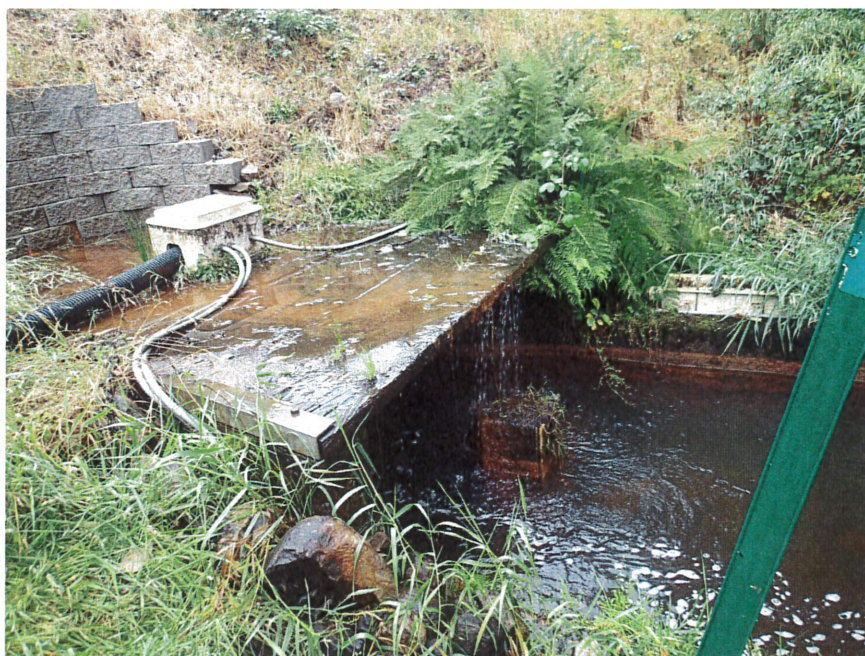
Low level outlet structure

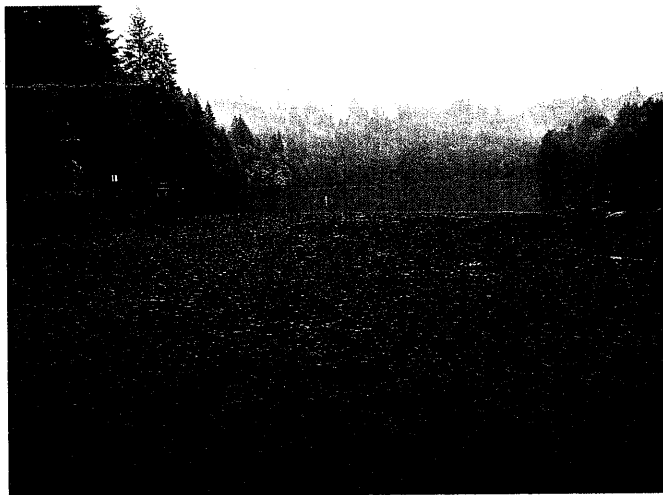
Spillway: Crushed aggregate was placed at the spillway approach to correct accumulated erosion and low spots as shown in the photo below.

Spillway approach with even coarse gravel
