**Re: Silver Creek Dam (S- 66) – Inspection Summary**

# Oregon Dam Safety Inspection Form

Name of Dam: SILVER CREEK			File #: S-66
Height: 65 ft.	Storage: 1,300 ac. ft.	Permit:	NID #: OR00622
<b>High Hazard Dam</b>	Condition Assessment: Fair		District: 16
Date: September 7, 2022	Weather: <input checked="" type="checkbox"/> Dry <input type="checkbox"/> Rain <input type="checkbox"/> Snow <input checked="" type="checkbox"/> Now <input type="checkbox"/> Recently	Prior Inspection: August 25, 2021	
Inspector(s): Arden Babb		Others on Site: Mike Dahlberg, Jacob Rush	
Issues from Prior Inspection:

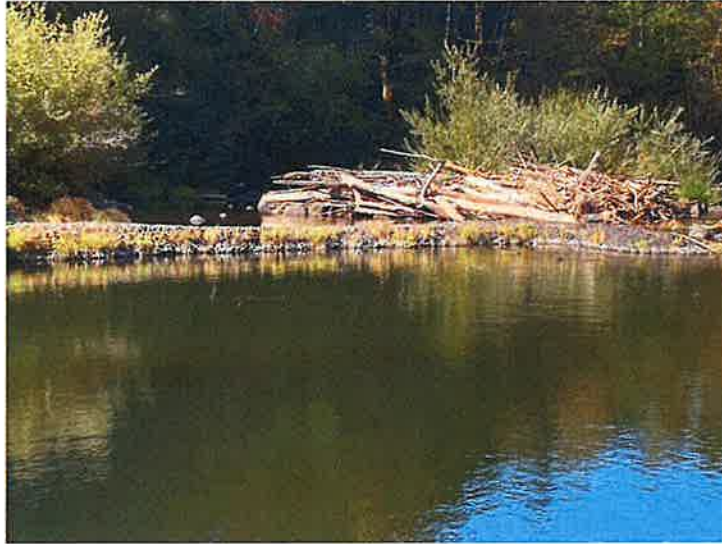
There were some large logs on the edge of the spillway discharge channel. Based on reports from staff onsite, these should wash downstream during the next heavy flow. Please monitor this area to ensure it does not become blocked.

Logs on edge of discharge channel

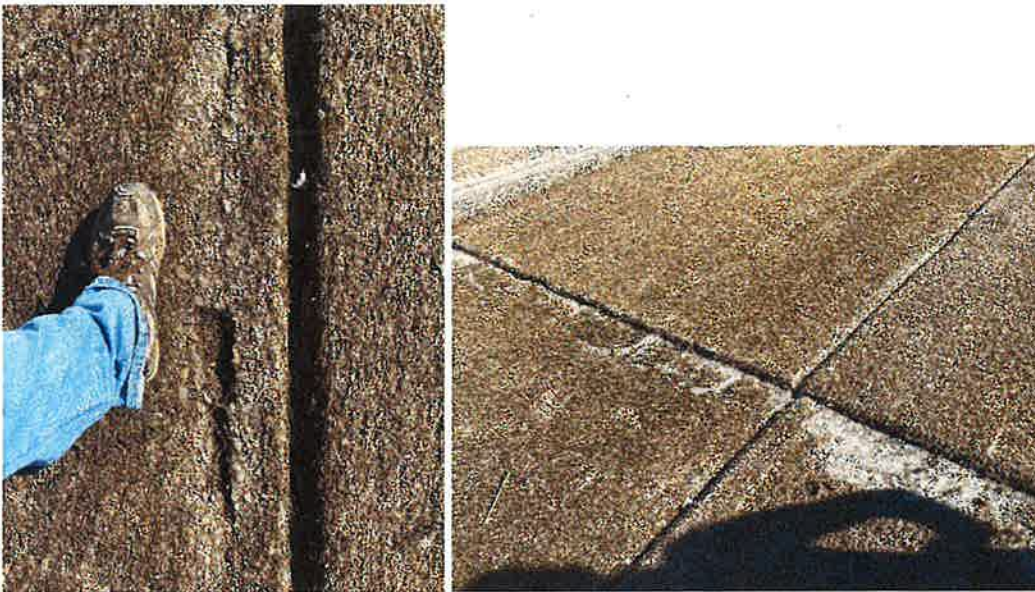
The joints in the spillway are large with some areas of scour. These areas should be monitored to ensure the scour does not increase.

Large joints with area of scour

Discharge Channel	<input checked="" type="checkbox"/> Clear <input checked="" type="checkbox"/> Trees/brush <input type="checkbox"/> Leakage <input type="checkbox"/> Headcutting feet from spillway control section, depth: feet.) <input type="checkbox"/> None	4-
Stilling basin	<input type="checkbox"/> None <input checked="" type="checkbox"/> Functional <input type="checkbox"/> Minor Erosion <input type="checkbox"/> Severe Erosion <input type="checkbox"/> Undercutting <input checked="" type="checkbox"/> No Issue	4
Aux. Spillway	<input type="checkbox"/> Yes <input checked="" type="checkbox"/> No (use "Detail" box below)	N/A
Detail:	Area of scour three slabs from bottom, about 12 inches long 1 inch deep

Please monitor the area of seepage for any changes and keep the weirs clear and functional. Also monitor the spillway cracks and scour for any changes after prolonged flows.

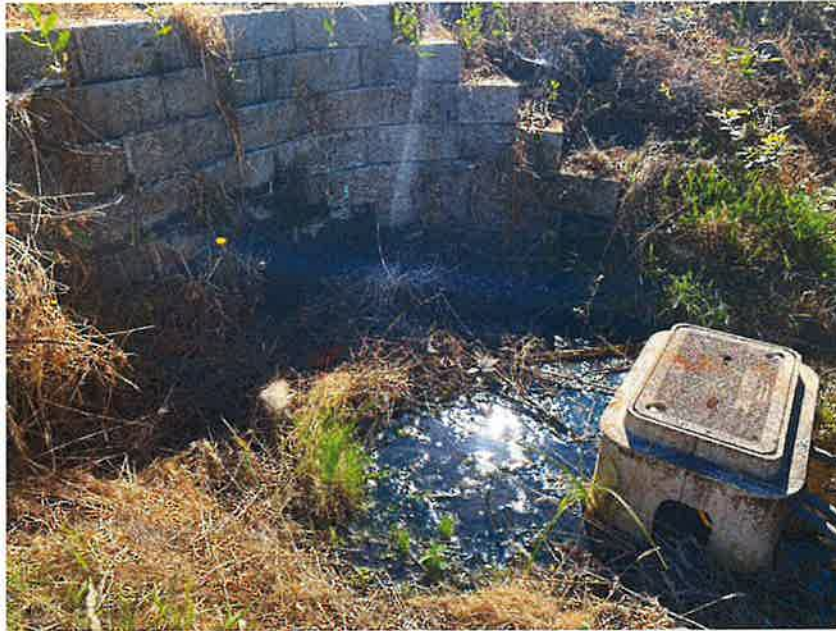
The normal seepage for this dam was observed during the inspection. There have been no significant changes in this area during the past few years. Please continue to monitor this area for any changes in flow, coloration, or sediment discharge. Because of this additional seepage, it is important to keep the weirs and toe drains clean and functioning

properly. They were in good condition during the inspection with some minor sediment and vegetation noted.

Typical seepage observed at reinforced area

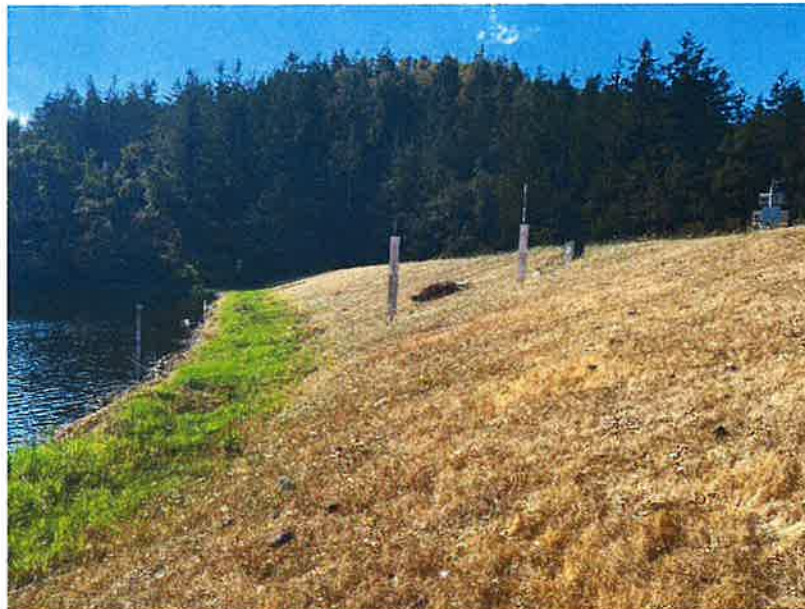
Upstream face of the embankment showing well-kept ground cover
