March 8, 2024

Re: Silver Creek Dam (S- 66) and Pettit Reservoir (P-43) – Inspection Summary

Silver Creek

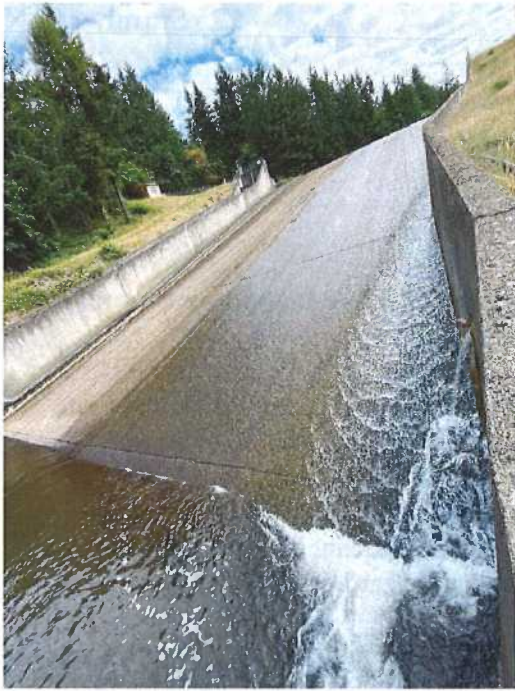
The spillway was flowing and looked to be in good condition during the inspection. Please keep an eye on any areas of turbulent water near the bottom of the spillway and monitor for any signs of spauling or cavitation damage to the concrete.

Flowing spillway

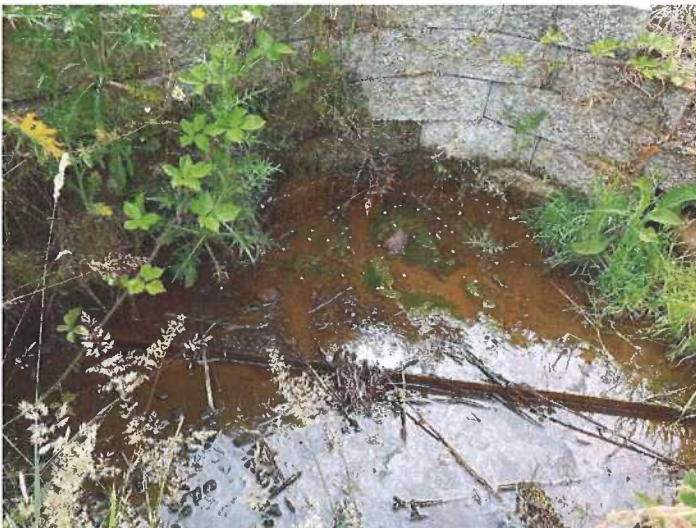
The usual area of seepage hasn't changed from the previous year. As always, please monitor this area in case of any changes in flow, water coloration, or sediment begins to build up. The weirs were all functioning with a minimal buildup of algae and debris. These should be periodically cleaned for the best reading and functionality.

Area of seepage

Seepage/Leakage		Rating
Serious Conditions	<input checked="" type="checkbox"/> None <input type="checkbox"/> New Seepage <input type="checkbox"/> Leakage <input type="checkbox"/> Piping <input type="checkbox"/> Discolored Water <input type="checkbox"/> Boils <input type="checkbox"/> Other	N/A
Seepage Locations	<input type="checkbox"/> Center <input type="checkbox"/> Left <input type="checkbox"/> Right <input type="checkbox"/> Around Pipe	
Flow	<input type="checkbox"/> Wet Vegetation <input type="checkbox"/> Spongy <input type="checkbox"/> Standing Water <input checked="" type="checkbox"/> Flowing Water	4
Toe Drains	<input type="checkbox"/> None <input checked="" type="checkbox"/> Working <input type="checkbox"/> Damaged <input type="checkbox"/> Buried <input type="checkbox"/> Other	4
Flow (gpm)/Detail:	1 gpm

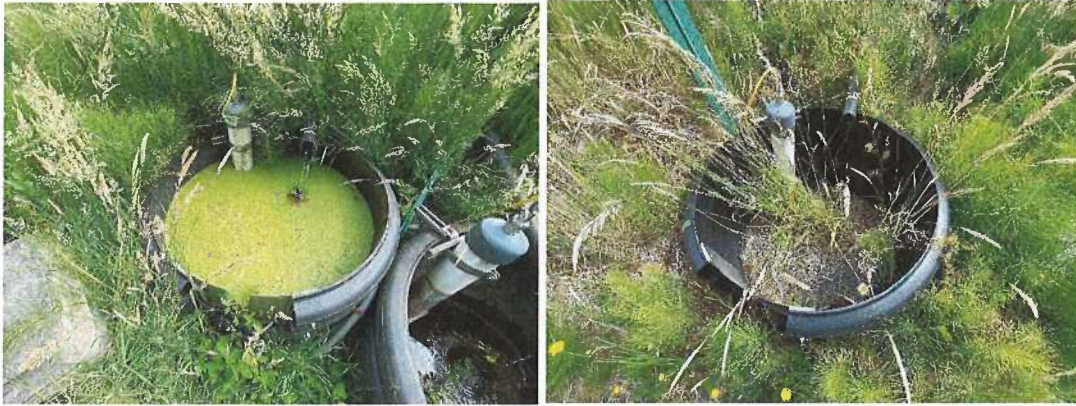
Two of the weirs on site

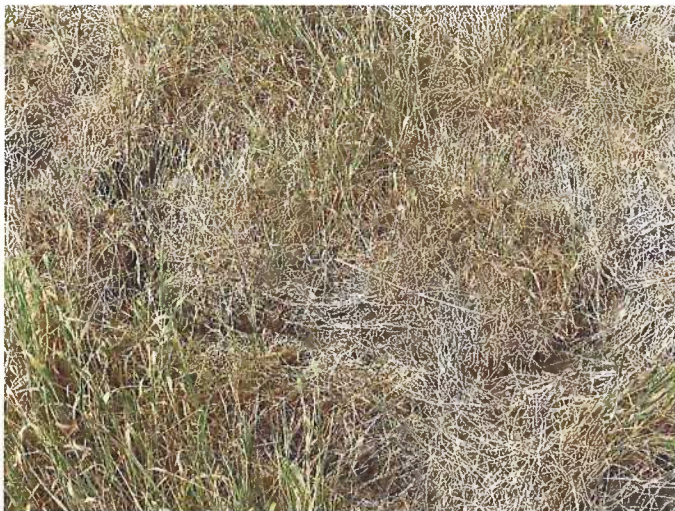
No issues with vegetation on the embankment. Short grass covered is maintained across both faces. There was some evidence of potential burrows which staff indicated were likely rats. If these areas appear to get any worse, a removal program will likely be needed for the animals.

Areas of apparent rodent activity

Animals		Rating
Evidence	<input type="checkbox"/> No Evidence <input type="checkbox"/> Trails <input checked="" type="checkbox"/> Burrows <input type="checkbox"/> Deep Burrows Max Depth: <u>0.5 ft.</u>	4
Locations	Approximately center of the upstream face Extensive: <input type="checkbox"/> Yes <input checked="" type="checkbox"/> No	
Detail:	Some rodent activity, staff indicated it was likely rats. There are trails along the upstream face of the dam that look like caved in burrows.

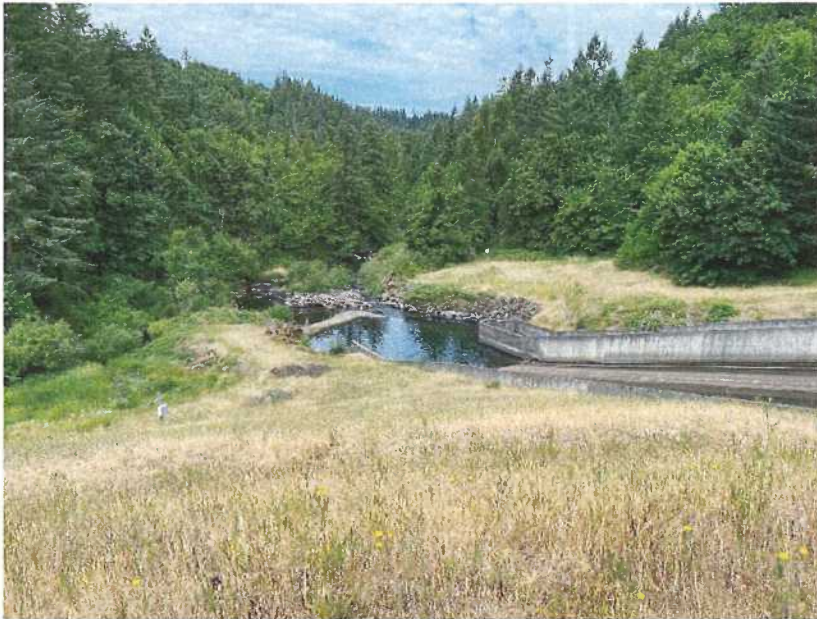
Downstream face of dam and spillway stilling basin
