Re: Silver Creek Dam (S- 66) – Inspection Summary

Oregon Dam Safety Inspection Form

Name of Dam: SILVER CREEK			File #: S-66
Height: 65 ft.	Storage: 1,300 ac. ft.	Permit:	NID #: OR00622
High Hazard Dam	Condition Assessment: Fair	District: 16	
Date: April 11, 2024	Weather: <input checked="" type="checkbox"/> Dry <input type="checkbox"/> Rain <input type="checkbox"/> Snow <input checked="" type="checkbox"/> Now <input type="checkbox"/> Recently	Prior Inspection: September 06, 2022	
Inspector(s): Arden Babb		Others on Site: Nate, Malcom, Brent, Jacob with city	
Issues from Prior Inspection:

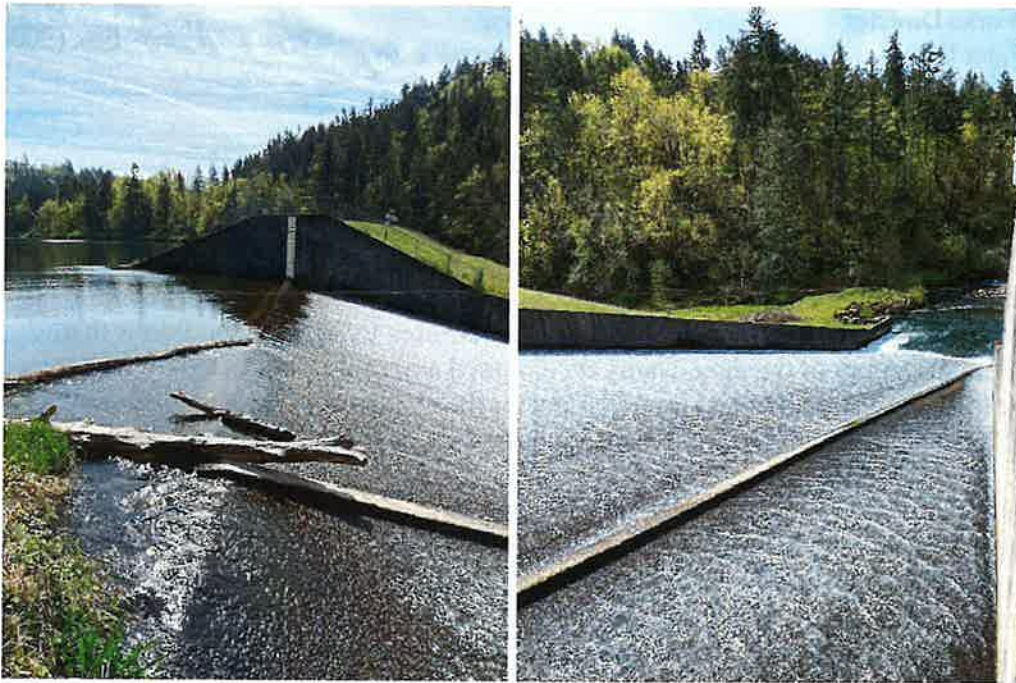
This inspection was done in coordination with the initial site visit set up by consultants Alden and Cornforth who are involved in spillway repair work. The spillway was flowing at the time of inspection preventing thorough inspection of the spillway slabs. As such a follow up visit is tentatively planned for August or September when the spillway is dry. This visit will be led by the consulting groups with someone from dam safety joining if

Flowing spillway

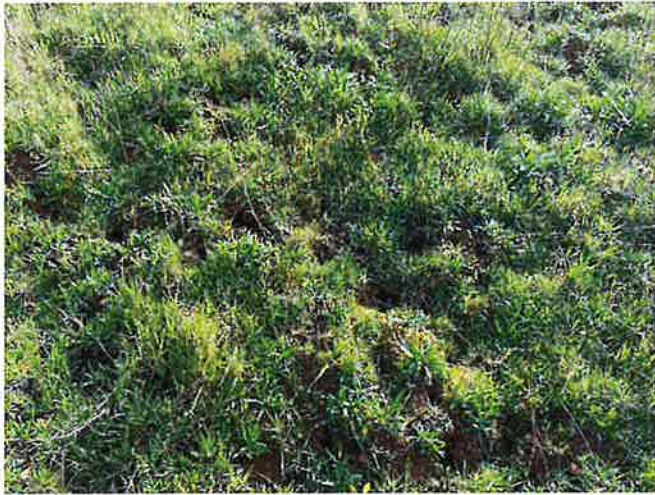
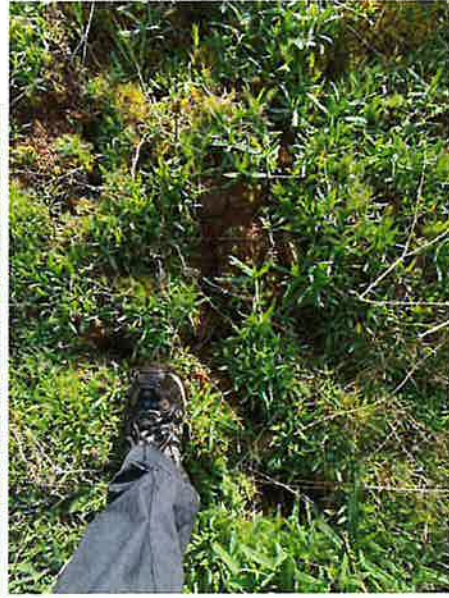
There was some evidence of rodent activity during the last inspection in 2023. This activity has progressed over the last year and should be addressed at this time. There is now an area approximately 20 feet long starting near the solar panels on the first terrace down from the crest of the dam. The trails and burrows appear to be from small rodents such as gophers or rats, and a removal program should be implemented. Once the rodents are managed, if there are deeper burrows, these areas can be filled and compacted down to prevent any areas of potential erosion or water infiltration into the dam.

Large area of burrows across downstream face

Animals		Rating
Evidence	<input type="checkbox"/> No Evidence <input checked="" type="checkbox"/> Trails <input checked="" type="checkbox"/> Burrows <input type="checkbox"/> Deep Burrows Max Depth: <u>1</u> ft.	4-
Locations	Rodent control needed especially for downstream face Extensive: <input checked="" type="checkbox"/> Yes <input type="checkbox"/> No	
Detail:	8 inch deep burrows in some places 4 inches diameter 20+ feet wide patch of burrows on ds face starting close to solar array near first terrace

Manage the rodents and any deep burrows
