Water Resources Department

RE: Dam Inspection Silver Creek Dam August 21, 2009 (S-66)

Dam Safety Inspection Form

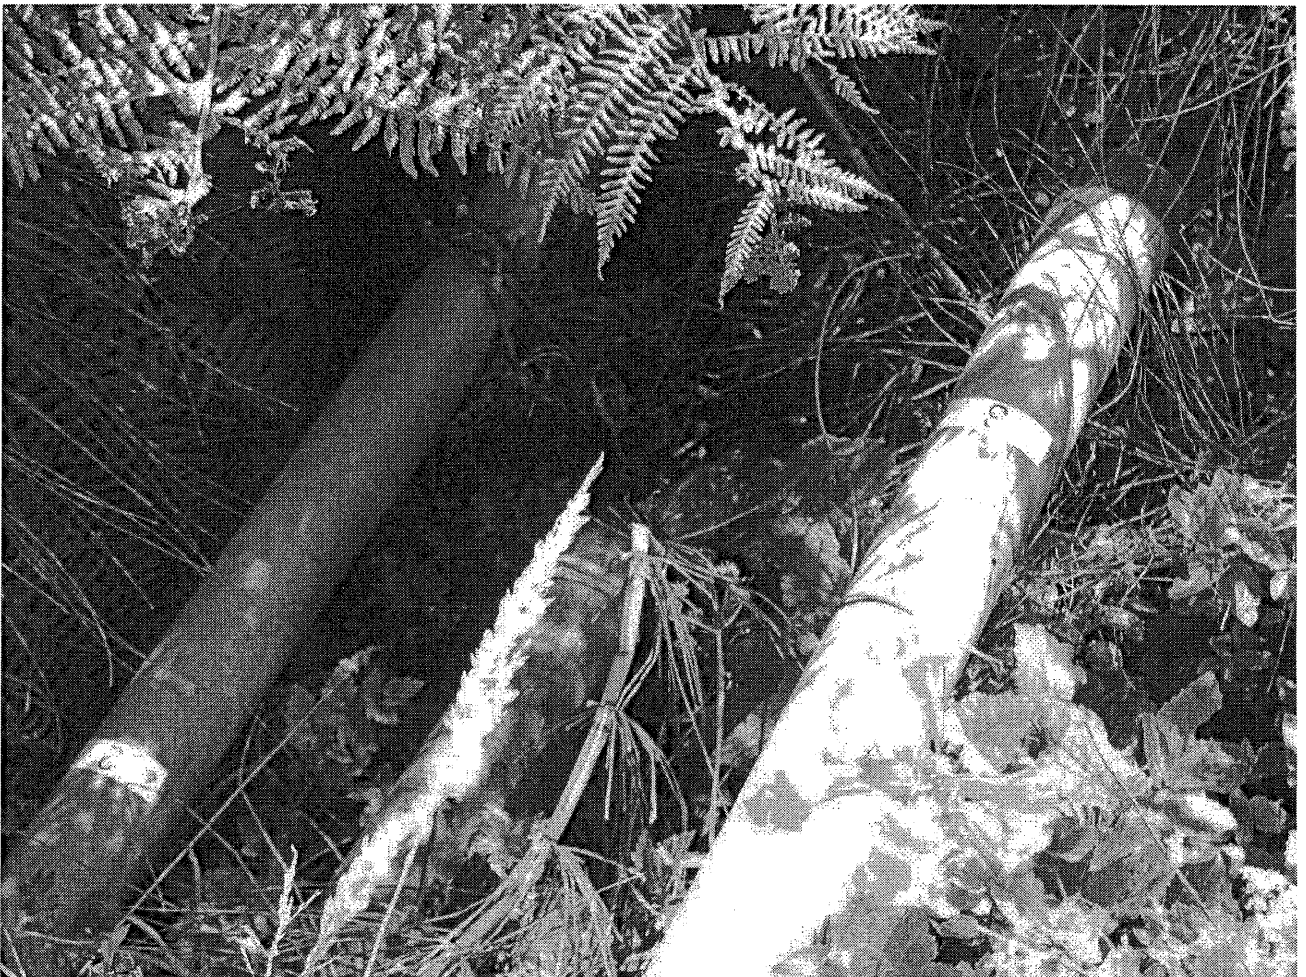
Figure 1a. Pipes 1,2,3 note that pipe 1 (middle) is flowing heavy while other two dripping.

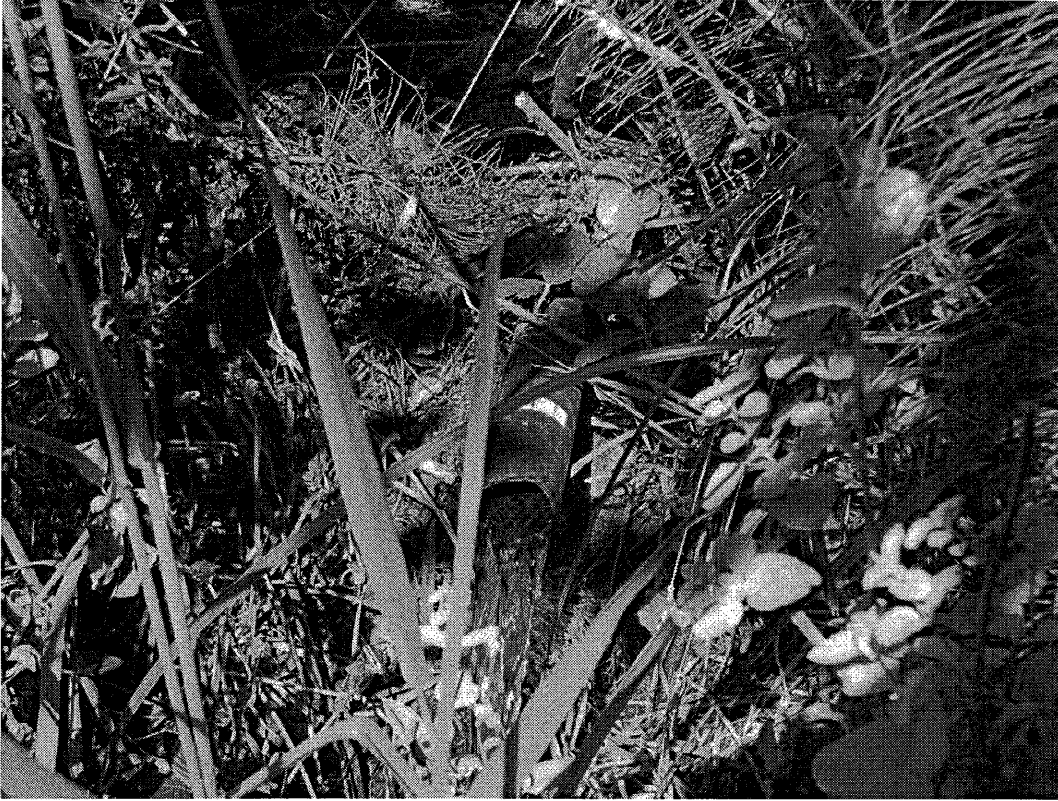
Figure 1b. Pipe 4 flowing moderately.

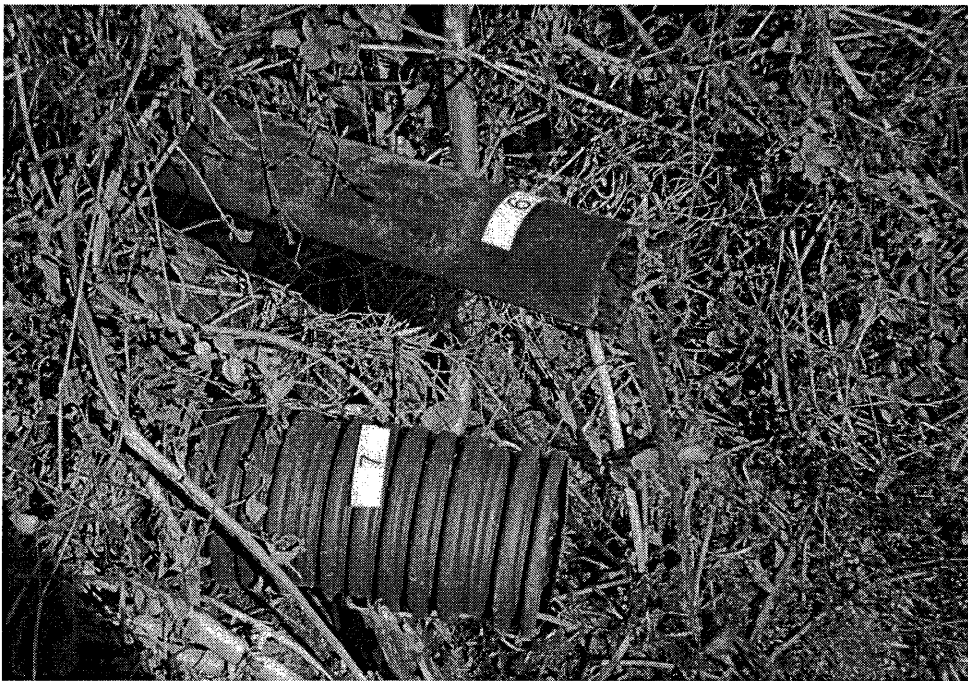
Figure 1c. Pipes 6 and 7 with 6 flowing light and 7 barely flowing.

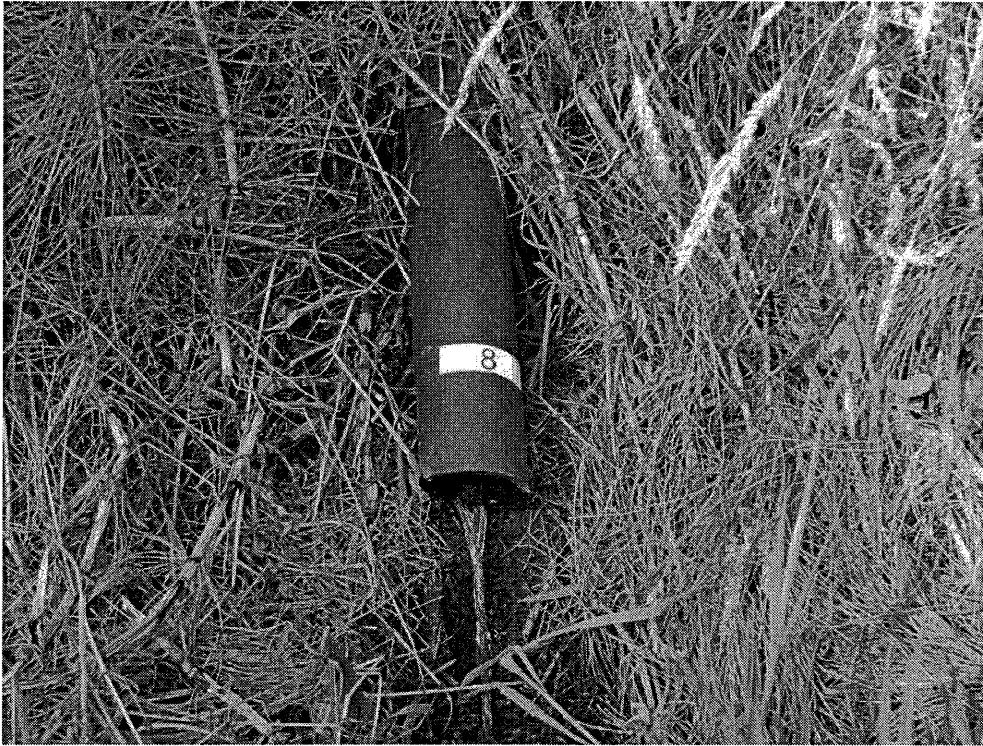
Figure d. Pipe 8 flowing lightly.

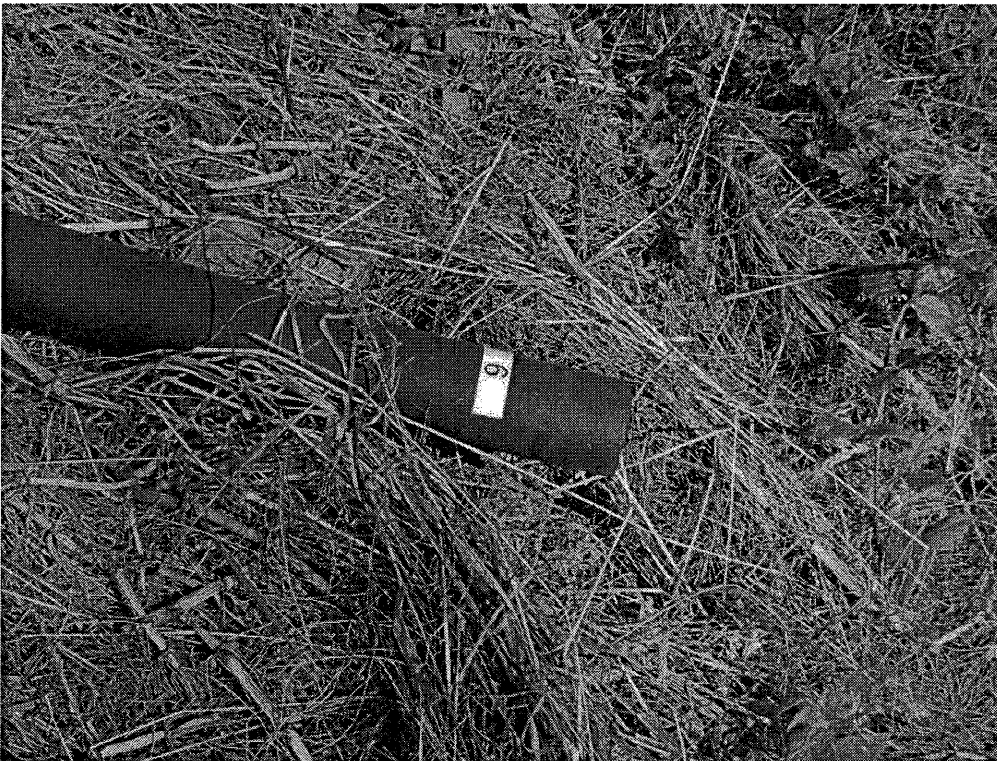
Figure 1e. Pipe 9 flowing lightly/dripping.

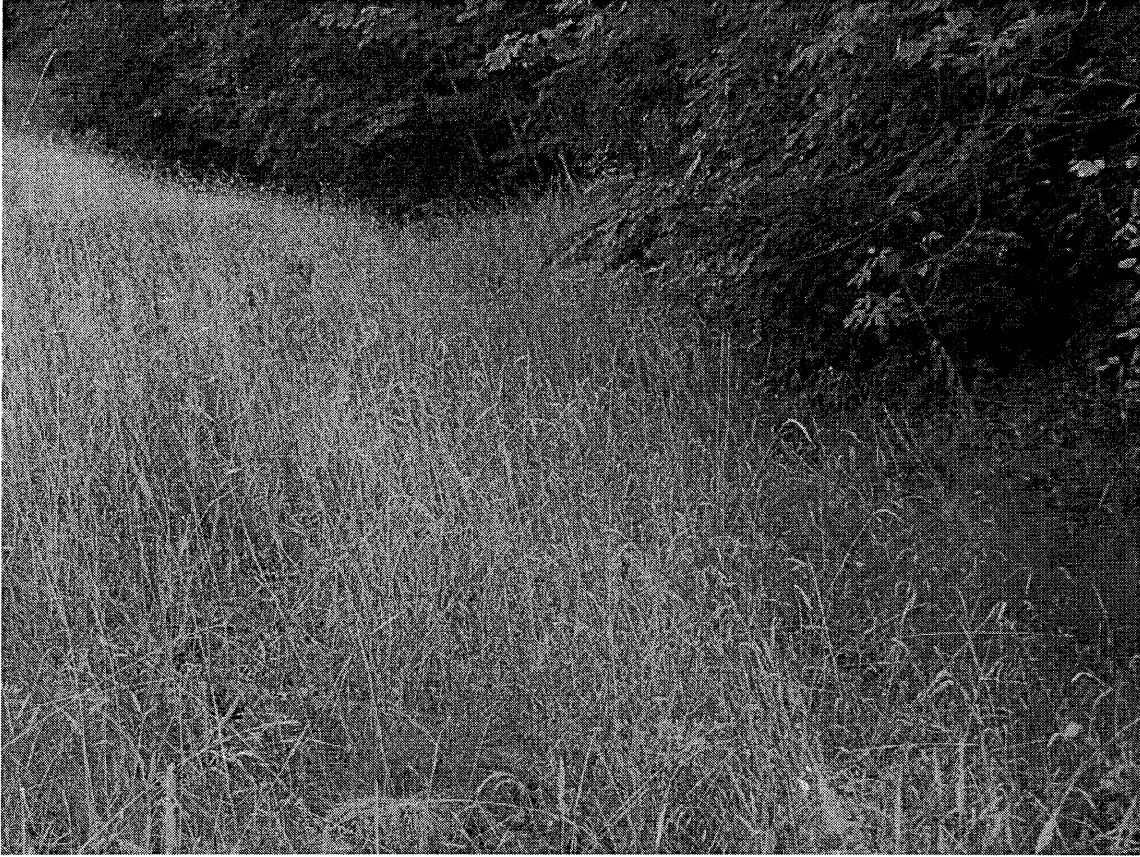
Figure 1f. “Seepage” or spring along left abutment with change in vegetation but no live water flowing.
