Water Resources Department

RE: Dam Inspection February 20, 2008

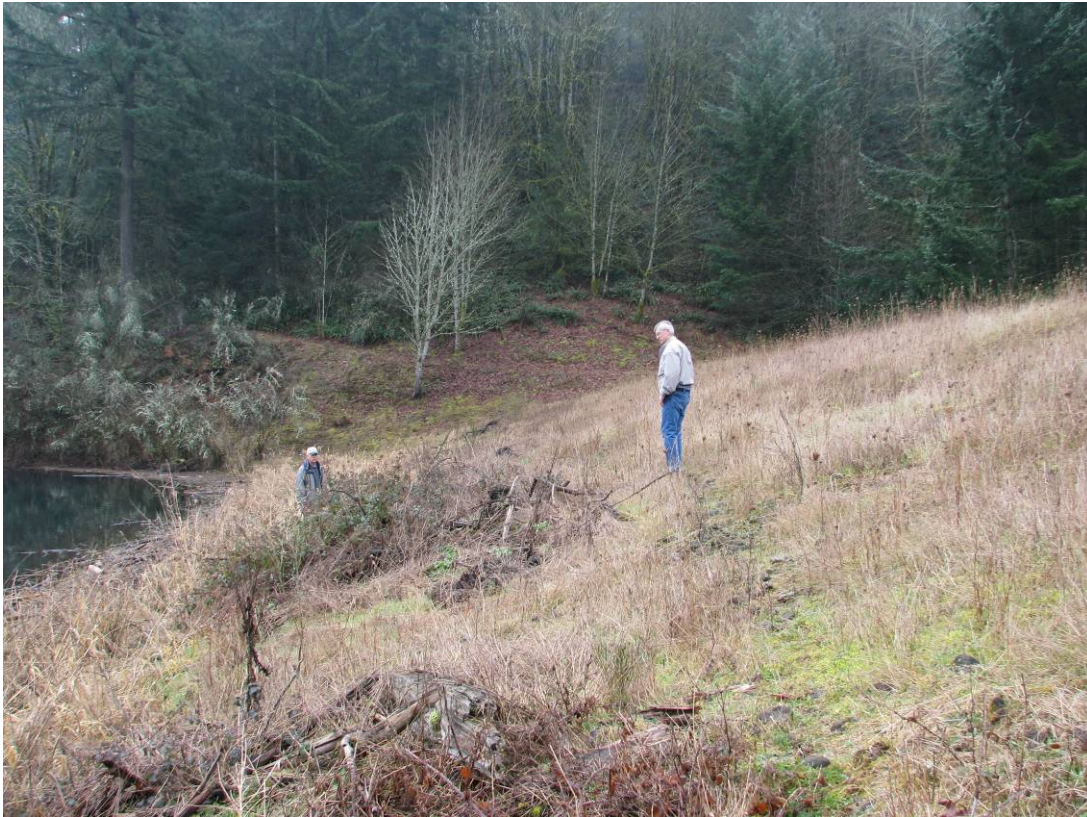
- On the upstream slope of the dam there was an outgrowth of Blackberrys (Figure 1). Woody shrubby vegetation can weaken the dams core by root action and their size and bulk can obscure problems. These should be removed in the near future. Notes about vegetation at other locations follow.

Figure 1. Vegetation on upstream face of dam.

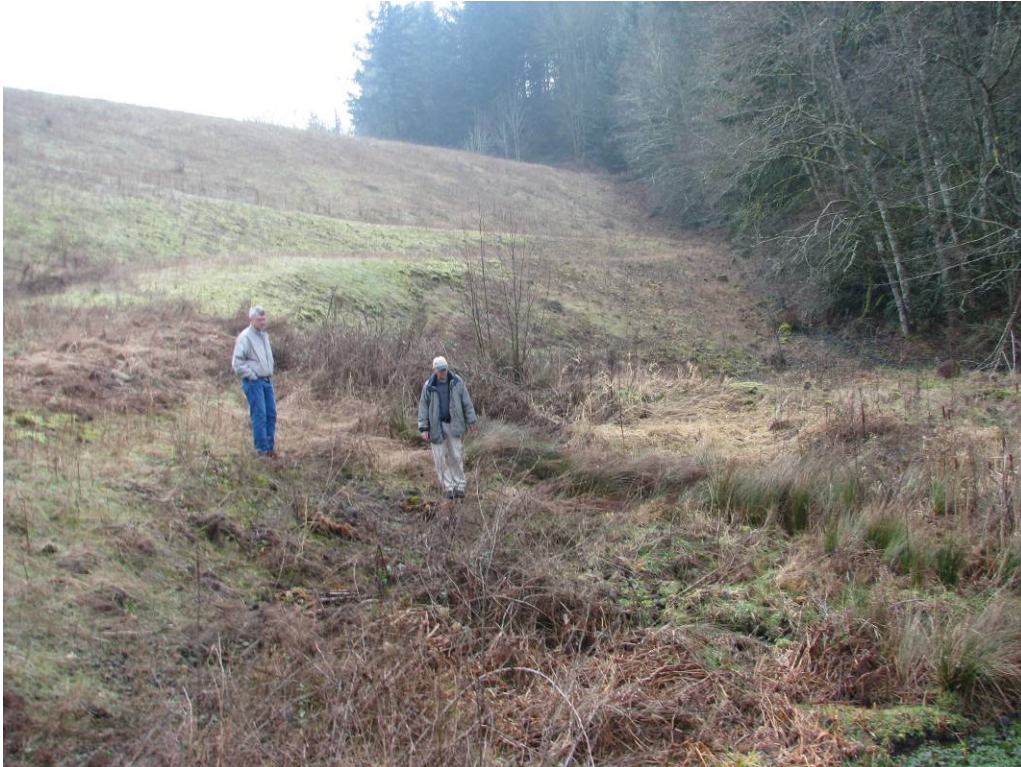
- On the right abutment (facing downstream) there was far too much woody vegetation that should be removed.
- On the downstream face there were small trees growing on the dam that should be removed (Figure 2)

Figure 2. Small trees growing on dam.

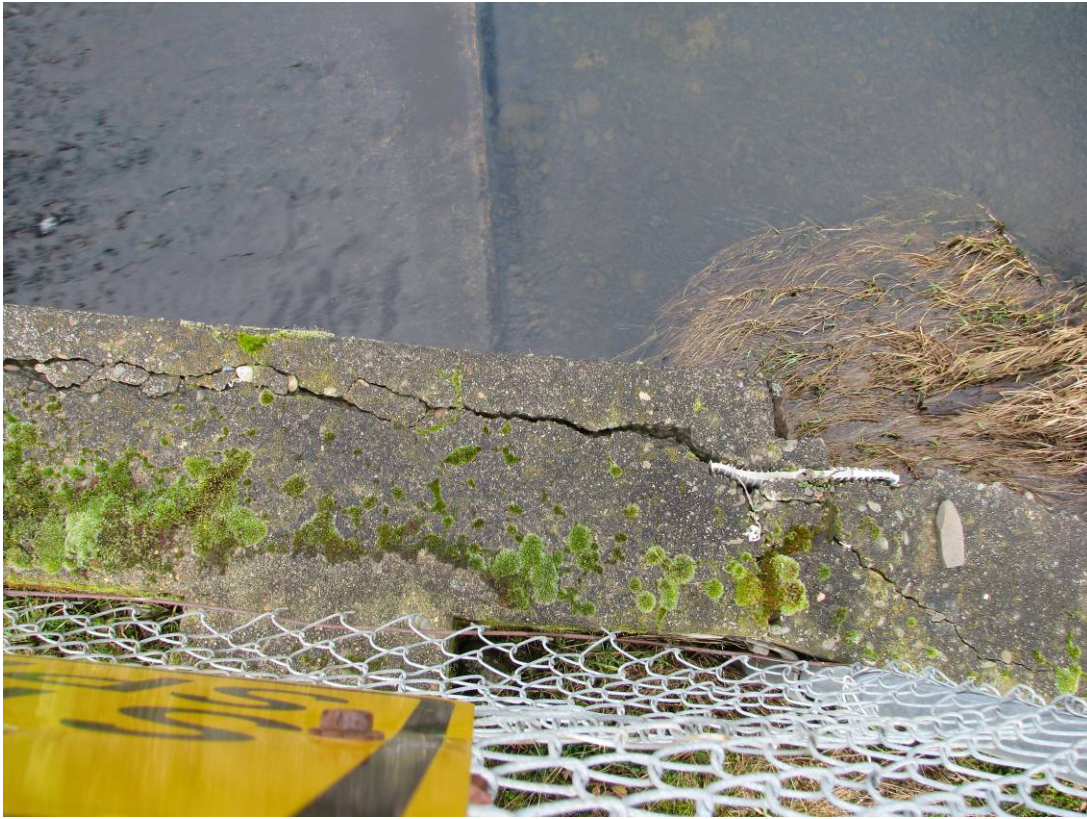
- On the left side of the spillway there was concrete spalling (Figure 3) there was also spalling on the right side of the spillway. There should be maintenance to fix these

problems. Especially the problems on the left side of the spillway. This is something observed in 2006 and not addressed.

Figure 3. Spalling on dam spillway (left side facing downstream)

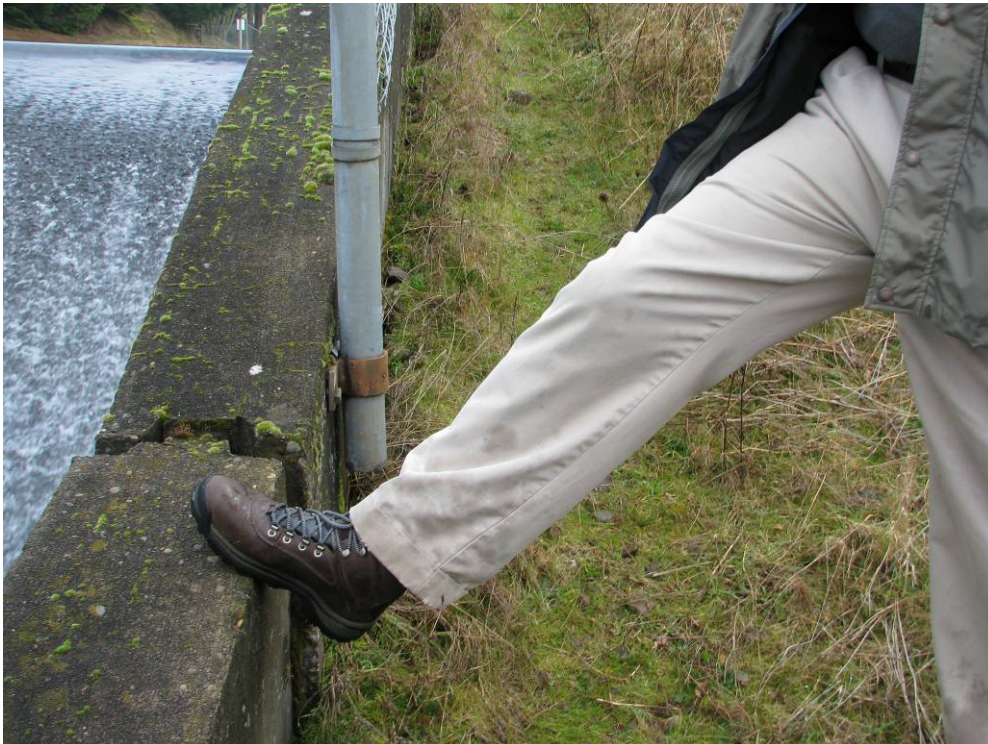
- There was deflection of joints along the spillway (Figure 4) but in examining this picture in comparison to the others we took in the past we do not see any additional movement for a great deal of time based on examining past pictures. No action is necessary regarding this issue.

Figure 4. Joint movement in past but stable no movement when compared with other photos.

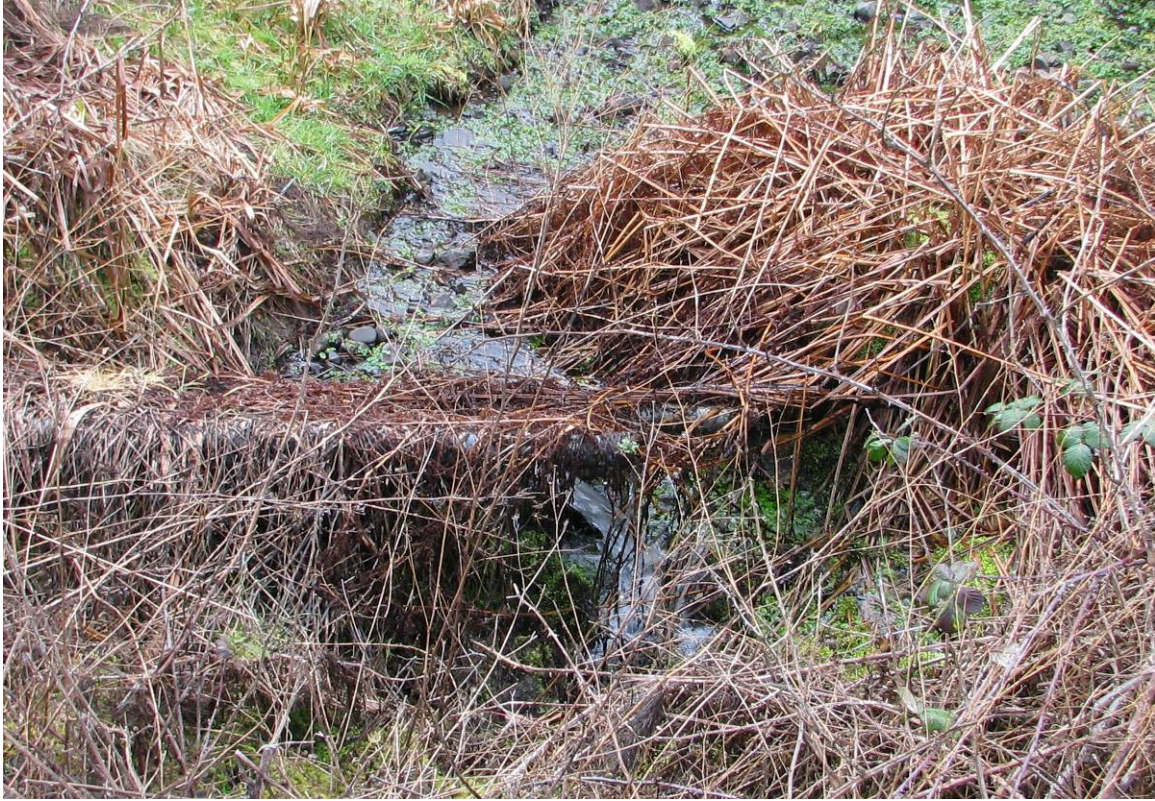
- We also saw seepage on the left abutment and through the normal drains near the toe area at the bottom of the dam Figure 5. In both cases flow was clear and these levels are similar to what has been observed during early spring inspections of the past. No action is necessary on this issue.

Figure 5. Seepage from toe drain (clear).
