Re: Silver Creek Dam (S- 66) – Inspection Summary

This dam was inspected on October 15, 2019. I performed the inspection. The Water Resources Department conducts routine inspections of the dams' exterior surfaces to identify conditions that might affect the safety of the dam. Dams are assigned a hazard rating based on downstream hazard to people and property, not on the condition of the dam. Silver Creek Dam is classified as a high hazard dam. High hazard dams are inspected annually.

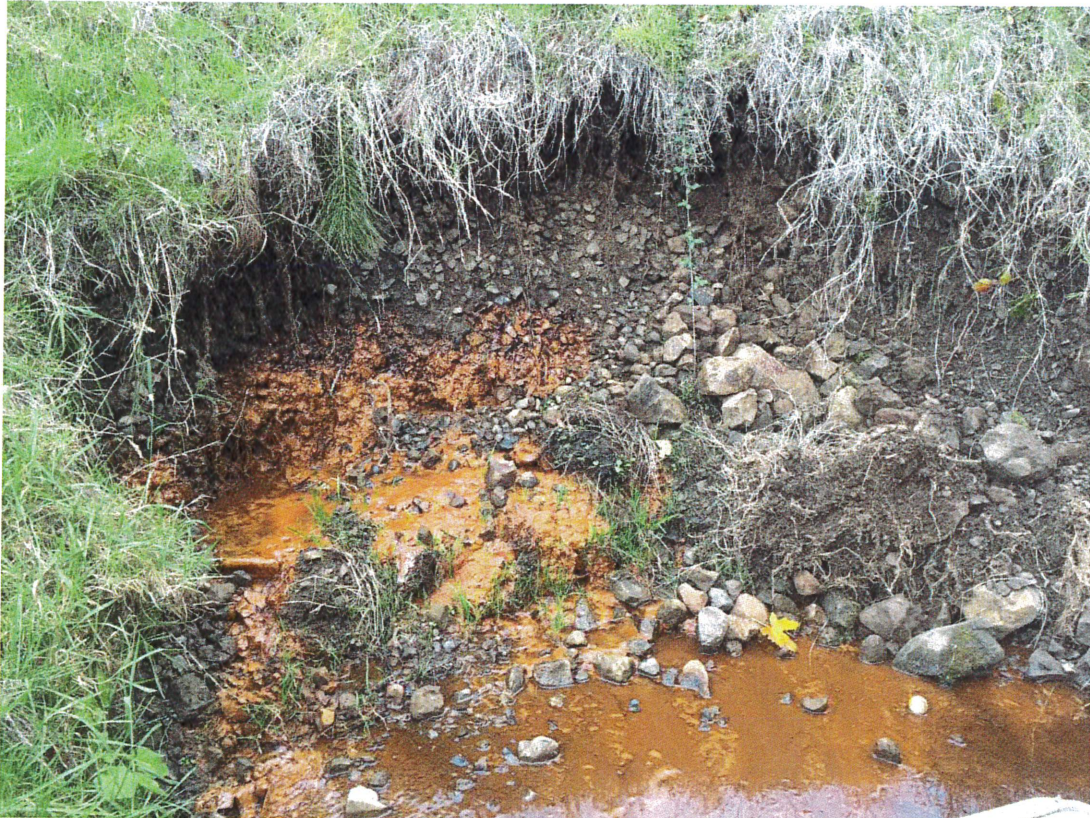
Excavated area of seepage above outlet

There was an area of seepage observed above the outlet pipe at the time of inspection. This area had been excavated to examine the extent of the seepage. Plans are in place to repair this area. After repairs, the seepage should be monitored for any changes to quantity or quality.

Other outlet(s)	<input type="checkbox"/> Yes <input checked="" type="checkbox"/> No Type(s) _____ Diameter(s) _____	-----
Detail:	seepage above outlet pipe which had been excavated. repairs to be carried out 2020

1. Develop an access road so that equipment can get to the dam if the spillway is flowing.
2. Conclude repairs on seepage area and monitor for any future changes.
3. Monitor the repaired spillway joints for new cracking.
