Existing Conditions Analysis and Recommendations

Aquatic Components of the Silverton Community Pool

October 09, 2016

Prepared for:
City of Silverton OR
306 S. Water St
Silverton, OR 97381

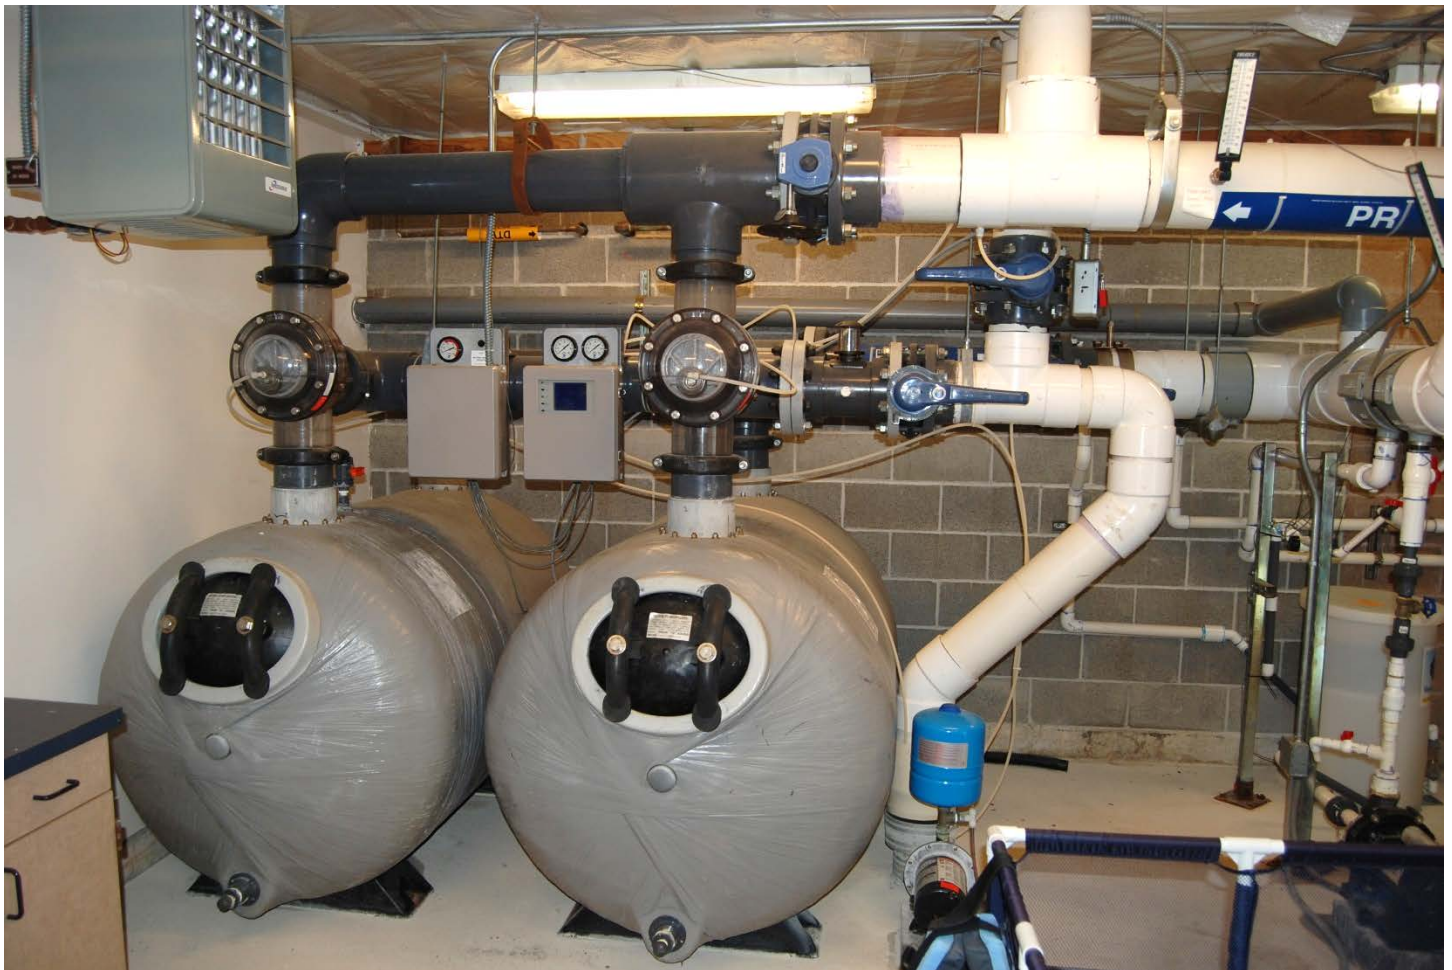
The filter is a dual horizontal sand filter located in the pool mechanical room. The Stark horizontal fiberglass sand filters are model number SS 72 and provide 20 sf of filter each for a total of 40 sf. These filters include an automatic backwash system that has been easy to use.

Stark Horizontal Fiberglass Sand Filters

- 1) Annually at the end of the summer season use a filter cleaner to remove accumulated oils and debris from filter media
- 2) Every 5 to 7 year replace the sand filter media.

Recommendation	Purpose	Priority	ROM Cost Opinion Range	
1) Annually at the end of the summer season use a filter cleaner to remove accumulated oils and debris from filter media.	Operational	First	\$1,200.00	\$5,000.00

2) Every 5 to 7 year replace the sand filter media.	Operational	First	\$7,000.00	\$12,000.00
3) Brace all piping to align with seismic code requirements	Compliance	First	\$6,000.00	\$12,000.00

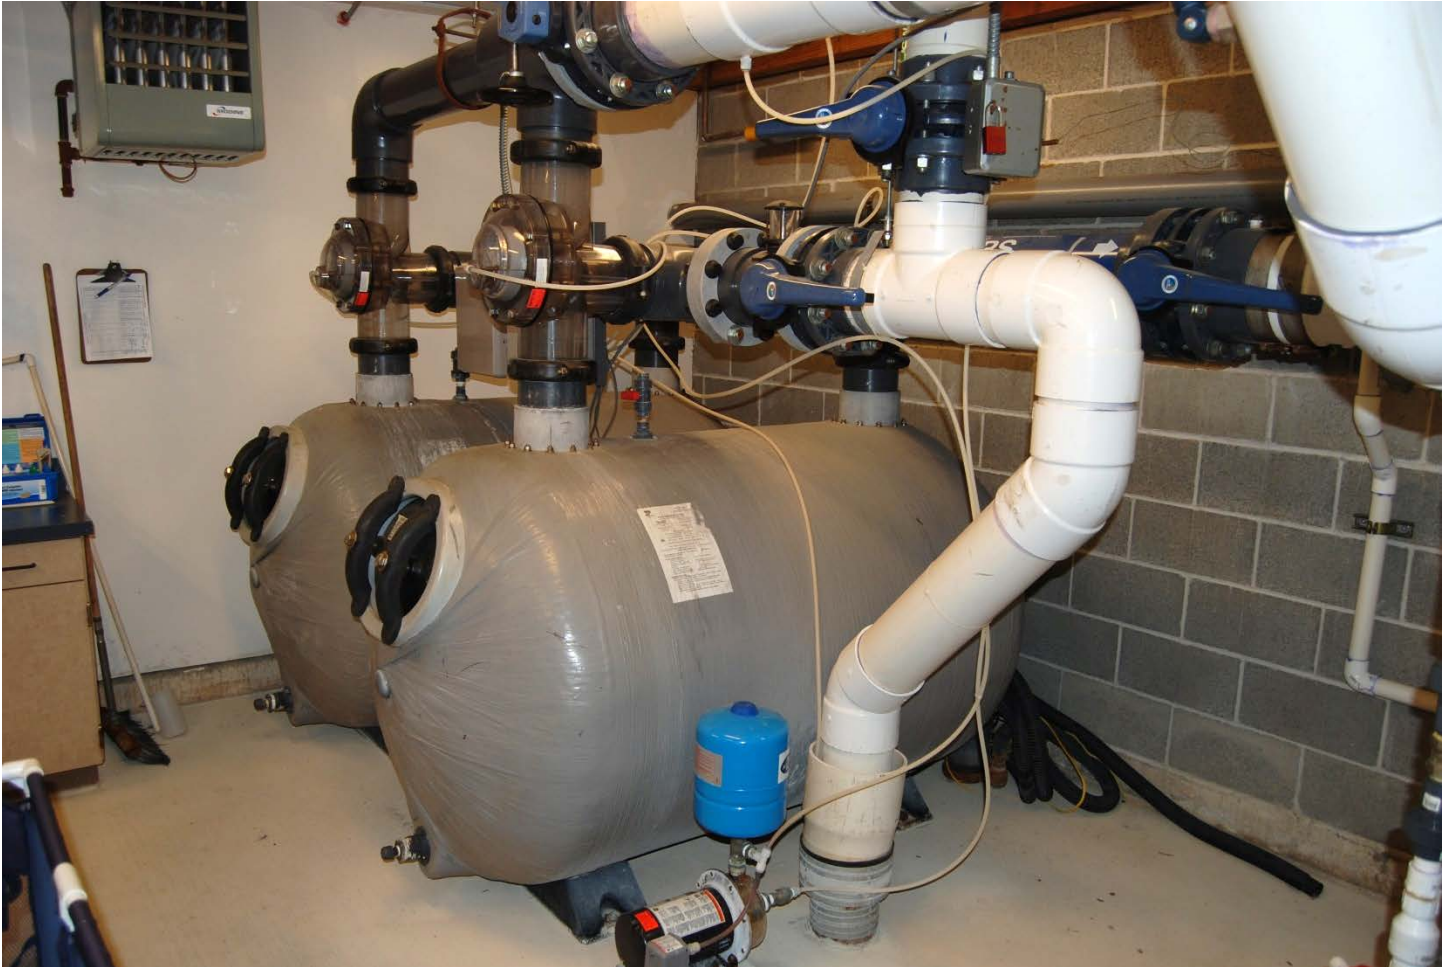
The circulation piping that can be visually inspected in the pool equipment room is mixed materials, including PVC, CPVC and copper. The majority of the PVC varies between schedule 40 and schedule 60. There are multiple valves that range from gear or handle operated butterfly valves to true union ball valves on pic sizes 2 inch and smaller. The plumbing appears to adequately support but is not compliant with seismic bracing. All poly tubing should be placed in conduits for protection.

Example mixed PVC circulation piping material

- 3) Brace all piping to align with seismic code requirements.
- 4) Replace all poly piping, install in conduit and ensure the compression fittings are mechanically sound

4) Replace all poly piping, install in conduit and ensure the compression fitting are mechanically sound	Operational	First	\$2,500.00	\$4,000.00
5) Replace circulation pump with new high efficiency pump and motor.	Operational	Second	\$8,000.00	\$14,000.00

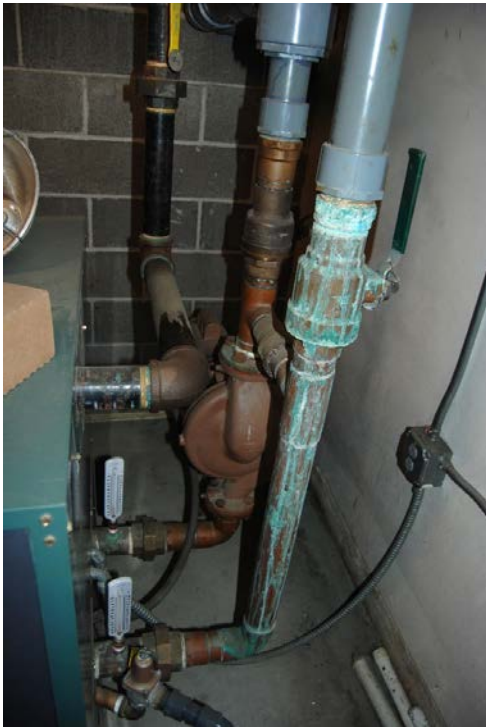
Mixed piping CPVC and Copper at Heater

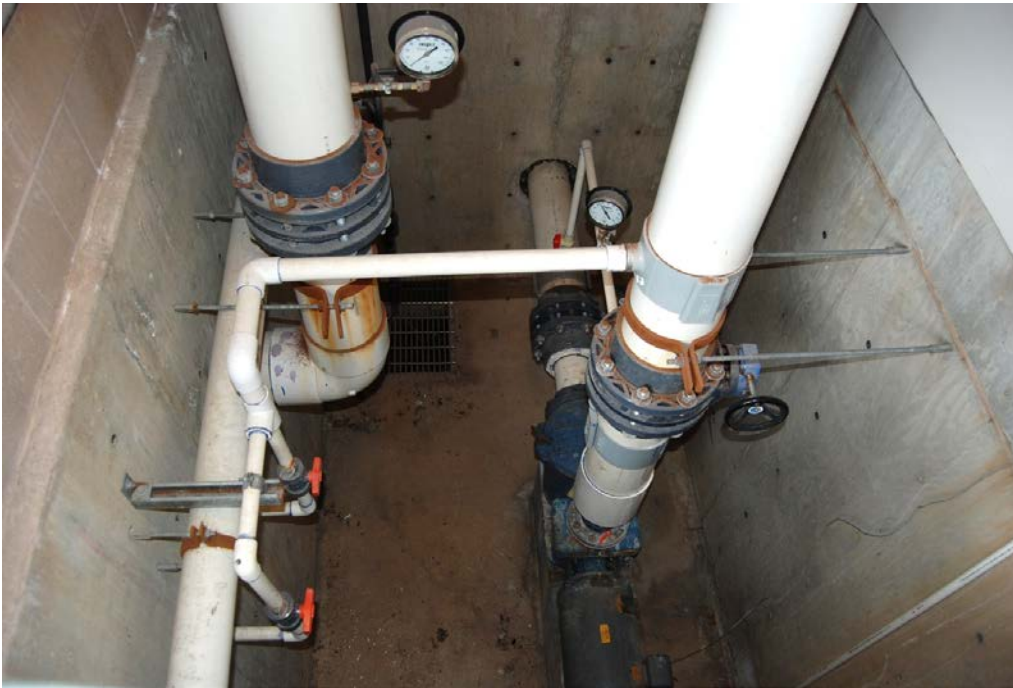
The circulation pump appears to be in good operational condition. The pump is a Sta-Rite model C 20 HP located in a pump vault for increased efficiency. There was some corrosion noticed on the motor and volute of the pump. Also, the pump has a variable output control, this VFD provides the pool pump motor with a soft start protection that appears to be installed in 2010.

- 5) Replace circulation pump with new high efficiency pump and motor.

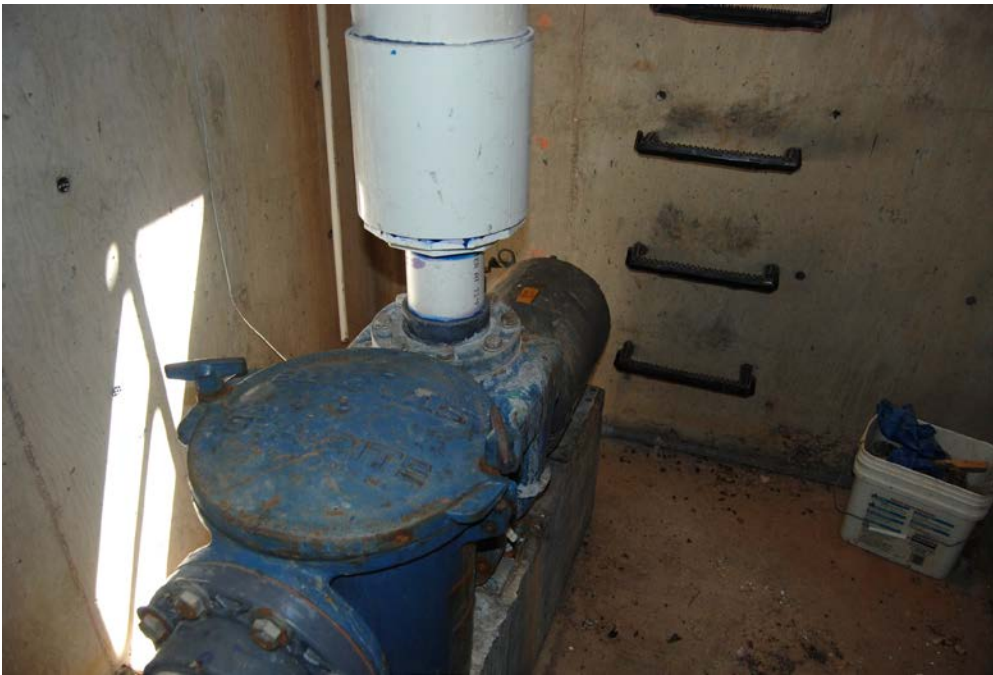
The pump hair and debris strainer is integrated to the pump. Both the strainer and baskets appear to be in good condition with some surface oxidation.

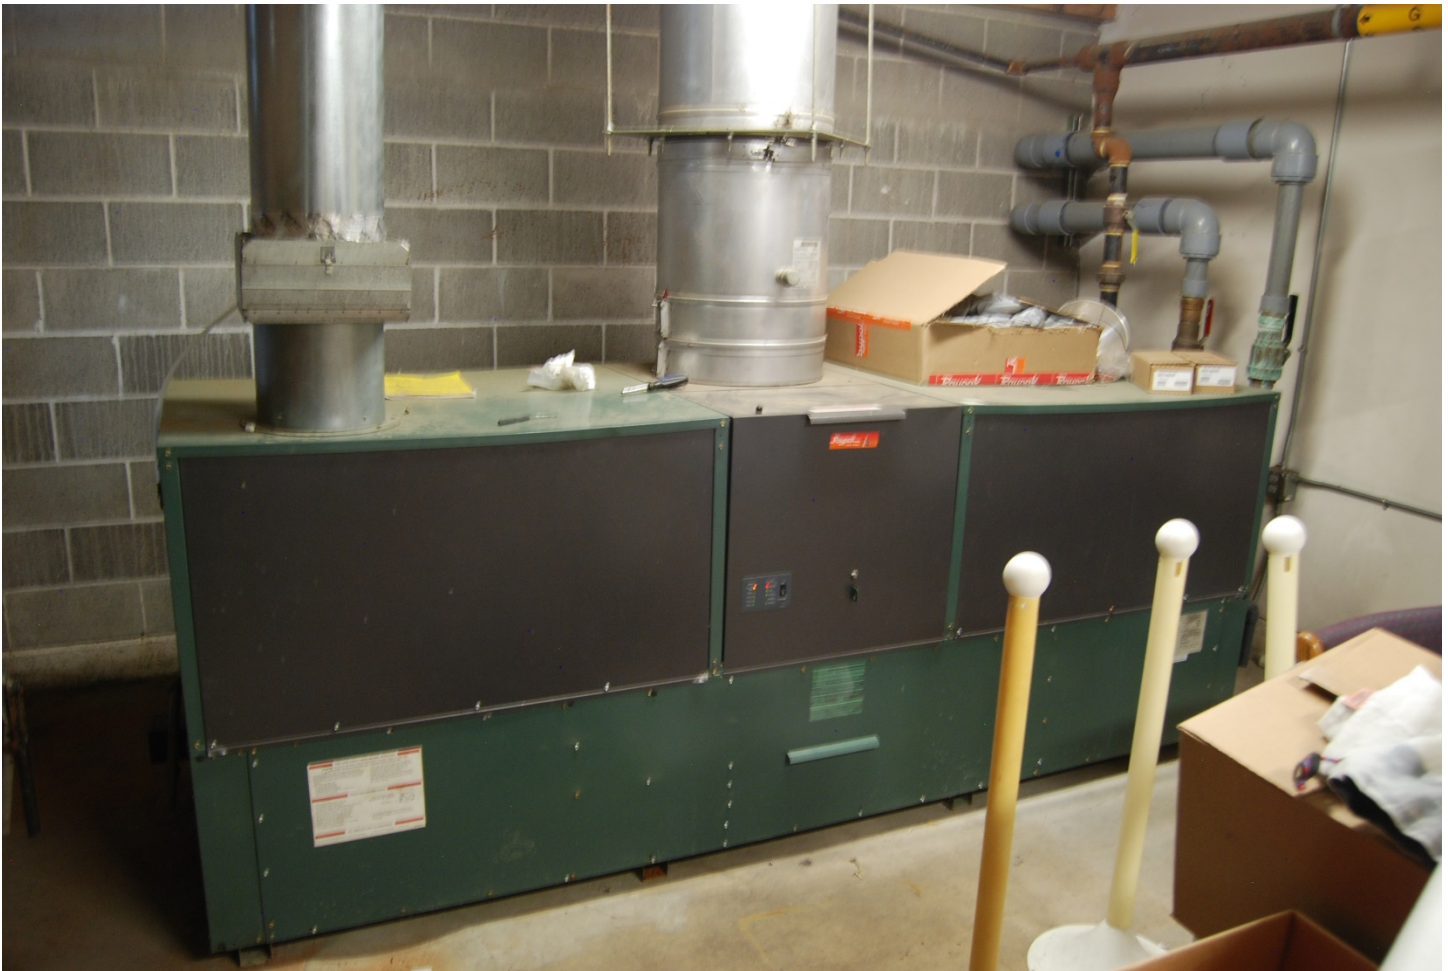
The pool is heated with a pool water heater with an integrated heat exchanger. The heater is a Ray Pak Hi Delta heater 2,340,000 BTU maximum output with a 78% efficiency rating, supplied by the building boiler system. The heater is of a recent vintage and appears to be in good operational condition.

6) Remove all combustible items from heater and ensure that there is free air flow around heater cabinet.

6) Remove all combustible items from heater and ensure that there is free air flow around heater cabinet.	Operational	First		No Cost
7) Perform a leak detection test to verify waterproof integrity of the pool vessel.	Compliance	First	\$9,000.00	\$15,000.00

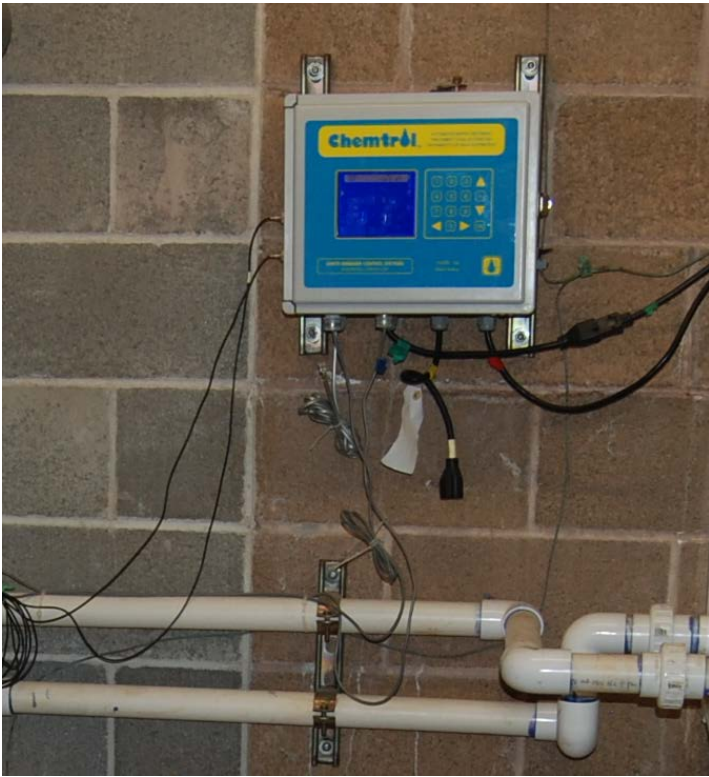
The chemical systems of the pool are governed by a Chemtrol PC 3000 automatic chemical controller. This controller complies with current code regarding operation and measurement of the disinfectant and pH levels of the water. However, a more updated model of controller would provide the operator with more dynamic control and deeper insight.

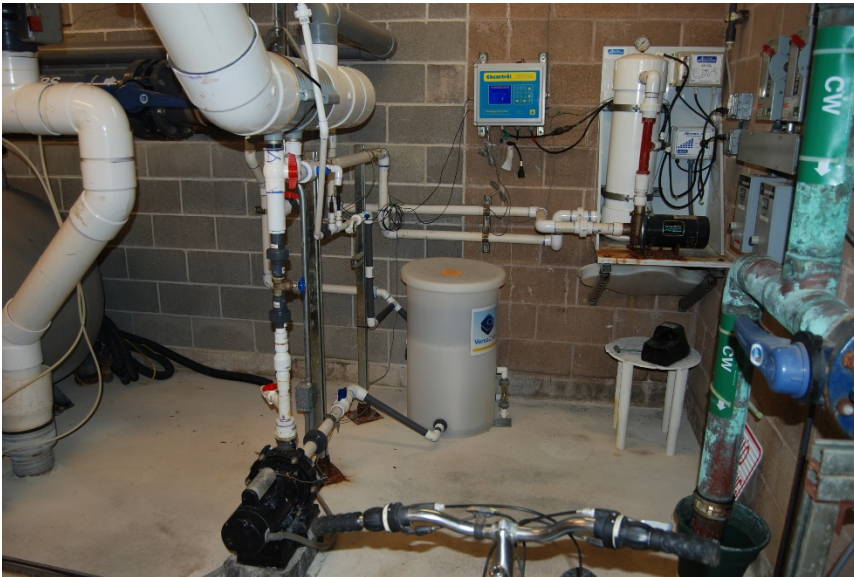
The pool's primary disinfection system uses a calcium hypochlorite feeder. The feeder has a booster pump and a venturi feed system. It is reported that this has been a very effective sanitizing unit.

Location of Versa Chlor cal hypo feeder

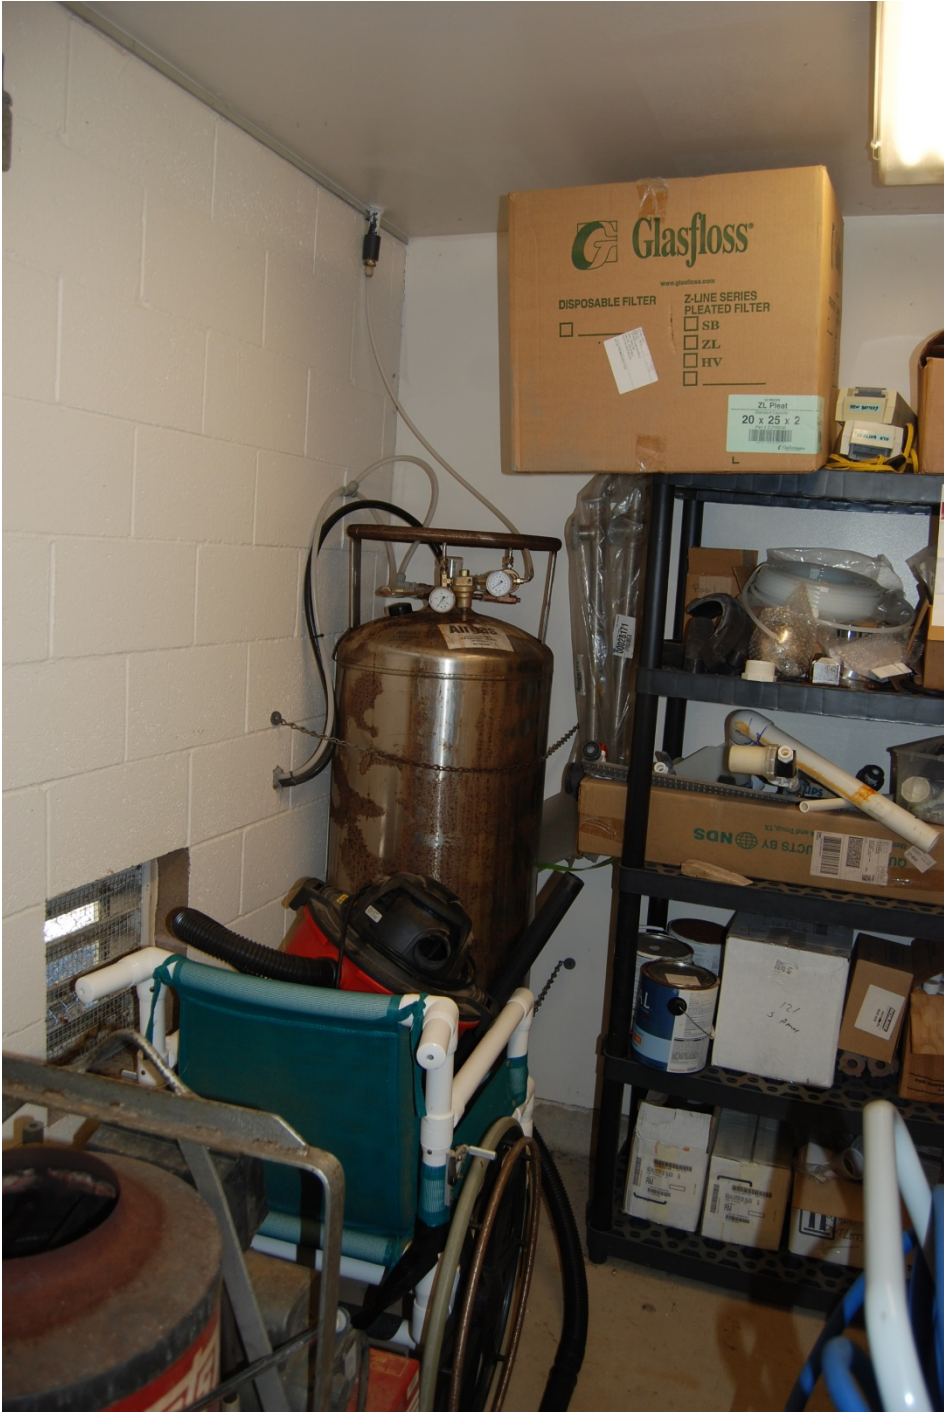
The pool is balanced using carbon dioxide injection. The large gas tank is stored in storage room with an exterior door and a long feed line is run from the storage location to the mechanical room.

Compressed carbon dioxide storage cylinder

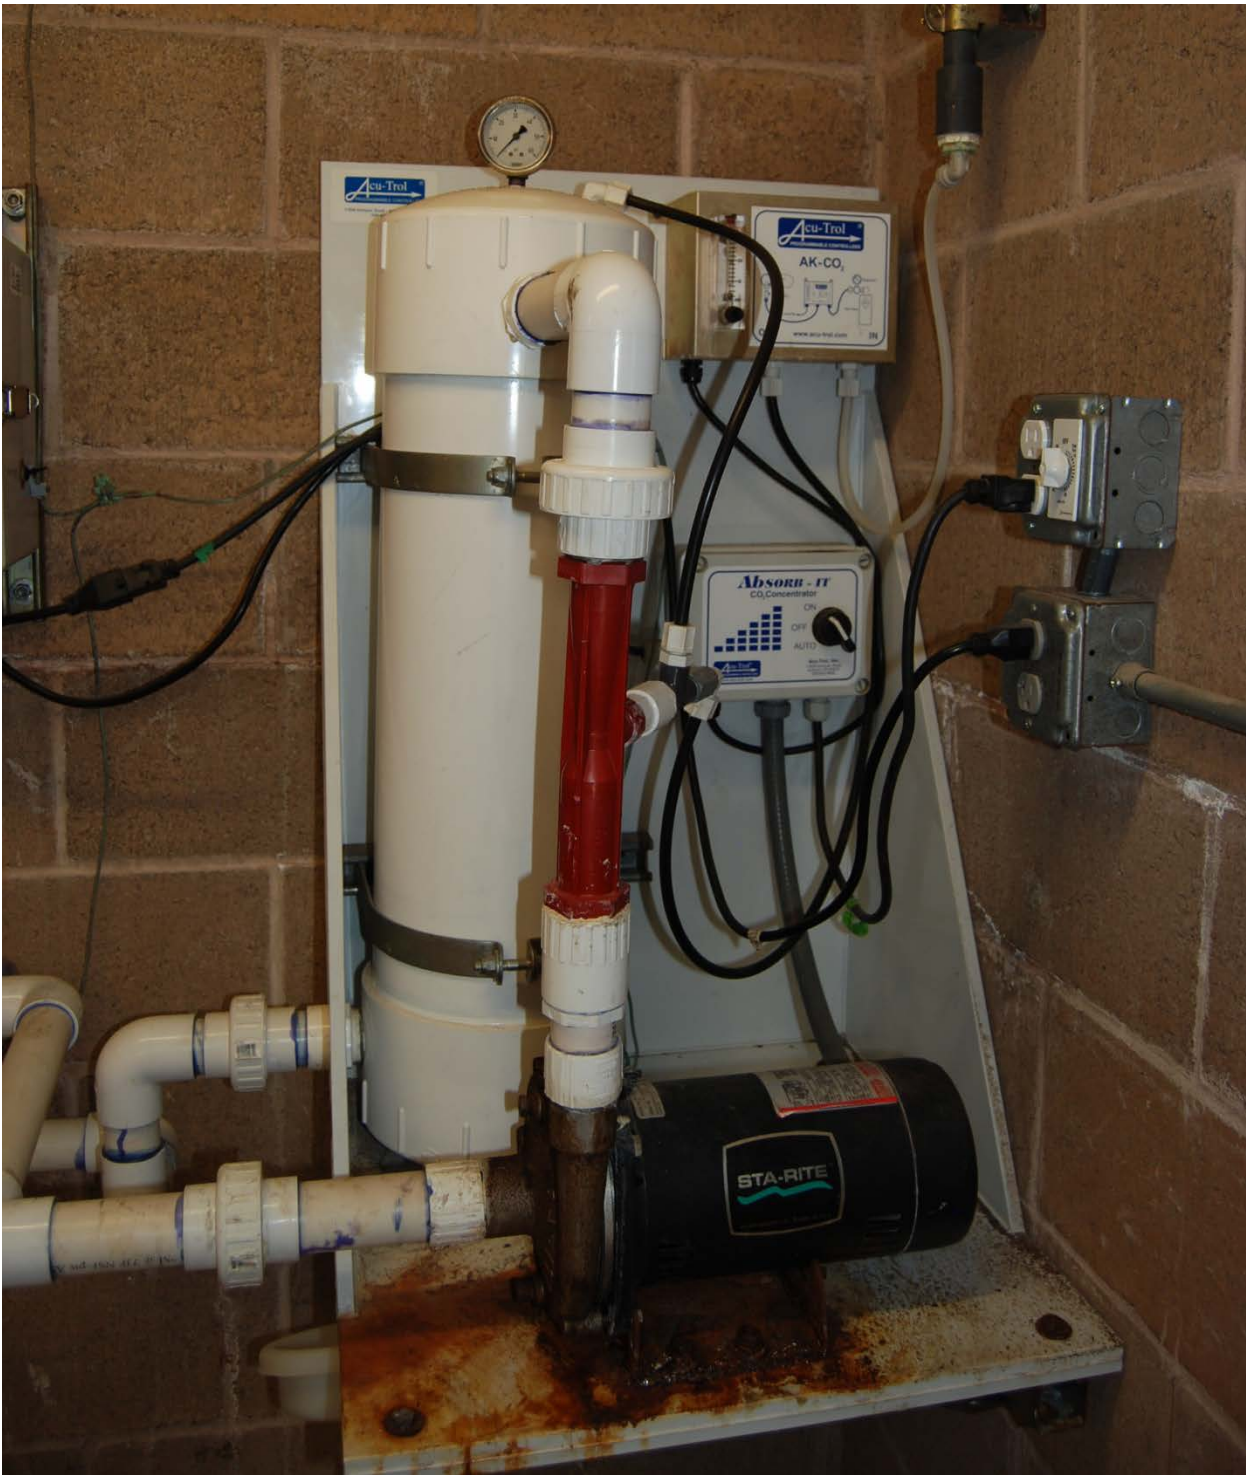
There is also a venturi feed with mixer installed in the system for efficient pH control. The mixer and tank lid appear in working order.

CO2 Venturi Feed System

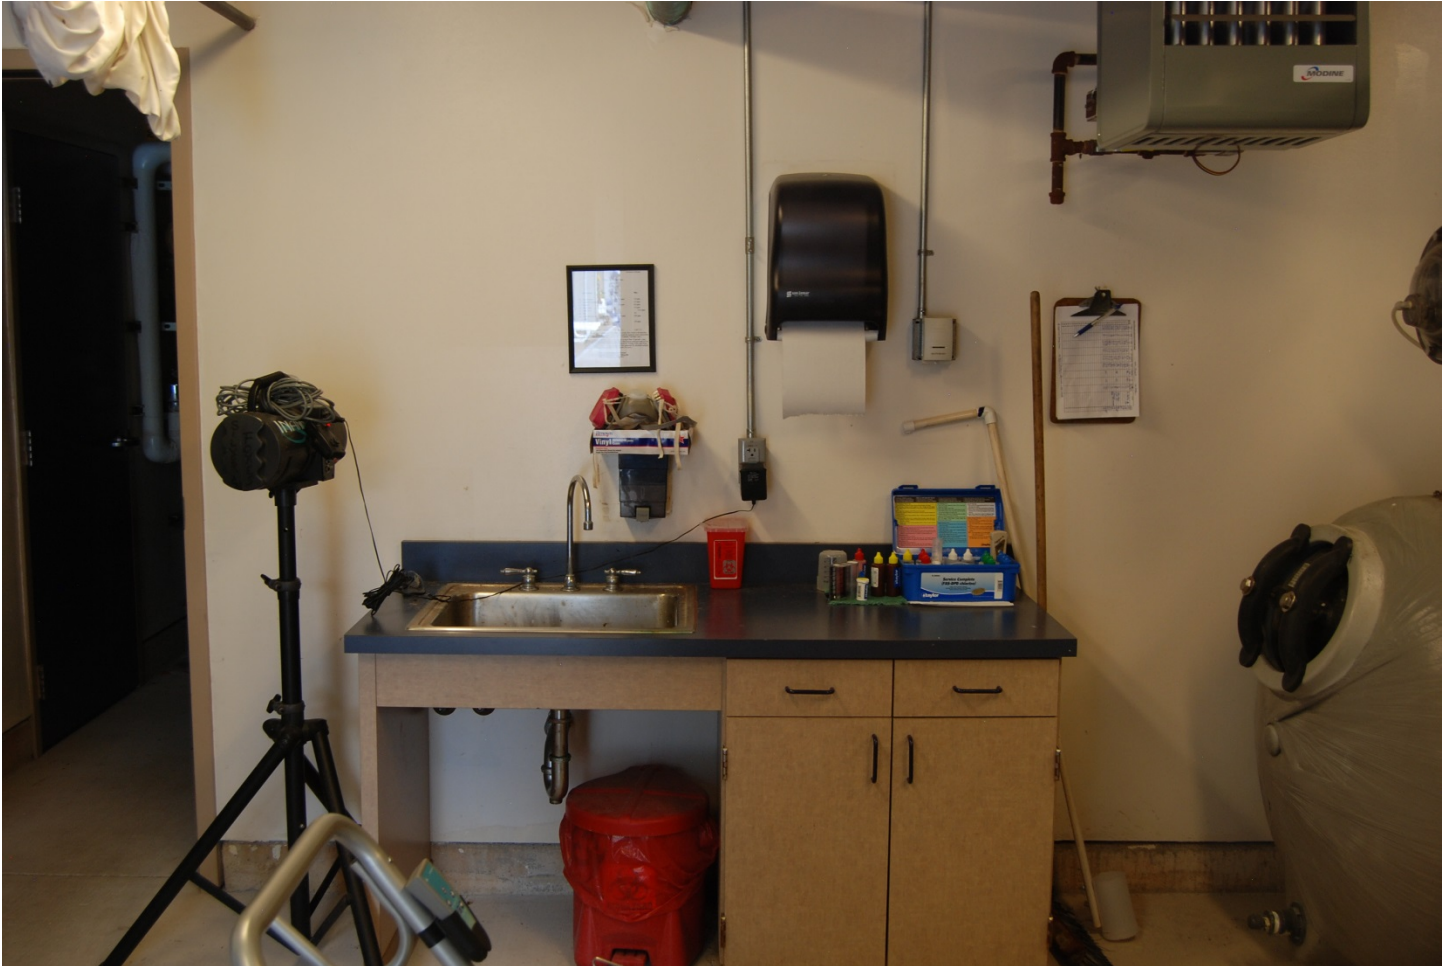
Chemical signage/placards, and Material Safety Data Sheets were not observed at the facility. Make sure that all placards are placed on exterior doors. There is a current MSDS sheet for all chemicals used or stored on site in the desk drawers.

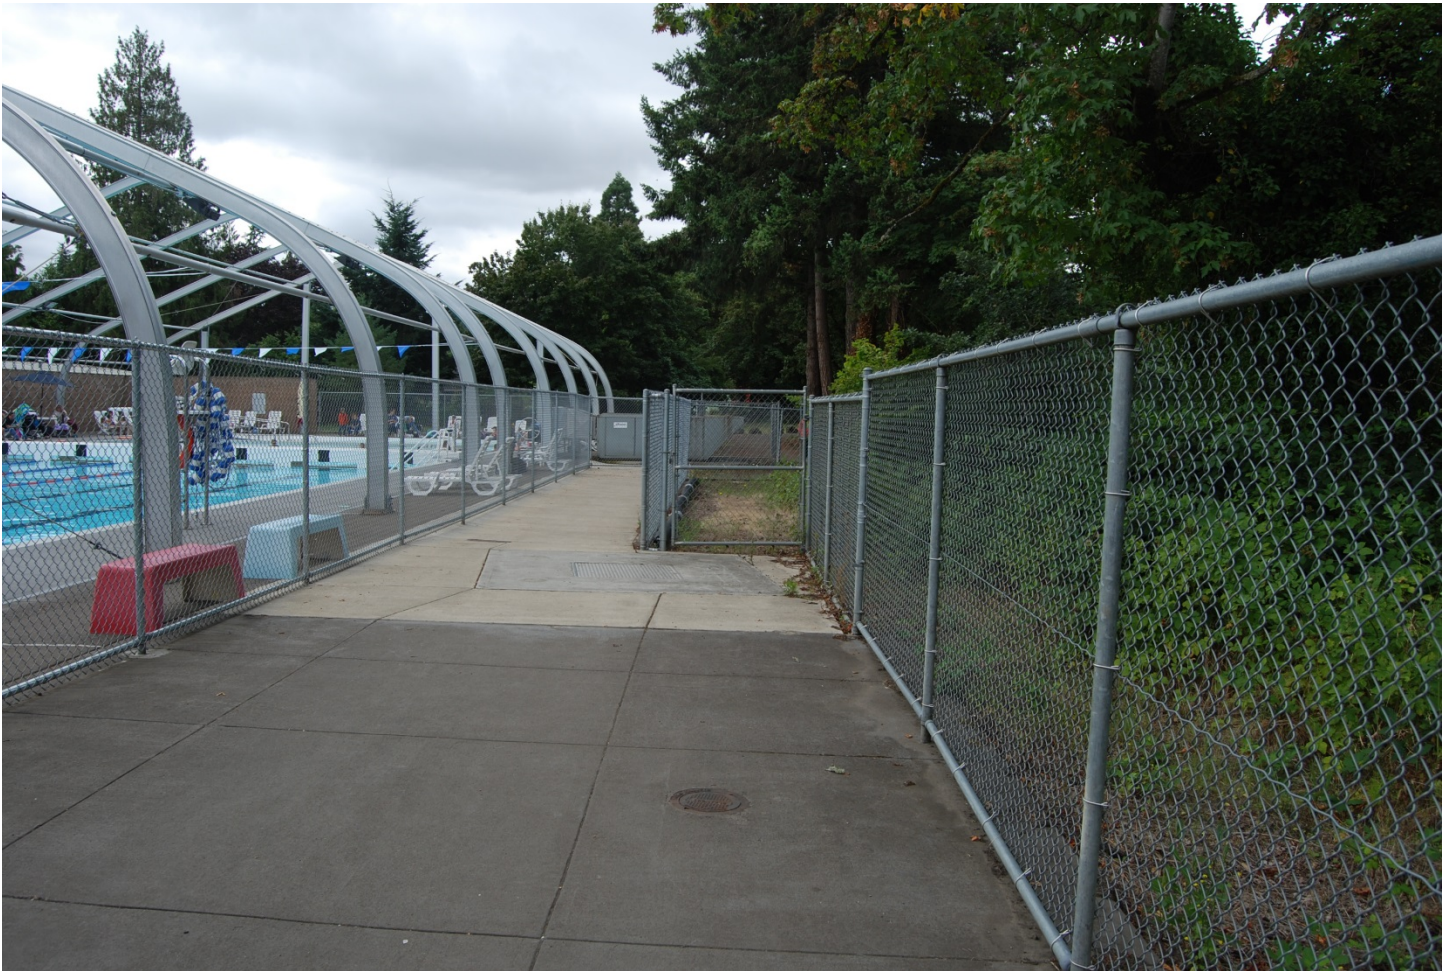
Location of original surge tank

The original surge tank is in poor condition. There is evidence that there is significant degradation of the concrete. This would potentially cause a source for leaking around old abandoned piping. When reviewing the tank from the surface there is evidence that there are abandoned metal pipe penetrations that could be the source of water loss. This need to be evaluated in greater detail to determine if this is the source for the pool water loss. If this is the area where water loss is occurring, it is recommended to either replace the surge tank with one surge tank or line the original surge tank with an imperious water proof material.

It was also observed that this appears to be some river bank deterioration between the surge tank and the river. When the bank was observed from the opposite side of the river looking towards the pool water could be observed and heard emanating from the river bank and trickling into the river. This could have a most destabilizing geo-technical impact sometime in the future if the source of this water is the pool.

- 11) Conduct testing on some trace chemical compound in the water for the pool and water seeping into the stream. Often it is simple to determine if the water seeping through the wall would be of a similar chemical nature by testing alkalinity, calcium hardness and even cyanuric acid levels.
- 12) If water test analysis and testing proves that the original surge tank is leaking, either line the existing surge tank or construct a new replacement surge tank to collect water from new gutter and main drain to eliminate any source of leaking.

12) If water test analysis and testing proves that the original surge tank is leaking, either line the existing surge tank or construct a new replacement surge tank to collect water from new gutter and main drain to eliminate any source of leaking.

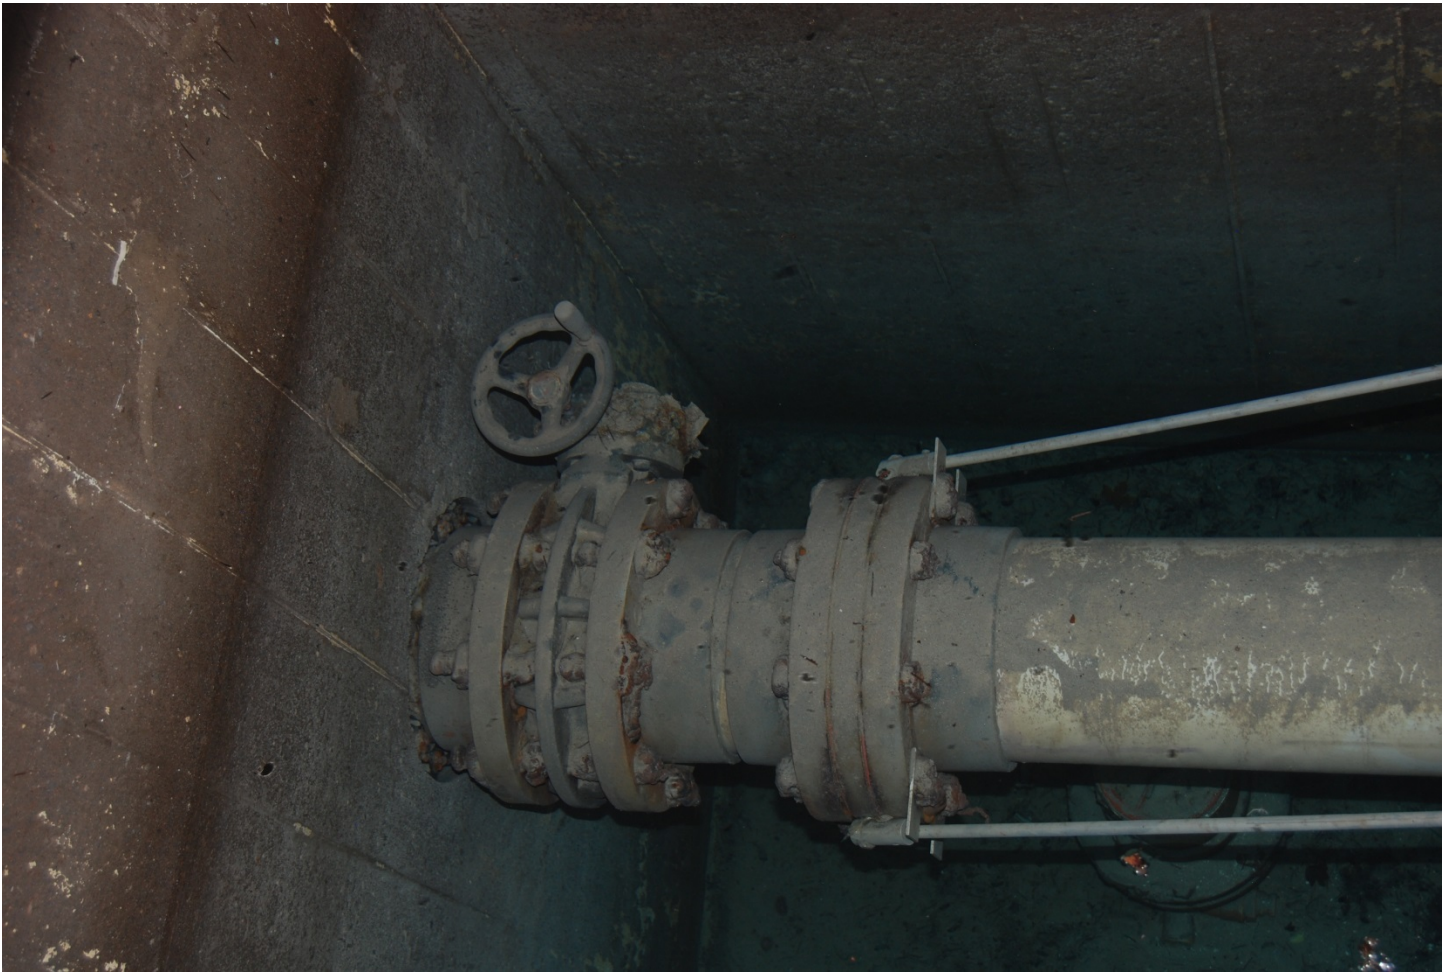
Image of original surge tank showing abandoned plumbing in floor and modulation valve.

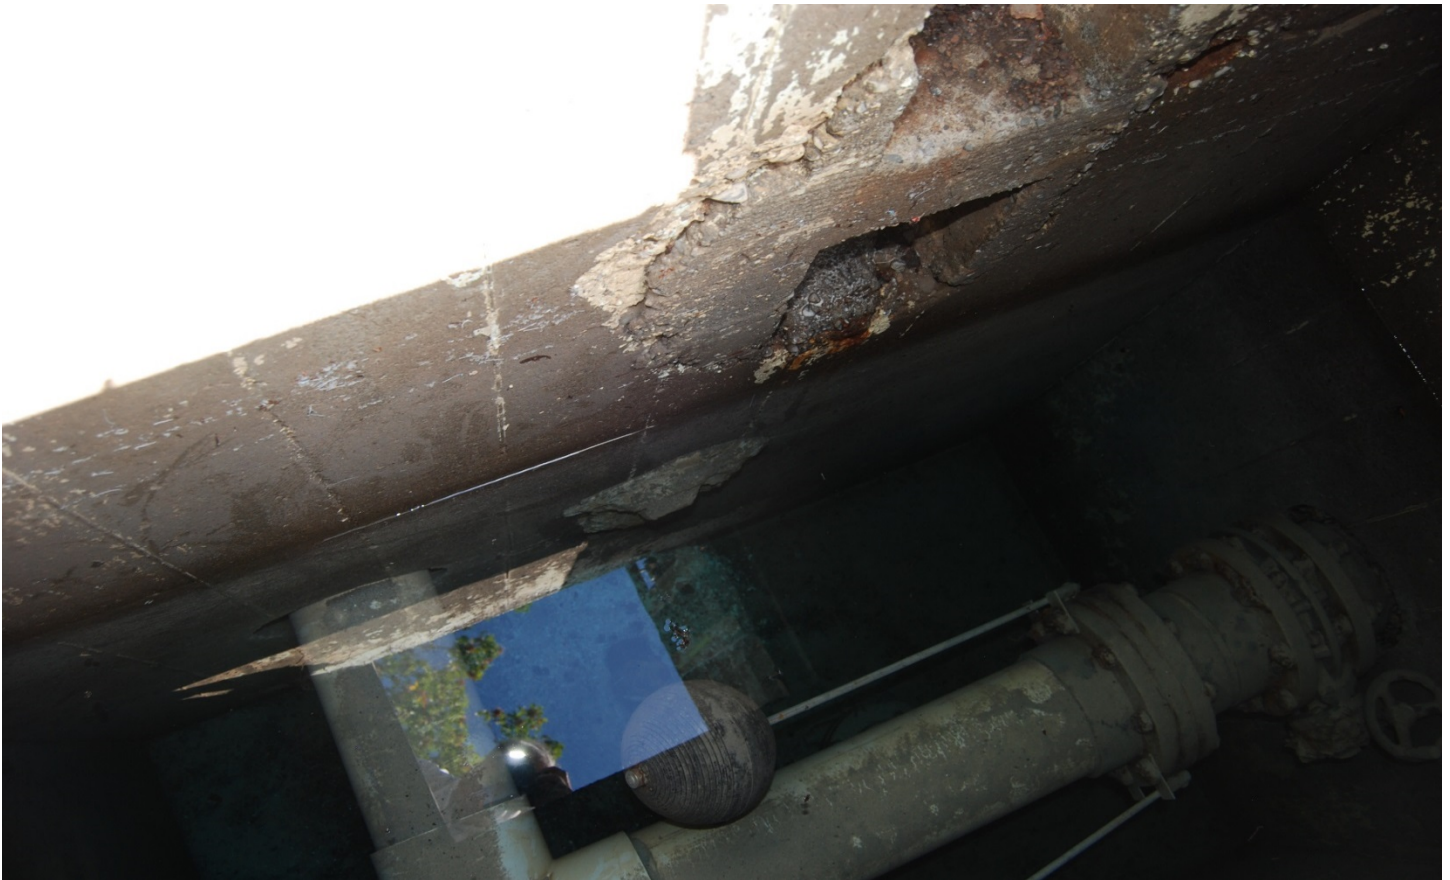
Image of original surge tank with wall degradation.

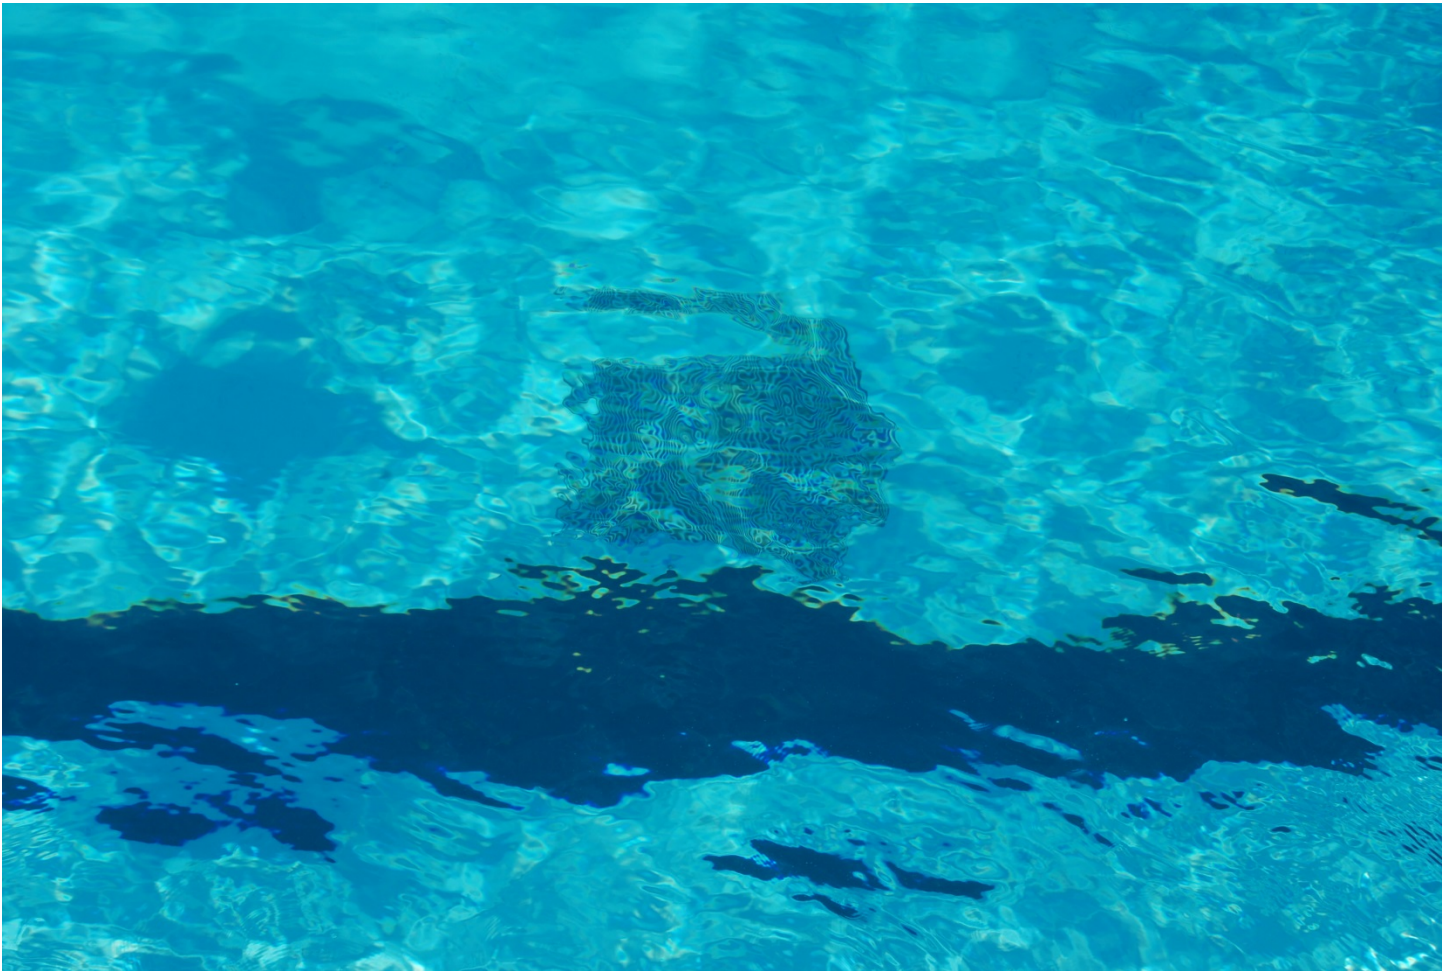
Pool water exits the pool and returns to the filtration system through three 24 by 24 main drain grates. The existing main drain appears to be compliant with the Virginian Graeme Baker Act (VGBA).

Main Drain Grate

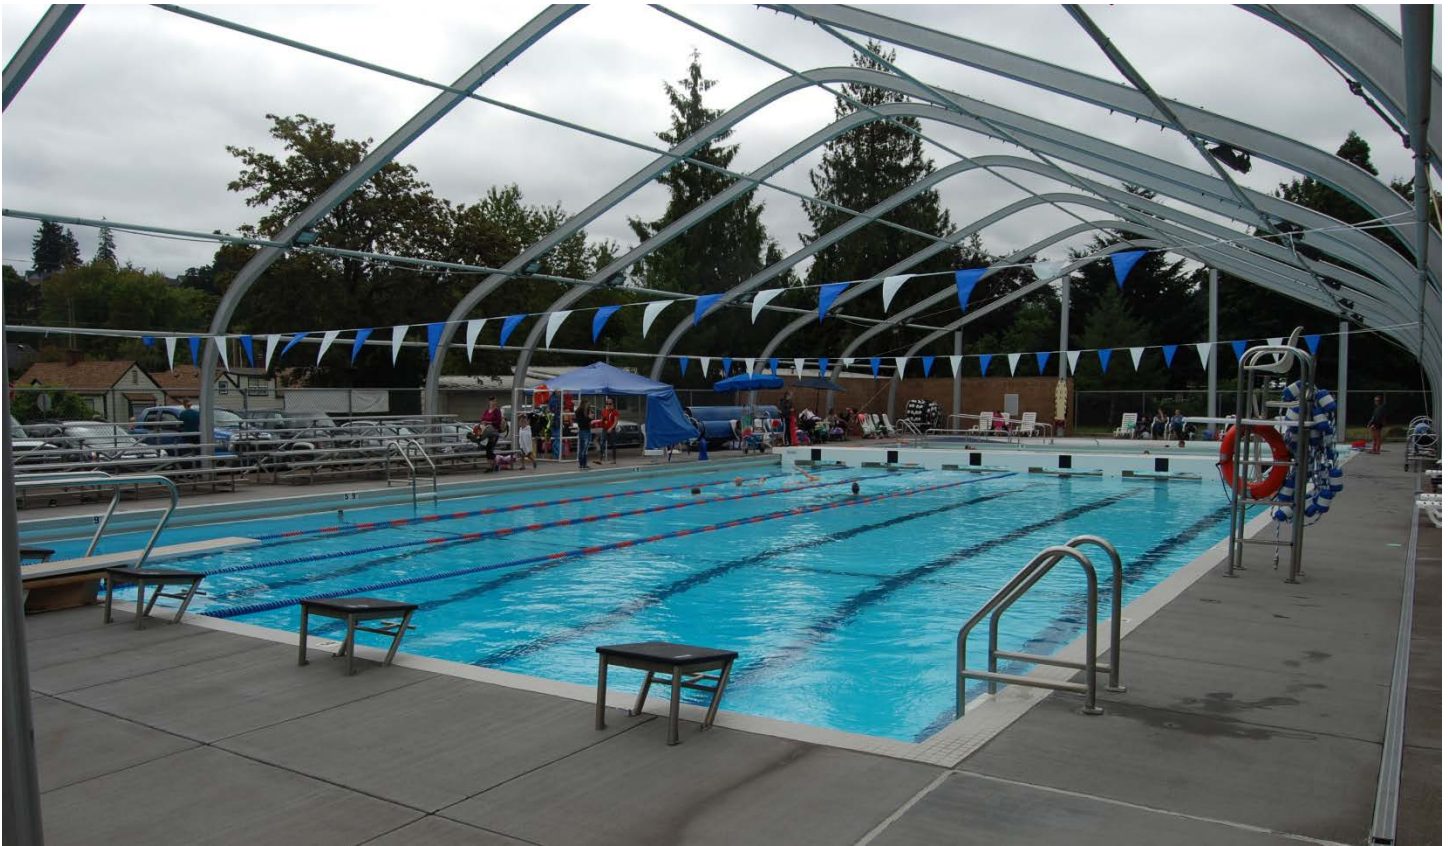
The pool deck and deck drainage system appear to be in reasonably good condition. It appears that the caulking joints are maintained and no areas of significant differential movement or separation was observed.

Pool deck

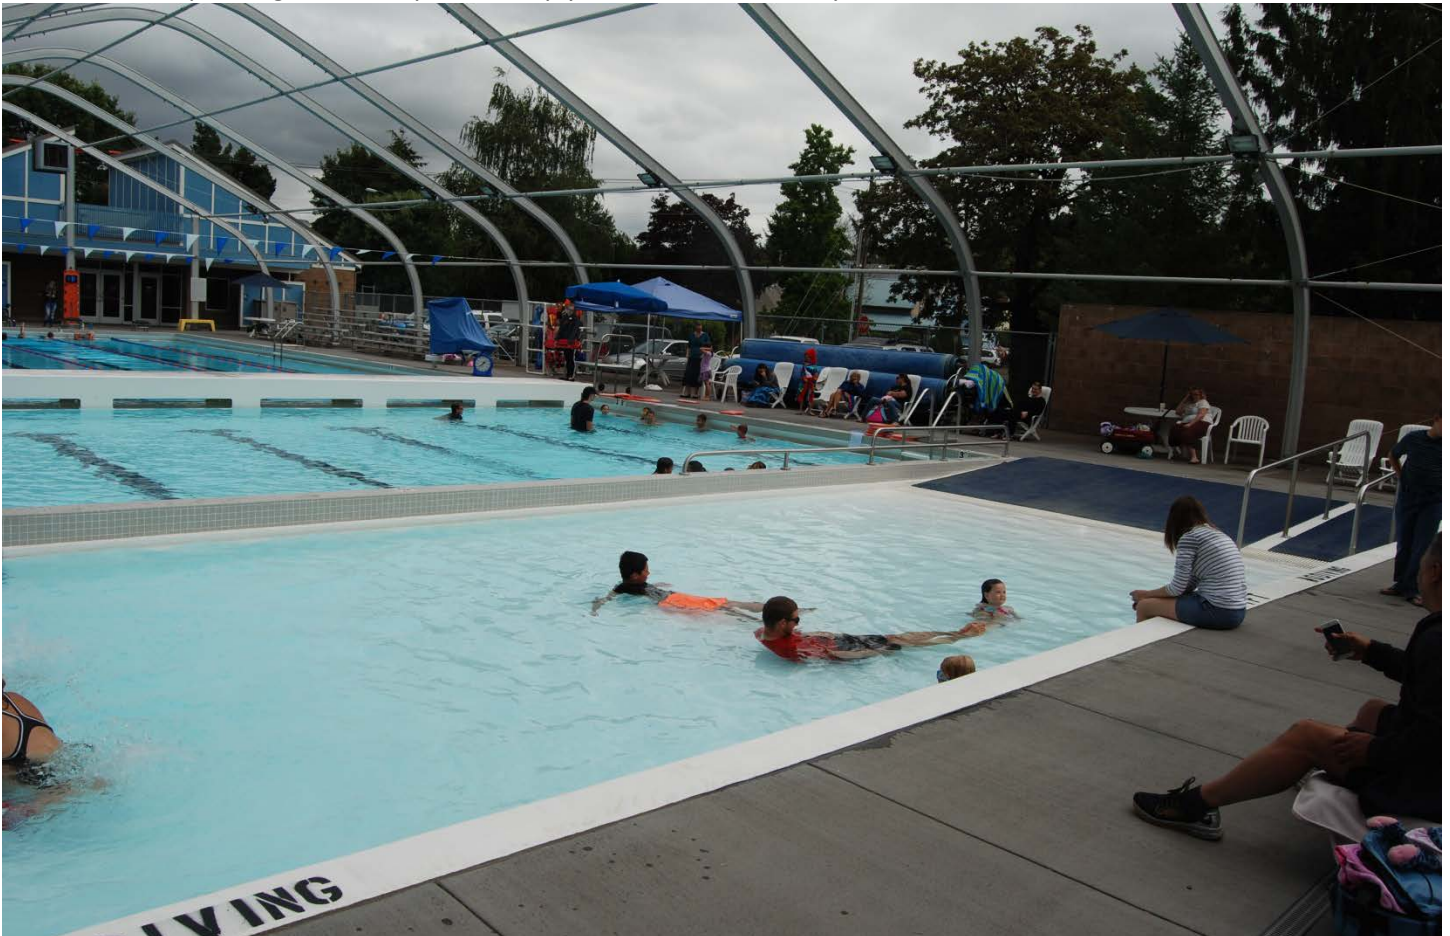
The pool perimeter is over 300 lf which would require two accessible entries to comply with the ADA guidelines. There is a lift that is installed at the pool edge with would qualify as one accessible entry. The rails in the zero depth area do not extend to a deep enough water depth to comply as an accessible entry.

Accessible lift and convenience ramp rails into pool

- 17) Install an additional ADA compliant chair lift on the edge of the pool, and extend the star rails to a water depth of two feet.

17) Install an additional ADA compliant chair lift on the edge of the pool, and extend the star rails to a water depth of two feet.
