National Register of Historic Places Registration Form

historic name Moser, Joseph Henry, Barn

street & number 507 South 3rd Street not for publication

OTHER: Bank Barn

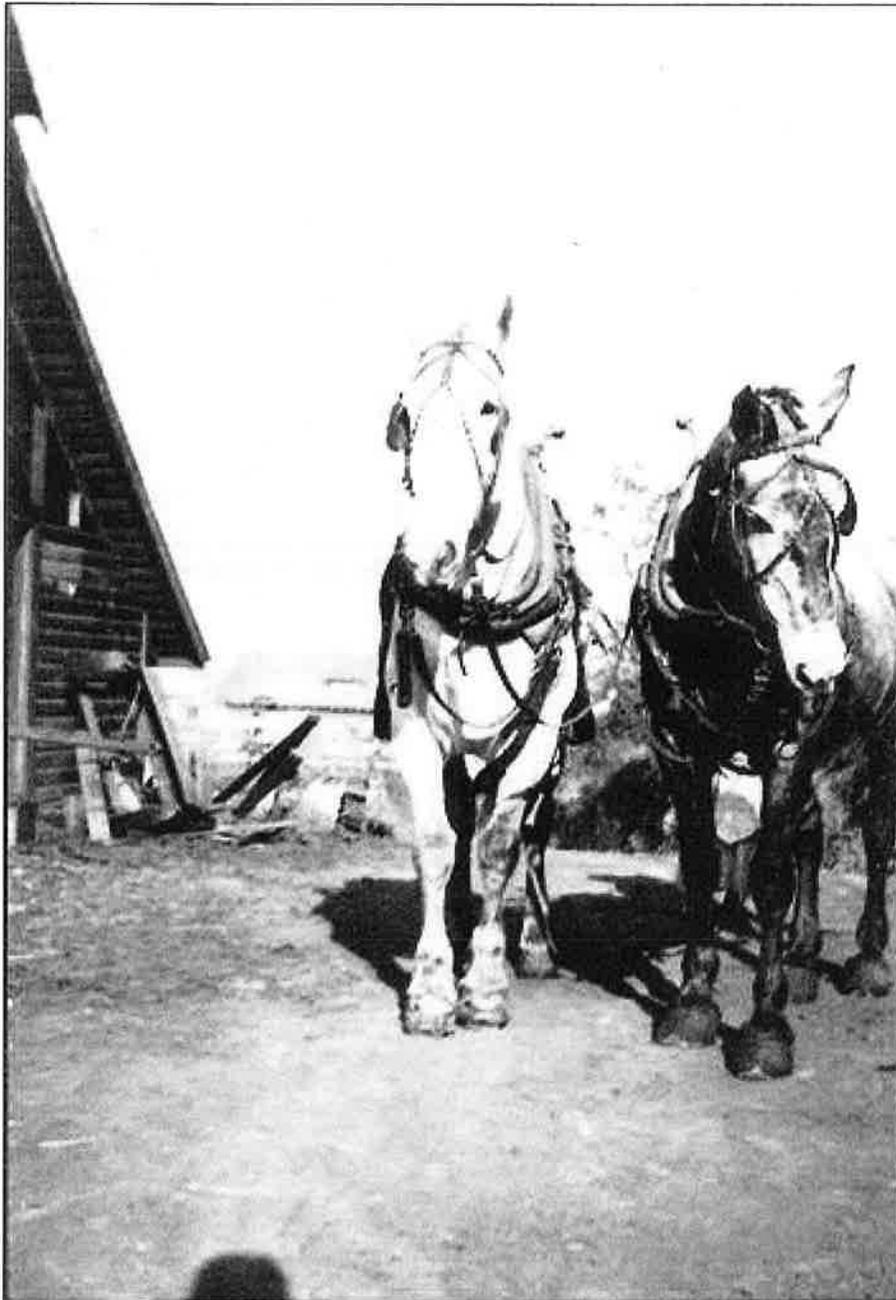
Figure 9: Horses in alley on northeast side of barn, unknown year; 1912 shed addition seen on left side of image.⁴²

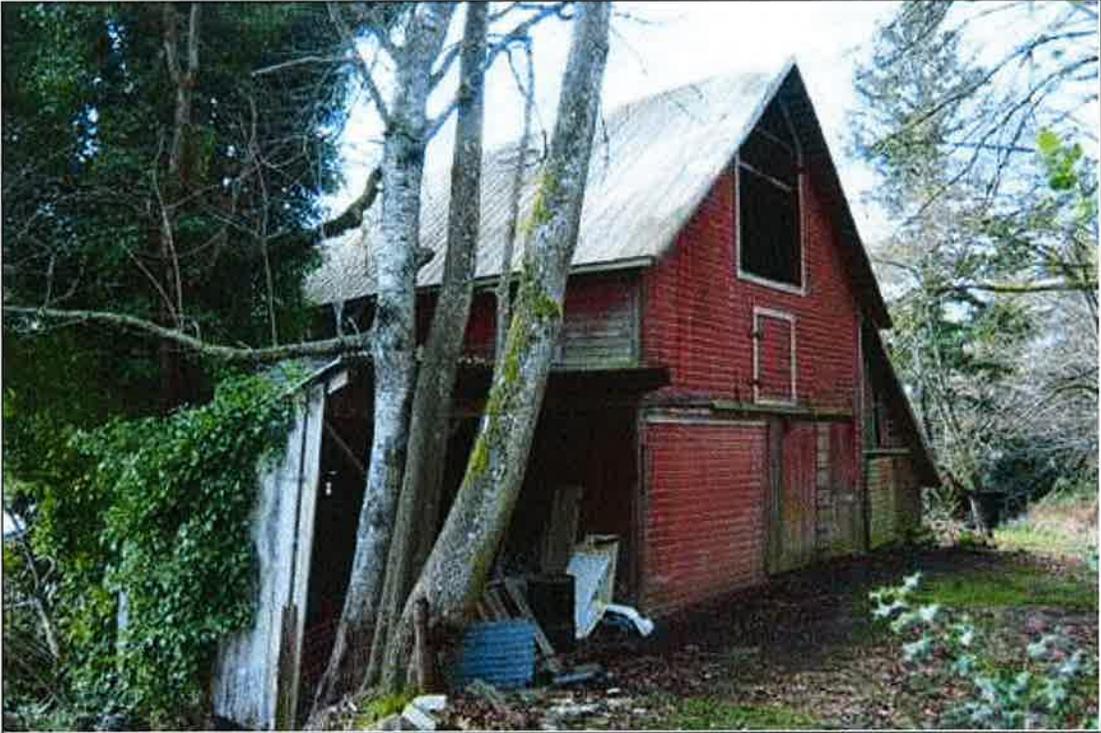
Photo 1 of 8: Looking northwest at the east façade with the south shed roof addition in the foreground.

On the south side of the east façade is the south shed addition, constructed in 1927. A wood board is attached to the front (east façade) of the main massing at the same level as the top of the drive door and then extends to the south where it is supported by a wood post. The roof structure of the south addition is supported by this board on the east façade and by the addition's walls on the south and west façades. The roof's exposed rafter ends are visible, and the addition is open on its east façade (see photo OR_MarionCounty_JosephHenryMoserBarn_0001).

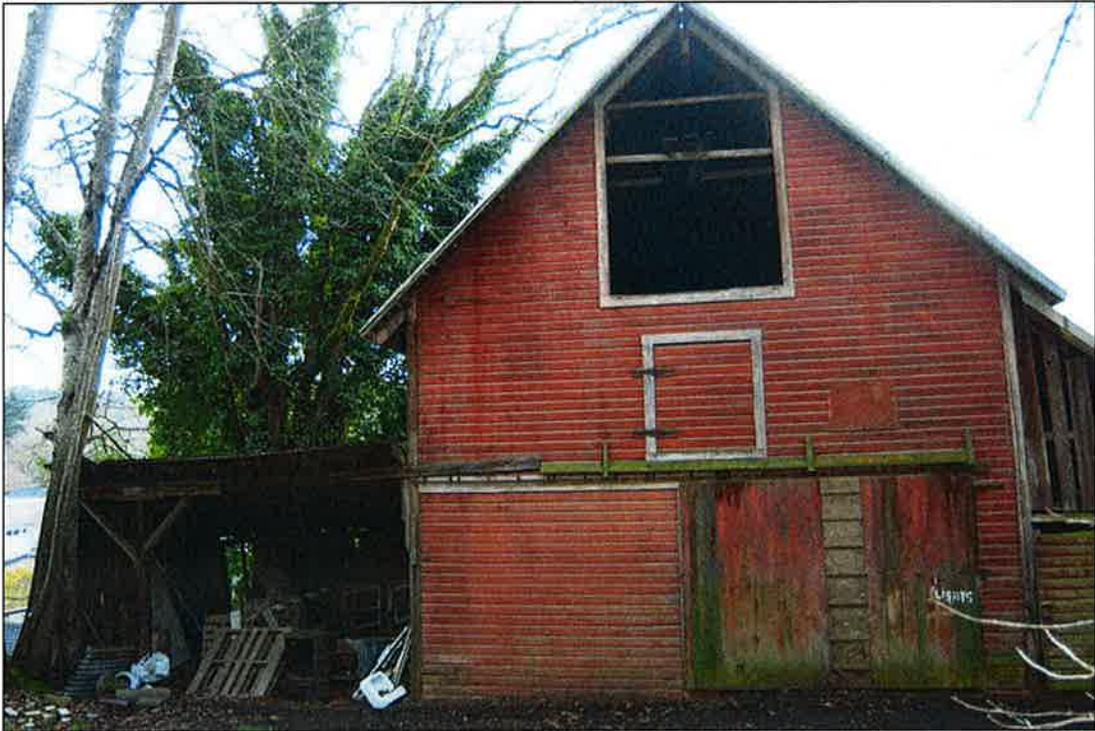
Photo 2 of 8: Looking west at the east façade.

The east façade faces East Hill, a wooded area. Functionally, the east façade is the front of the barn, containing drive doors on the middle level and loading doors on the loft (upper) level. The central portion, the original side-gabled barn, includes a large, rectangular hay loft door, centered just beneath the gable peak, and includes the remains of the original hay track used for loading bailed hay into the upper loft area. The hay loft door itself is missing, but the simple board trim remains. Centered beneath the large hay door is a smaller hay-loading door, also with simple wood trim. The small hay loft door is constructed of the same siding that was used for the rest of the barn. The door is framed on the inside and is attached to the south side of the door frame with simple strap hinges. The primary drive door, which gives access to the large storage area on the center level, occupies the northern portion of the east façade. This door is a hanging side-sliding door, sheathed in vertical tongue-and-groove boards, framed on the inside, and hung with rolling hardware that slides to the south when opened (see photo OR_MarionCounty_JosephHenryMoserBarn_0002).

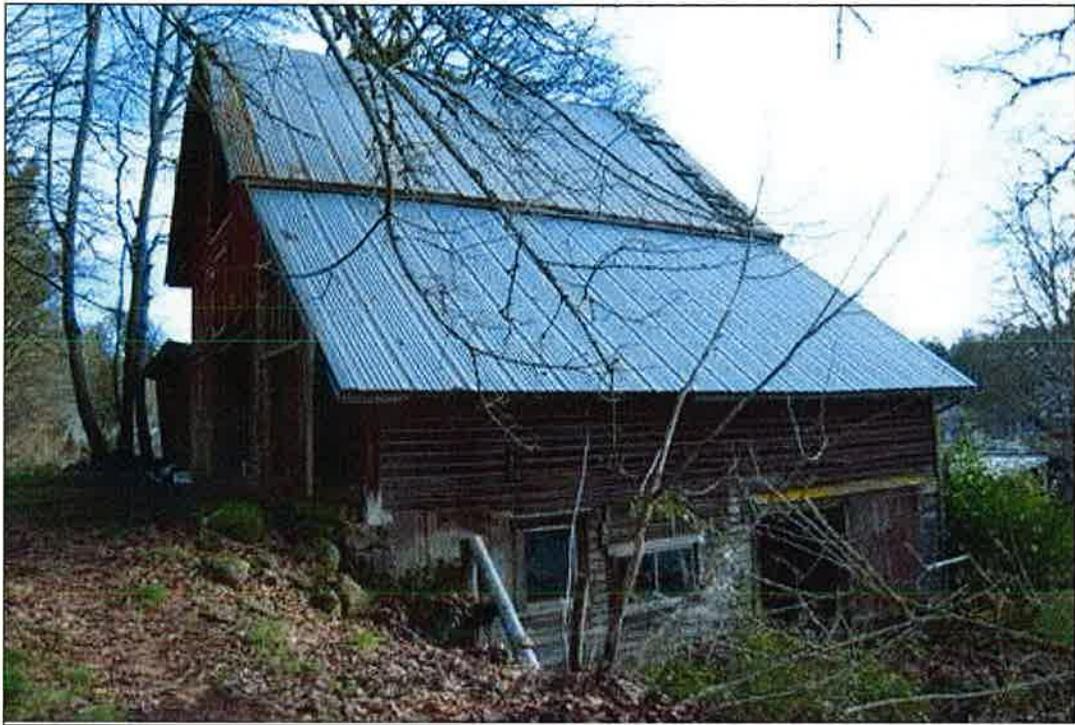
Photo 3 of 8: Looking southwest at the east and north façades.

The northern shed addition, constructed in 1912, runs along the entire north façade. It is covered by a shed roof that descends toward the north, extending from beneath the north eave of the main roof. This addition is clad in drop siding matching that on the main massing of the barn. The east elevation of the northern addition has a drive door made of matching siding, hung to the frame on the north side with heavy iron hinges. The area beneath the slope of the shed roof, above the drive door, is sided with vertical board, some of which is falling away (see photo OR_MarionCounty_JosephHenryMoserBarn_0003).

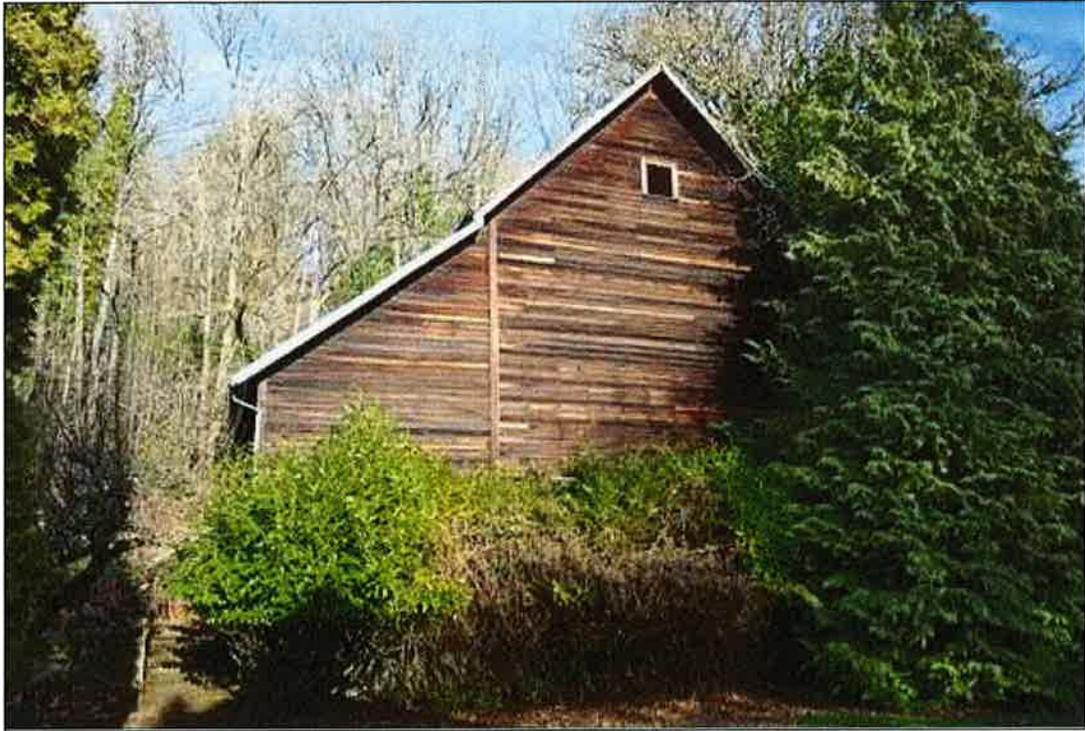
Photo 5 of 8: Looking east at the west façade.

The west façade faces S. 3rd Street. This section of the barn sits on a stacked stone foundation. The main massing of the barn and the north shed addition are divided by a simple vertical board. This façade has three window openings. Two of these are located on the lower level of the main massing of the barn, both with salvaged glazing added ca. 1956. On the north is a six-light, wood-framed window, and to the south is a four-over-four wood-sash window with simple board surround. The third opening is an unglazed opening located in the upper level of the main massing of the barn, beneath the peak of the gable. It has chicken wire mounted from the inside, intended to keep birds from entering (see photo OR_MarionCounty_JosephHenryMoserBarn_0005).

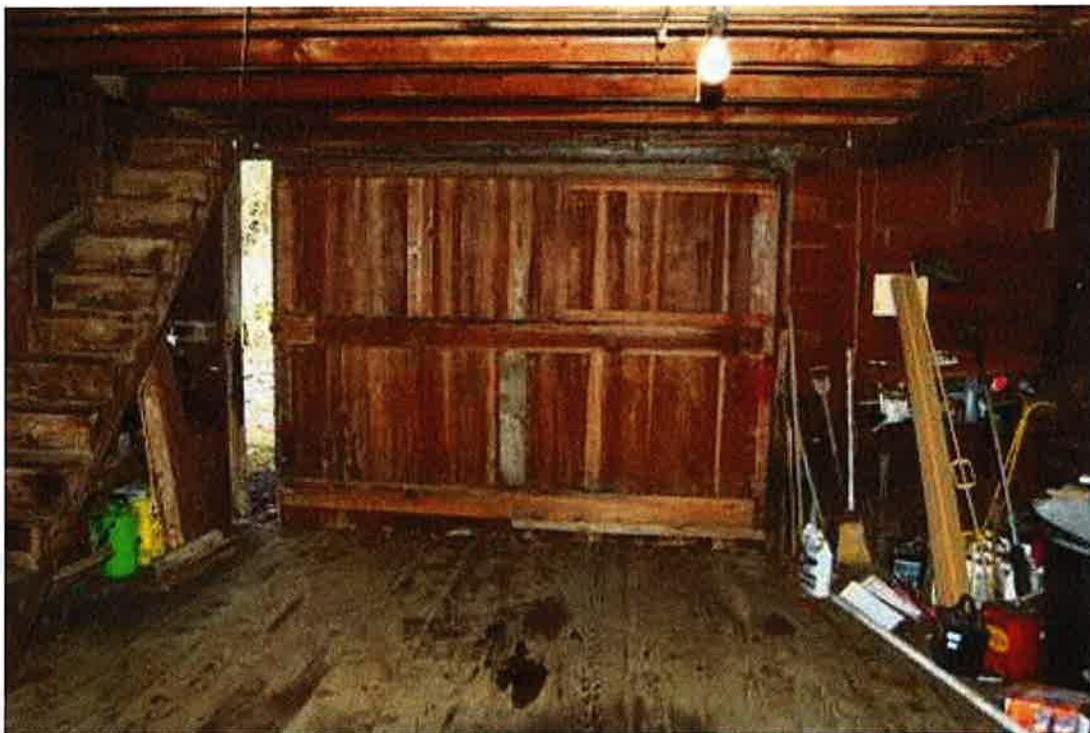
Photo 6 of 8: Looking east at the interior main mass, second floor, drive door closed.

The middle level has two interior areas (excluding the open south elevation shed addition), that within the main massing and that within the north elevation shed addition. There is no interior access between these two interior spaces. At the east end of the north wall of the main massing is a set of wood steps, ascending toward the east into the loft area (see photo OR_MarionCounty_JosephHenryMoserBarn_0006). The interior framing on this level includes the 2" x 6" wall framing and 2" x 4" diagonal cross-bracing descending from the northeast corner along the north wall, from the northwest corner descending along the north and east walls, and from the southwest corner descending along the east and south walls. Similar cross-bracing likely exists in the southeast corner; however, this area has interior walls clad with flush 1" x 8" horizontal shiplap. The upper loft level is supported by a single central beam oriented east-west down the center of the main massing, itself supported by one large square post approximately 12' feet east of the west wall. A second post, occupying a similar position from the east wall, has been removed. The floor joists for the upper level span from the built-up plates, with support from the center beam. These joists are paired 2" x 10" boards. A hay hole, evident from the lower level, exists at the south side of the middle level floor, near the southwest corner, above the former location of the horse stalls.

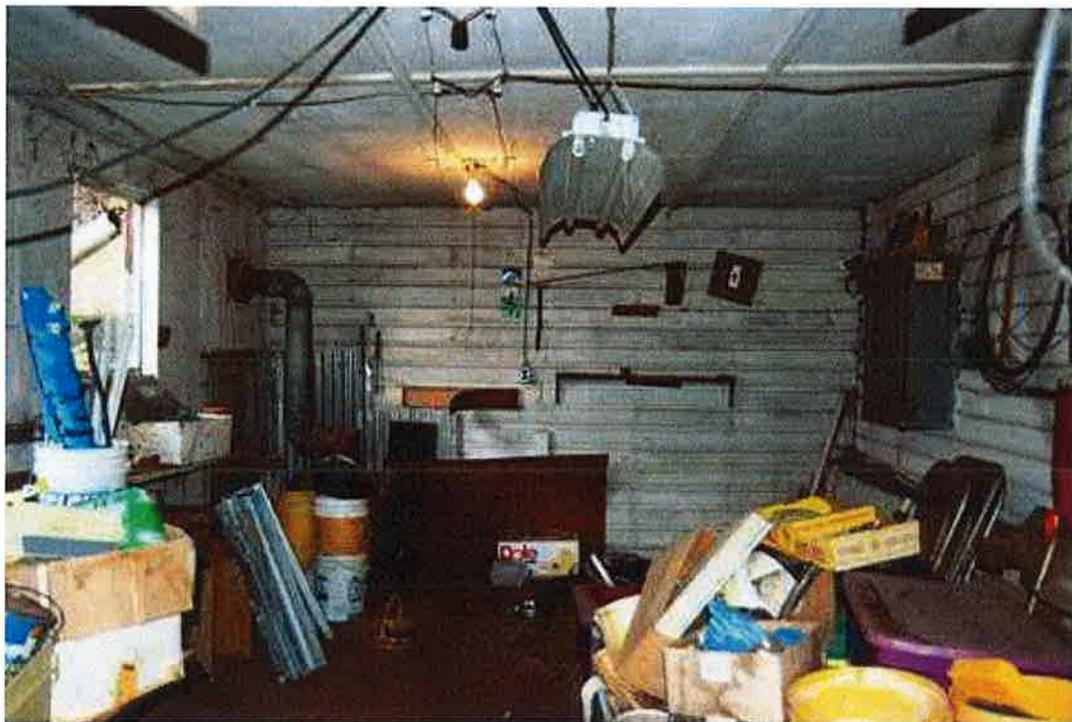
Photo 8 of 8: Looking east at the interior of the north side shed addition, first floor.

The lower level includes three areas. At the north, within the shed addition, is a workshop occupying the northeast corner and one remaining animal stall occupying the southeast corner. The interior of the main massing of the barn is a single open area. The workshop area is sided on the interior with coved shiplap salvaged from a home in Silverton and applied in this area in 1956 (see photo OR_MarionCounty_JosephHenryMoserBarn_0008). The shop has a slightly raised floor clad with plywood, and a ceiling clad with plywood. Access is through a hung sliding door on the west wall of the shop, made from exterior-framed coved shiplap siding. The north wall is also clad in plywood. Salvaged shelves and cabinets are attached to the north, south, and east walls, and a cast-iron wood stove sits in the northeast corner with a stovepipe that exits through the north wall. Opposite the shop area, on the west wall of the shed attachment, is the only remaining animal pen, a small calf pen partially enclosed to contain livestock. The south wall of the stall, and that of the shop area, is the former exterior wall of the main massing and is sided accordingly (coved shiplap). The original hung sliding door remains, dividing the shed addition area from the interior main massing. The interior of this area, which once contained six horse stalls, is now open. Scarring on the overhead beams indicates the locations of the former horse stall walls. The east elevation is composed of the mortared stone foundation wall, with stem walls extending approximately 8' to the west along both the north and south walls of the main massing. At the east side of the south wall is an exterior door made of internally framed tongue-and-groove vertical boards corresponding to those evident on the east side's exterior on the south elevation, of the main massing. This door is unused.
