Feasibility Study

Silverton Community Pool

City of Silverton

Silverton Community Pool Feasibility Study Summary Report

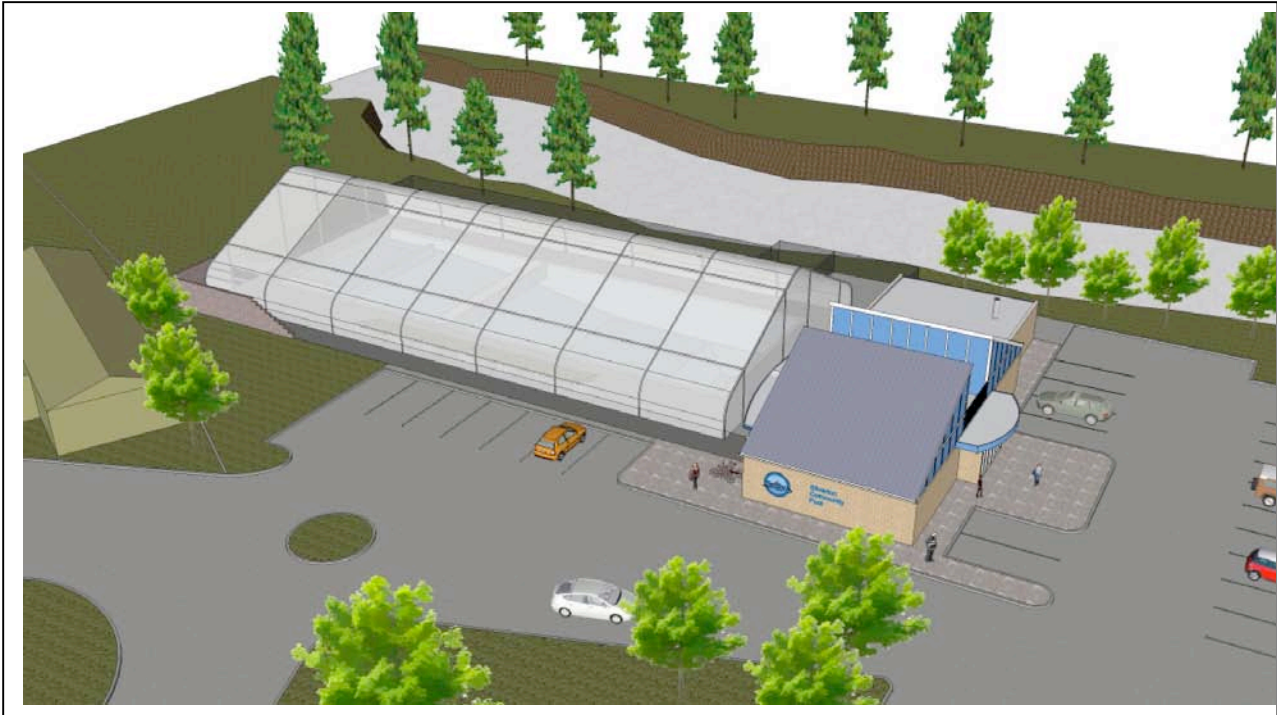
Scenario 1 – Maintain Current Facility

1. Replace and erect fabric (roof only) for roof structure in Fall 2012
 - a. Replace short bolts with proper length bolts
2. Make repairs to pool for long term use
 - a. Repair/replace all pool joints
 - b. Resurface all pool edge gutters/drains
3. Provide new connection to bathhouse for winter use
4. Maintain HV system as needed, plan for replacement

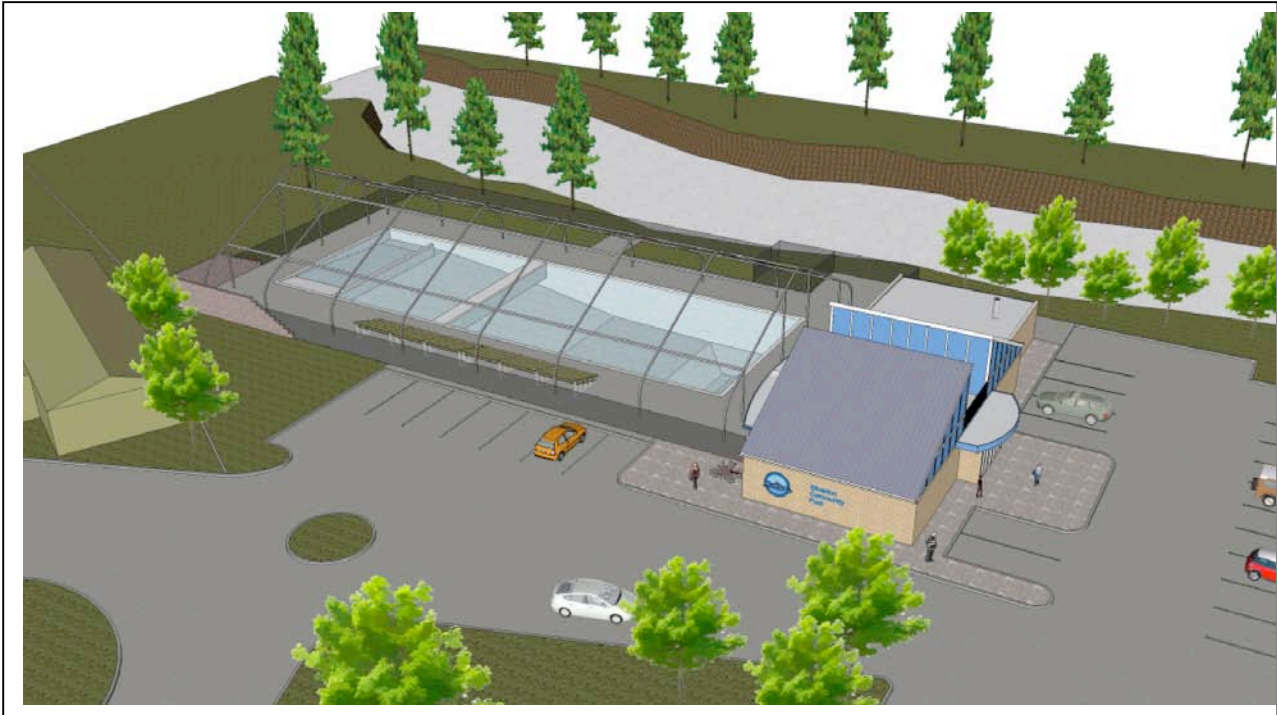
Scenario 2a – Summer Only - Temporary

1. Remove existing cover and make no plans to reinstall for Winter/Spring 2012/2013
2. Winterize pool and bathhouse on selected date for winter shutdown, install pool and tile edge safety cover
3. Repair only to pool shell components until future decisions are made (no 'permanent' repairs)
 - a. Repair pool joints as needed
 - b. Repaint pool as needed

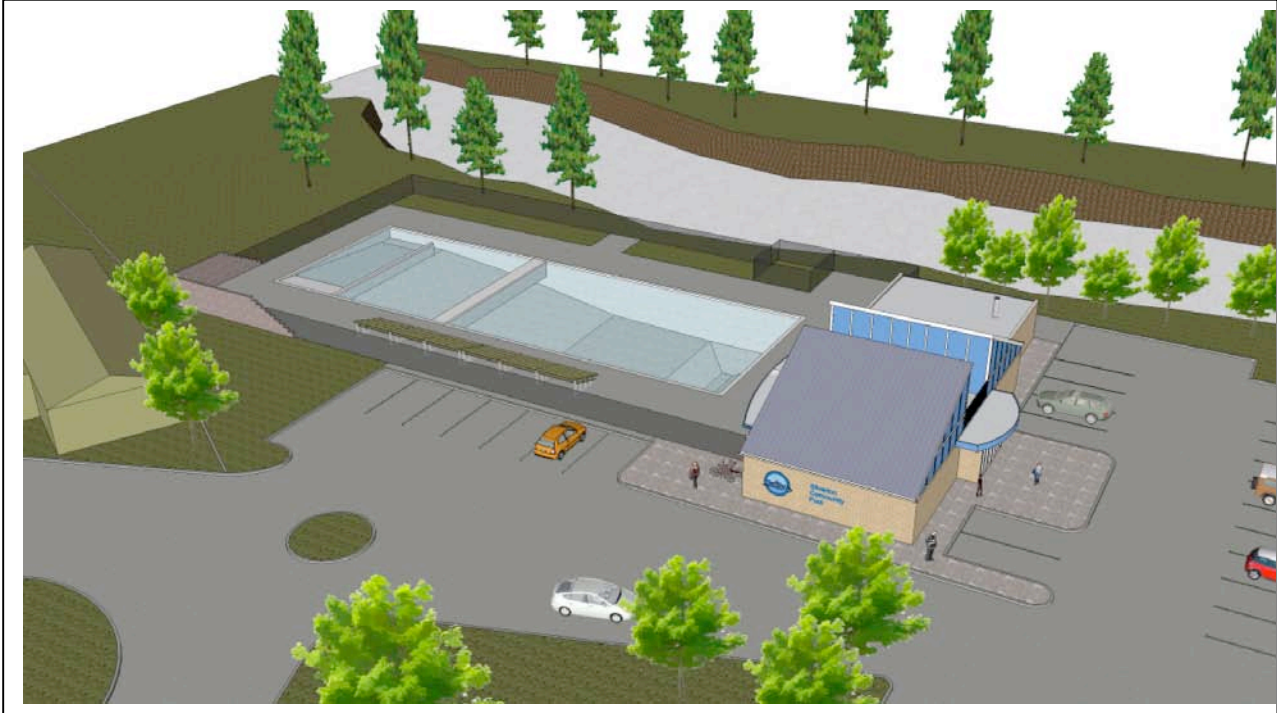
Scenario 2b – Summer Only – Permanently

1. Remove aluminum structure in the Fall of 2012
 - a. Make provisions for pool and pool deck lighting and sound systems for seasonal use, currently attached to aluminum structure
2. Winterize pool and bathhouse on selected date for winter shutdown, install pool and tile edge safety cover
3. Make repairs to pool for long term use
 - a. Replace/repair all pool joints
 - b. Resurface all pool edge gutters/drains

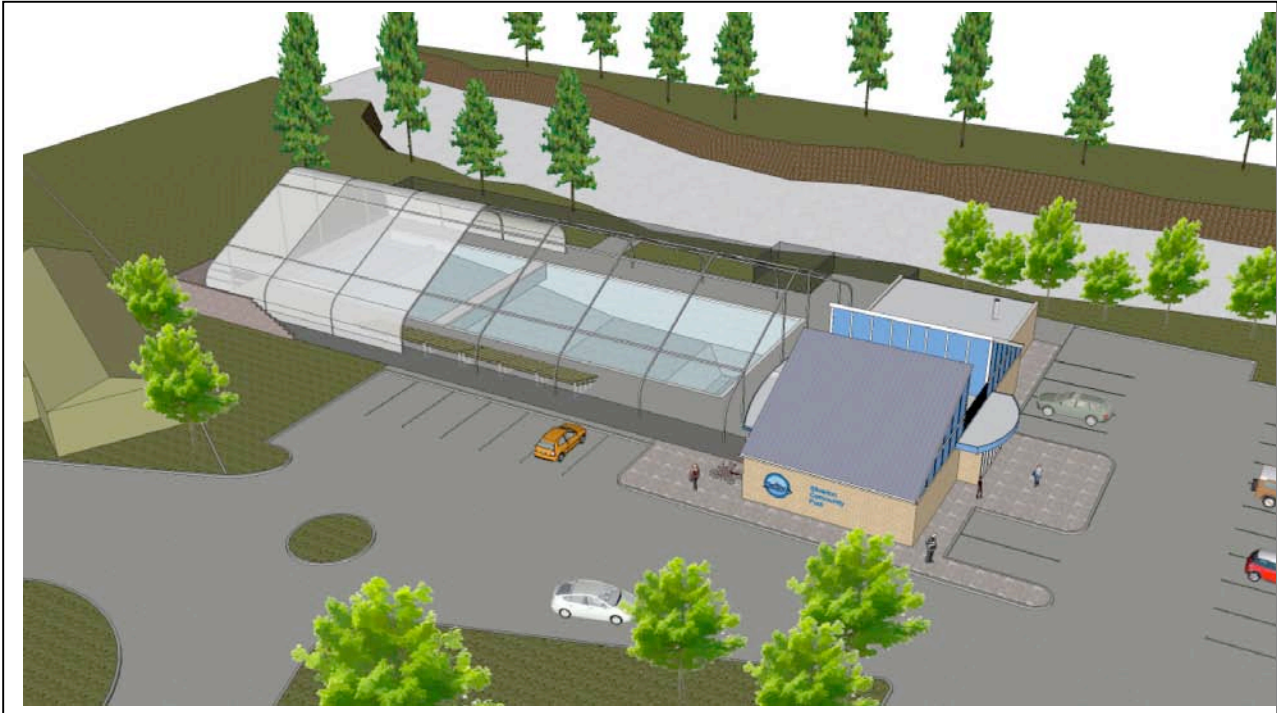
Scenario 3 – Partial Year-Round Cover

1. Replace (roof, plus side/end panels, and doors) and erect fabric for roof structure in Fall 2012
 - a. Add fire sprinkler system to portion of fabric structure to be year-round
2. Make repairs to pool for long term use
 - a. Replace all pool joints
 - b. Resurface all pool edge gutters/drains
3. Maintain HV system as needed, plan for replacement

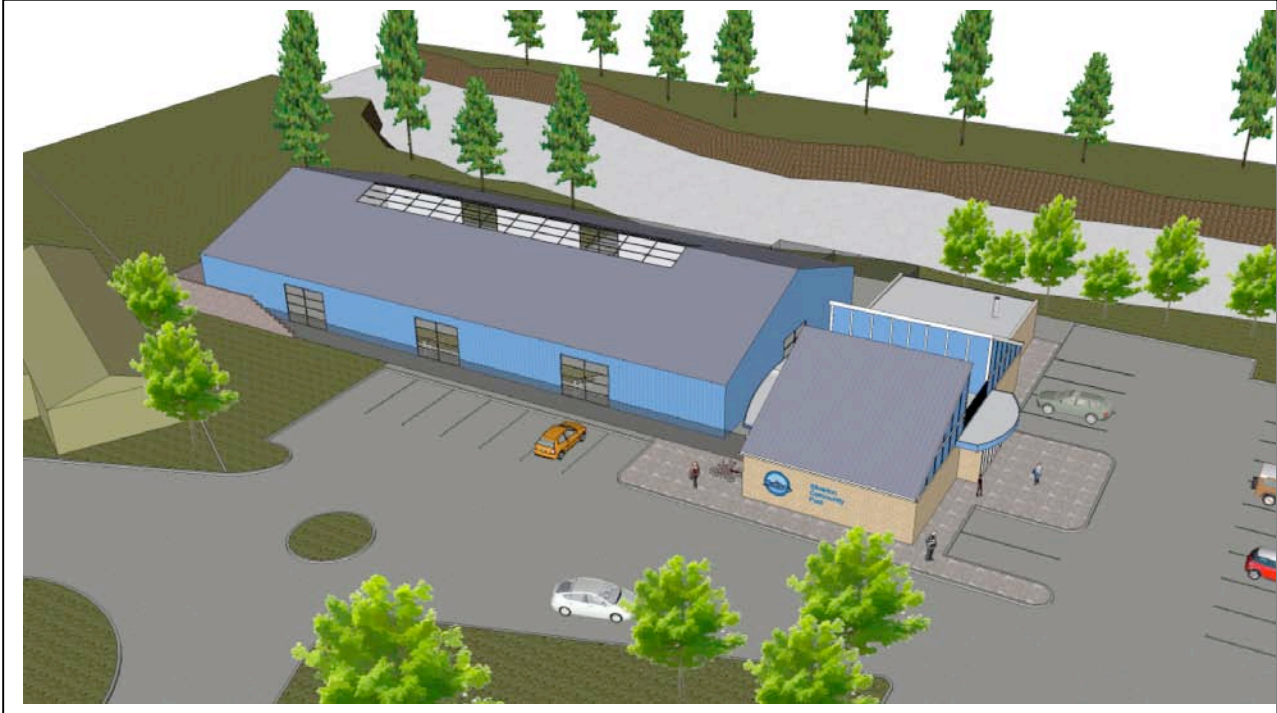
Scenario 4a – Permanent Replacement – Conventional Construction

1. Operate as a seasonal facility until funding secured and ready to construct
2. Prepare design and construction documents, and bid project (6-10 months)
 - a. Construct natatorium beginning in Fall (no earlier than 2013)
3. Make repairs to pool for long term use
 - a. Replace all pool joints
 - b. Resurface all pool edge gutters/drains

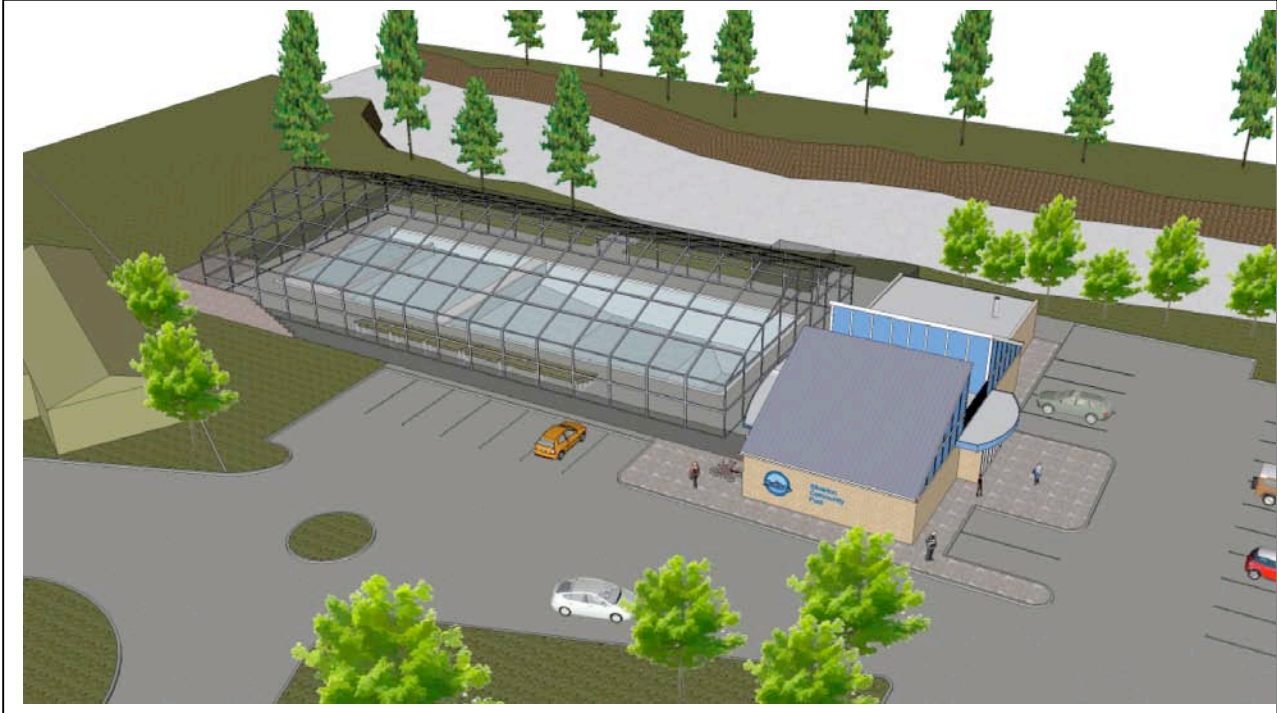
Scenario 4b – Permanent Replacement – Polycarbonate Glazing System

- Provides for permanent, year-round indoor programming with view to outdoors
- Provides permanent indoor connection to existing year-round bathhouse
- Possible reduction in energy costs in winter/spring due more energy efficient building envelope
- Operable portions of structure allow for natural ventilation when appropriate
-
-

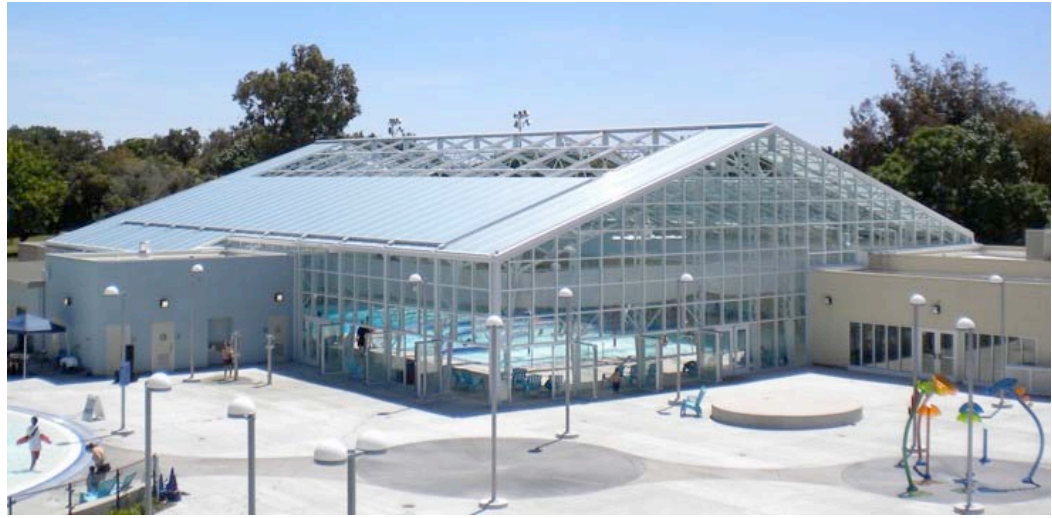
Polycarbonate Glazed Structures

Open Aire, Inc.
Manufacturers information:

When compared with traditional construction, OpenAire structures offer tremendous long-term value costing less to maintain and operate.
