January 4, 2016

## Re: Silver Creek Dam (S-66) – Inspection Summary

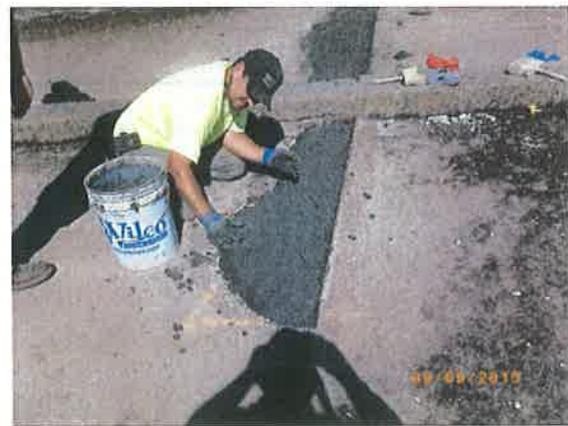
Cracking and spalling was observed along some of the concrete spillway's transverse slab joints. It appears that this condition may have been caused by hydraulic uplifting of the downstream edge of the adjacent slab. The inspection team returned to the site on September 9, 2015, for the City's repair of the worst of these slab joints, the second from the crest, on the right side of the spillway. Loose concrete was removed and the top of the joint was exposed. The joint was dry. A ¼-inch layer of fine soil was observed underneath the waterstop, where it had lost its bond with the underlying concrete. It appeared that the upper slab had lifted about 3/4-inch relative to the lower slab. The repaired area should be monitored for any changes. If similar cracking returns, it may be an indication that slab uplifting has recurred and further investigation would be required.

Repairing damaged concrete at second traverse joint from crest; September 9, 2015.

Stilling basin	<input type="checkbox"/> N/A <input checked="" type="checkbox"/> Functional <input type="checkbox"/> Minor Erosion <input type="checkbox"/> Severe Erosion/Undercutting	
Aux. Spillway	<input type="checkbox"/> Yes <input checked="" type="checkbox"/> No (use comments below)	
Comments:	Cracks and spalling at right side of second lateral joint below crest.

1. Continue vegetation management in your ongoing maintenance program.
2. Provide vehicular access to the main embankment section.
3. Monitor the repaired spillway joint for changes.
4. Continue to develop a remote monitoring program for the dam.
5. Investigate leakage through the low level conduit.
