US Army Corps
of Engineers®
Portland District

Final Report

Silver Creek Dam Potential Failure Modes Analysis (PFMA)

11 APRIL 2011

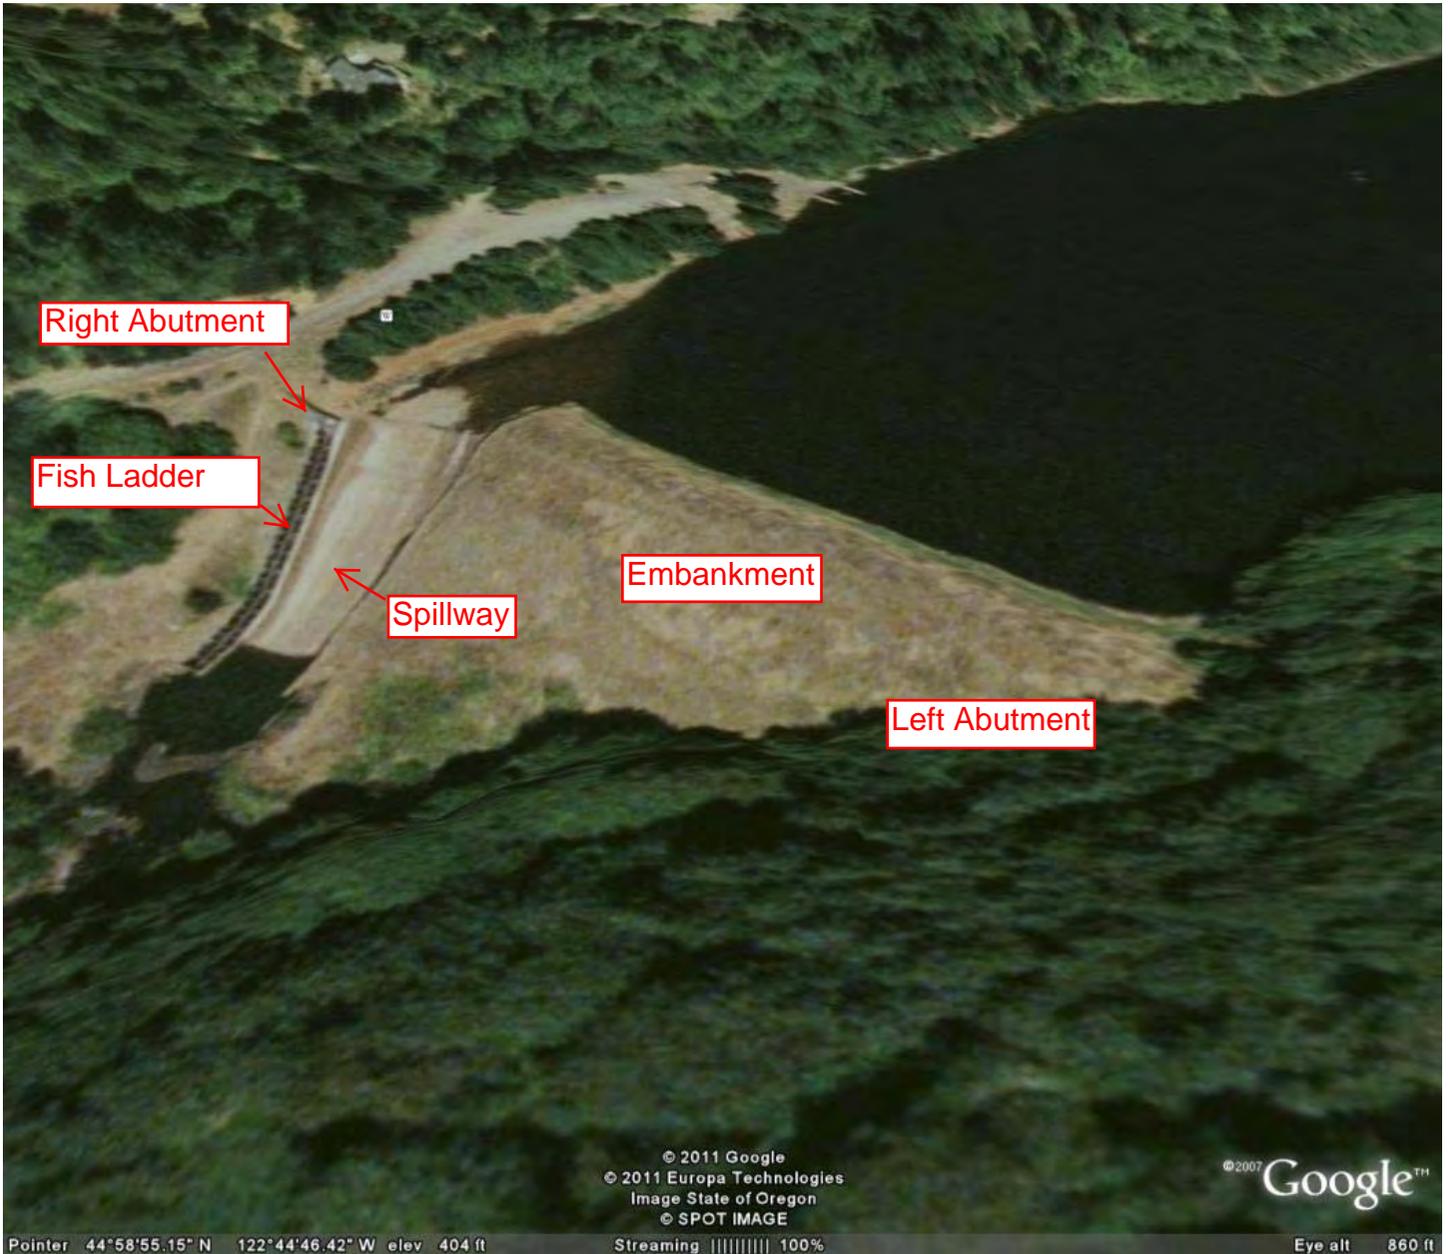
Figure 1. Site Plan

The dam was constructed between May 1973 and November 1974. Upon first filling, seepage was observed on the right side of the earth embankment. Figure 1 is a site plan for the dam. The reservoir was lowered shortly thereafter and a series of horizontal drains were installed into foundation materials below the right side of the earth embankment. In addition, a buttress filter layer berm was placed on much of the right side of the embankment to intercept seepage not captured by the drains.
